RECAPP Facility Evaluation Report

Belmead Elementary School

B3054A
Edmonton

Evaluation Company: Francis Ng Architect Ltd.
Evaluation Date: August 18 2010
Evaluator Name: Francis Ng

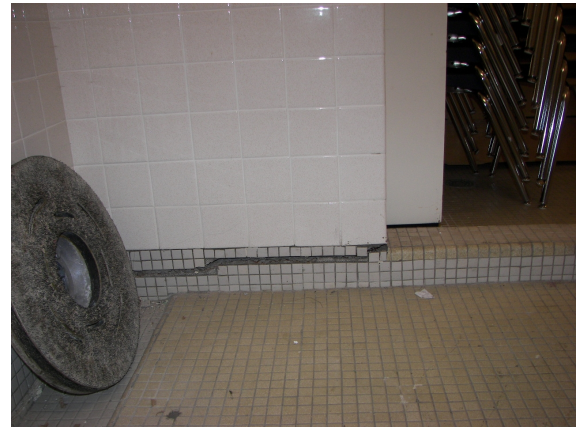
(1978) (Early Childhood 18, Classroom 29; Boys Locker/Shower 17; Girls Washroom 27; Boys Washroom 24, 52; Unisex Washroom 39) - concrete slab on grade has settled.

(1978) (Boys Locker/Shower 17) - concrete slab on grade has settled.

Mudjack concrete slab on grade. (approx. 270 square metres)

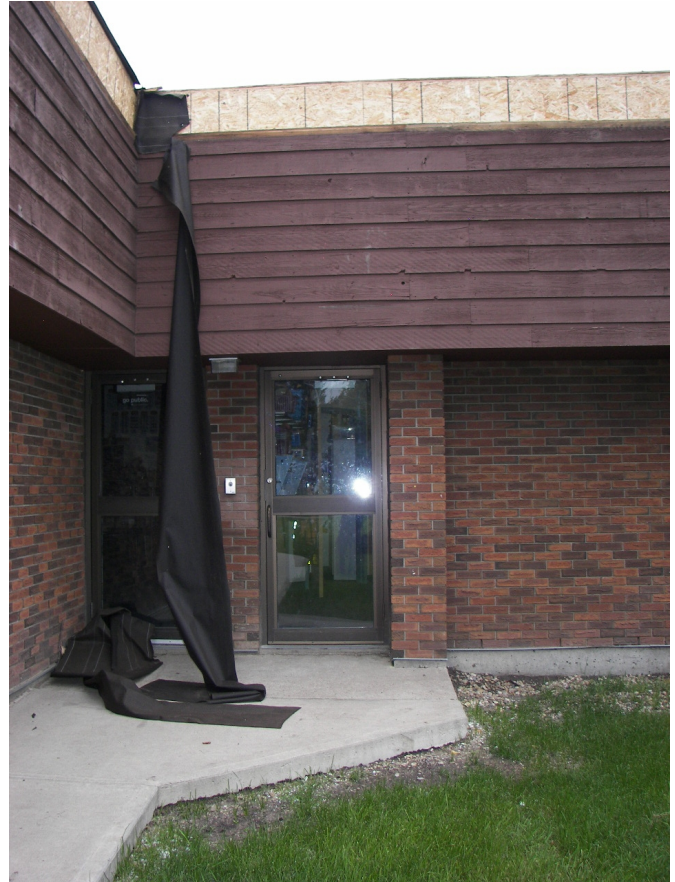
<u>Rating</u>	<u>Installed</u>	<u>Design Life</u>	<u>Updated</u>
3 - Marginal	1978	30	MAR-11

(1978) Metal flashing is being installed on site.

Replace metal flashing. (approx. 280 linear metres)

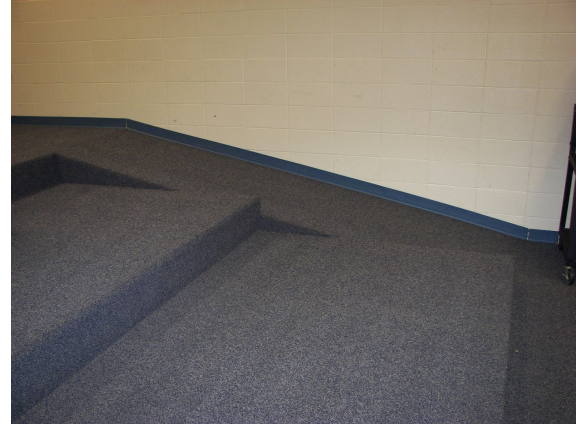
(1978) (Music 8) - wood ramp is too steep.

Replace ramp. (1 ramp)
