RECAPP Facility Evaluation Report

Edmonton School District No. 7

Lee Ridge Elementary School

B3194A
Edmonton

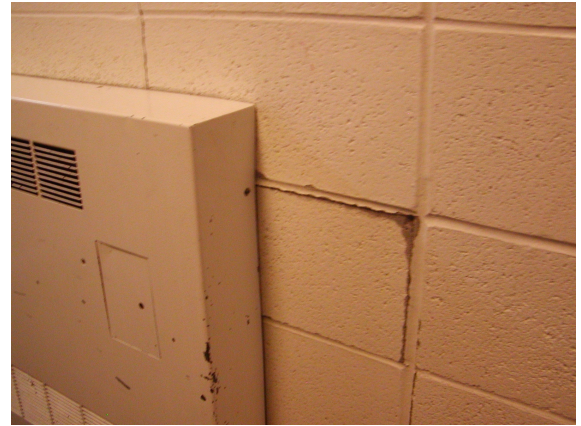
corridor #c4

Event: Repair concrete block**Concern:**

Stress cracks in interior concrete block walls in corridor #c4, corridor #c3 at exit F2, strg. #55, stage ancillary #36 / #c10, stage ancillary #36 / gym wall and ancillary #41at wall dividing #41/#42.

Patch and repaint cracks.

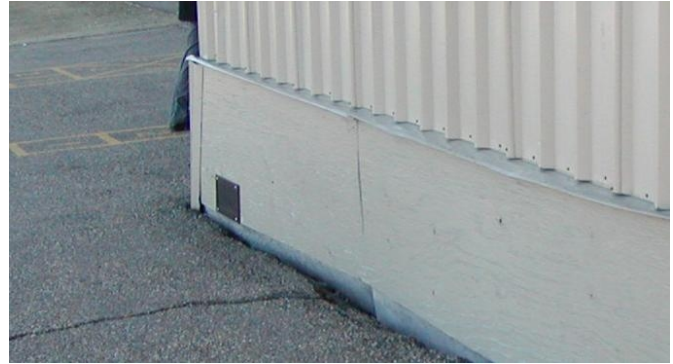
Pod #29

Event: Replace skirting around pod (6 m2)**Concern:**

Metals siding skirt on pod #29 covering crawlspace is missing on one side and has been replaced with plywood sheathing which is deteriorating.

Replace plywood sheathing with metal siding to match existing siding on pod.

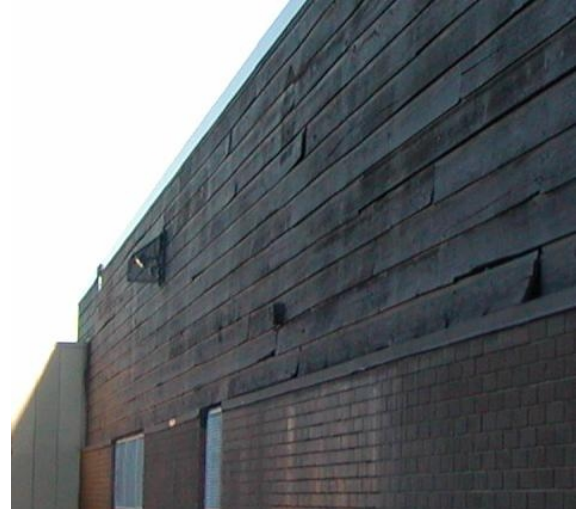
Event: Replace wood siding (564 m2)**Concern:**

Wood siding is old and cracking and splintered in many areas and falling off.

Replace wood siding with metal siding all around building.

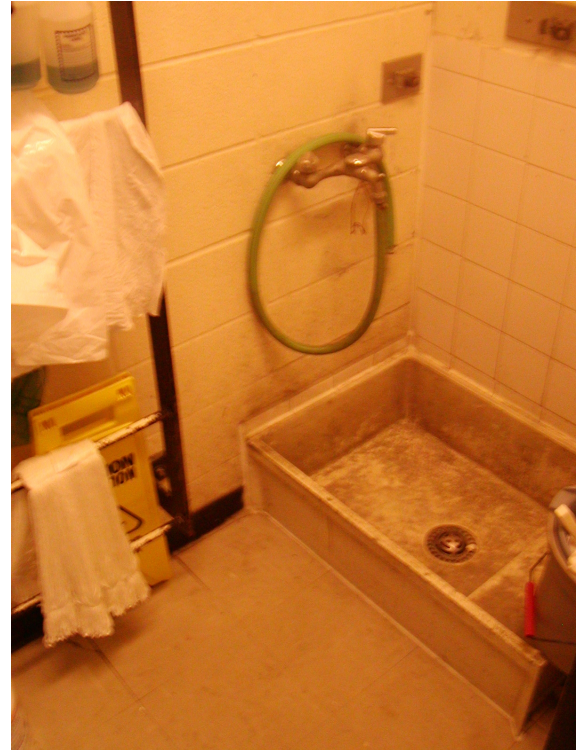
Janitor room

Event: Replace 1 janitor slop sink**Concern:**

Slop sink in janitor room needs to be replaced.

Replace slop sink.

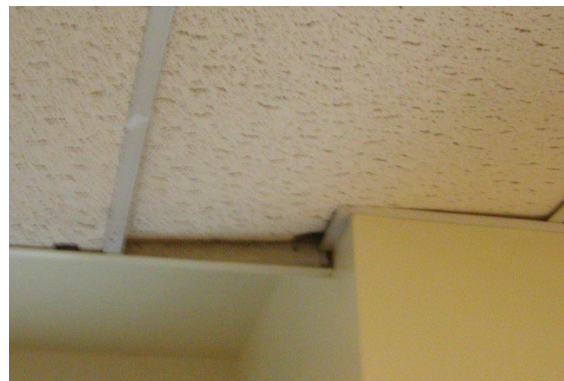
Ceiling tile corridor #c4

Event: Repair suspended t-bar ceilings**Concern:**

T-Bar ceiling is sagging at wall/ceiling intersection in classroom #5, in classroom #17, Ancillary #41. Sagging occurring in some areas of corridor #c4 and other locations. Ceilings in all pods except #30 are sagging. 4 damaged ceiling tiles in computer room #4, 6 tiles in office #8. Stained ceiling tiles need to be replaced in numerous other locations. Damaged fibreglass ceiling tiles in pod corridors need to be replaced.

Repair and prop up ceilings.

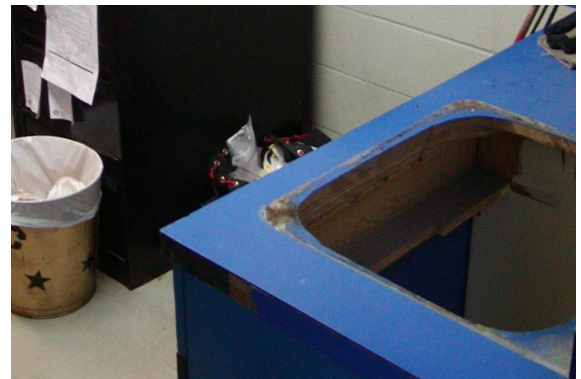
Caretakers office

Event: **Replace sink.**

Sink in caretakers office is missing.

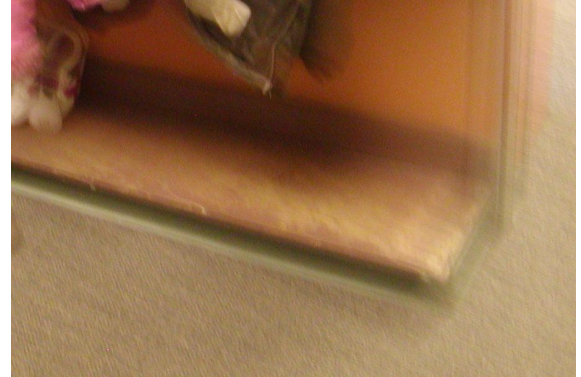
Shoe shelf

Event: Replace shoe shelf**Concern:**

Shoe shelves in coat areas are worn and damaged.

Replace shoe shelves in all pods.

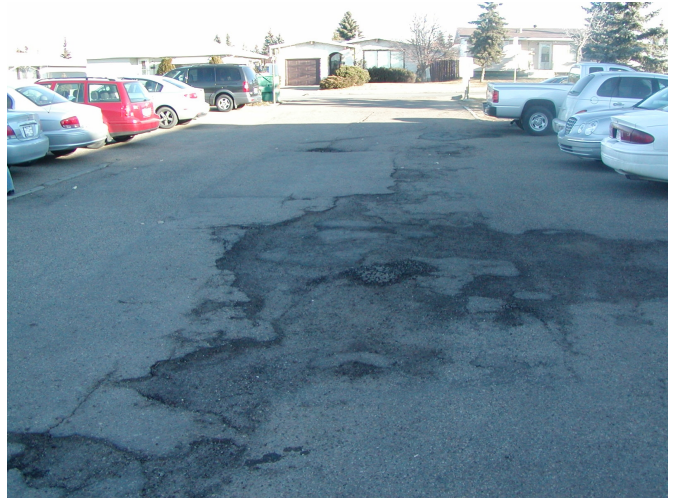
Staff parking lot.

<u>Rating</u>	<u>Installed</u>	<u>Design Life</u>	<u>Updated</u>
2 - Poor	1976	25	MAR-08

**Event:** **Replace asphalt parking lot (685 m2)****Concern:**

Staff parking lot has significant potholes and deterioration.

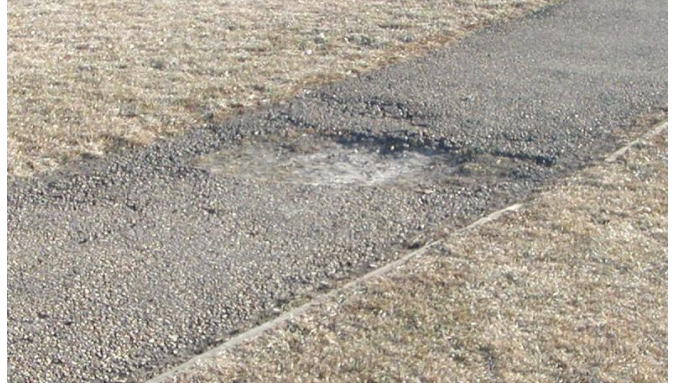
Asphalt pavement walkway around back of the building between pods and along the staff parking lot.

<u>Rating</u>	<u>Installed</u>	<u>Design Life</u>	<u>Updated</u>
3 - Marginal	1976	20	MAR-08

**Event: Repair asphalt paved walkways (127 m2)****Concern:**

Asphalt walkways are deteriorating, worn and uneven in some areas.

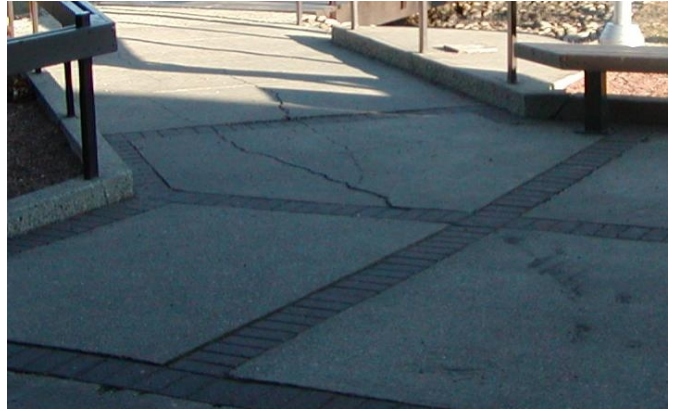
Rigid pedestrian pavement at front of the buiding and entrances.

<u>Rating</u>	<u>Installed</u>	<u>Design Life</u>	<u>Updated</u>
3 - Marginal	1976	25	MAR-08

**Event: Rpelace concrete walkways (185 m2)****Concern:**

Pavement at front entrance is cracking and is uneven in some places.

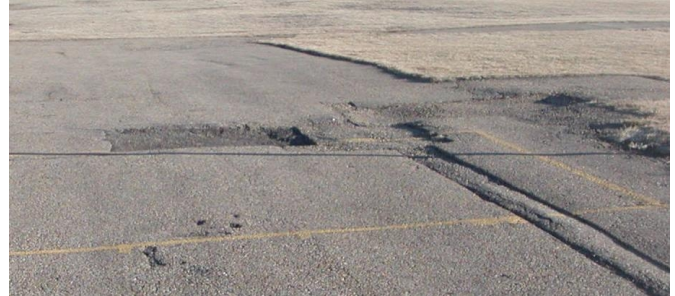
Asphalt paved recreation areas on south side and rear of school.

<u>Rating</u>	<u>Installed</u>	<u>Design Life</u>	<u>Updated</u>
2 - Poor	1976	25	MAR-08

Event: Life Cycle Replacement repave recreation areas
(1507 m2)

Asphalt paving in recreation areas has potholes, deterioration and is uneven in some areas.
