RECAPP Facility Evaluation Report

Edmonton School District No. 7

Meadowlark Elementary School

Evaluation Details	
Evaluation Company:	A&E Architectural & Engineering Group Inc,
Evaluation Date:	October 29 2007
Evaluator Name:	Vic Maybroda

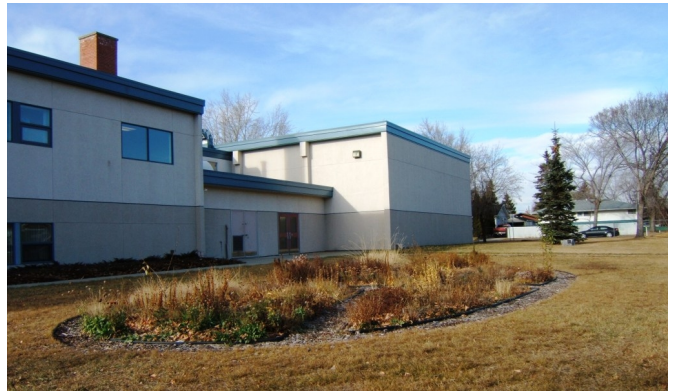
Picture 070.jpg

Two colour textured finish.

<u>Rating</u>	<u>Installed</u>	<u>Design Life</u>	<u>Updated</u>
5 - Good	1998	75	MAR-08

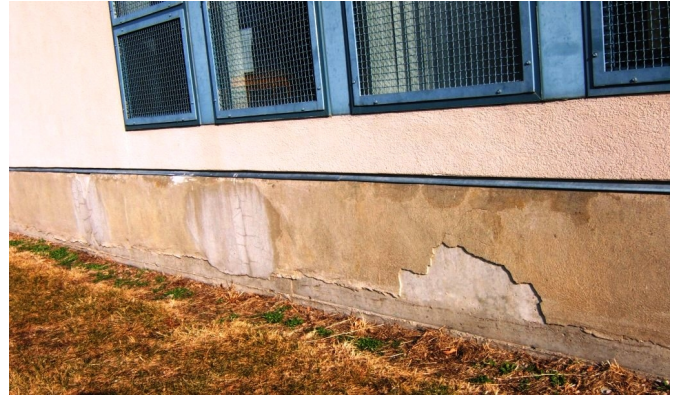
Coloured textured EIFS finish.

<u>Rating</u>	<u>Installed</u>	<u>Design Life</u>	<u>Updated</u>
3 - Marginal	1998	75	MAR-08

Damaged acrylic stucco finish.

Exposed substrate subject to weather damage.

Event: Repair 5 sq. M Exterior Insulation and Finish Systems (EIFS)* - 1963 Section]

Repair damage finish to match existing.

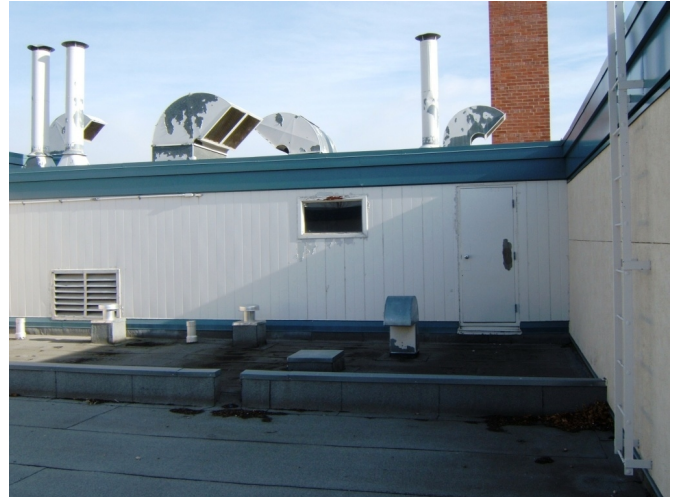
Mechanical room exterior walls.

<u>Rating</u>	<u>Installed</u>	<u>Design Life</u>	<u>Updated</u>
3 - Marginal	1958	40	MAR-08

Painted mechanical room exterior finish.

Exterior panels deteriorated and lack adequate weather protection to wall system.

Event: Replace 60 sq M Siding Panels - 1958 Section

Refinish/replace wall paneling and related elements.

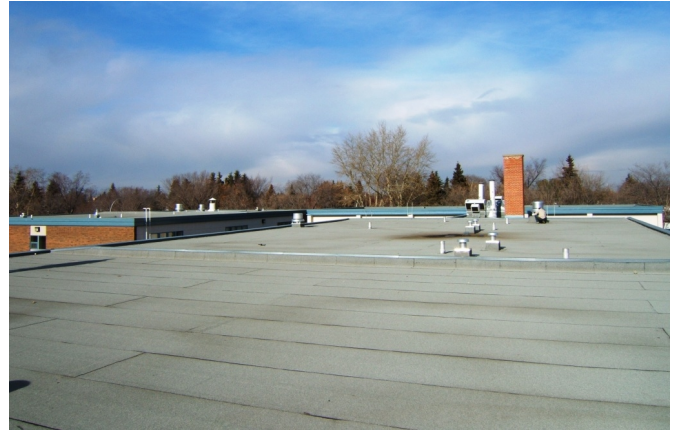
<u>Rating</u>	<u>Installed</u>	<u>Design Life</u>	<u>Updated</u>
4 - Acceptable	1998	25	MAR-08

View of 1958 Roof Section.

Event: Replace 4,100 sq. M SBS Membrane Roofing

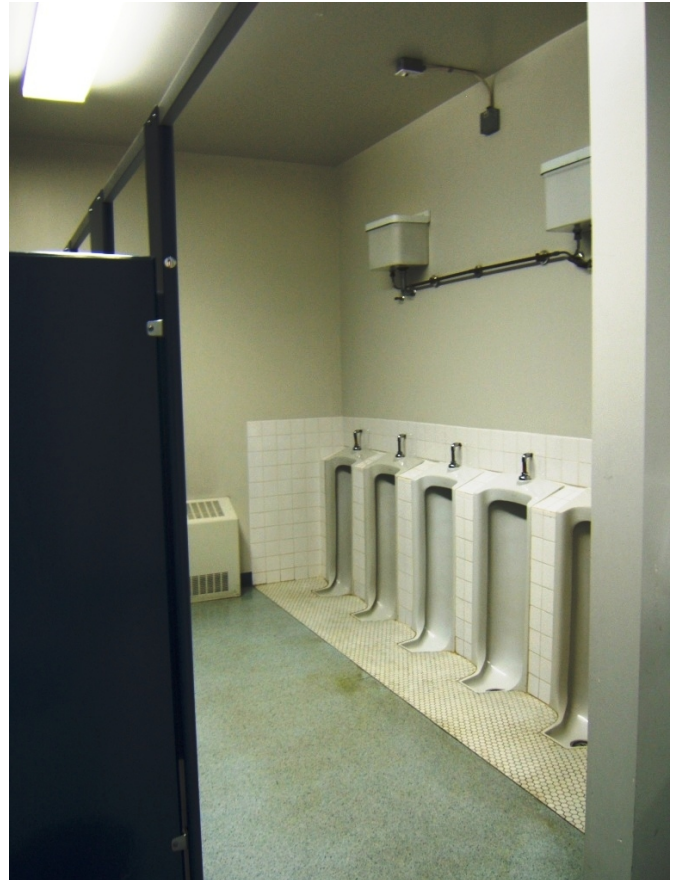
Ceramic tile located around boys urinals only.

<u>Rating</u>	<u>Installed</u>	<u>Design Life</u>	<u>Updated</u>
4 - Acceptable	1958	40	MAR-08

View of boys washroom.

Event: Replace Tile Wall Finishes - All Sections**

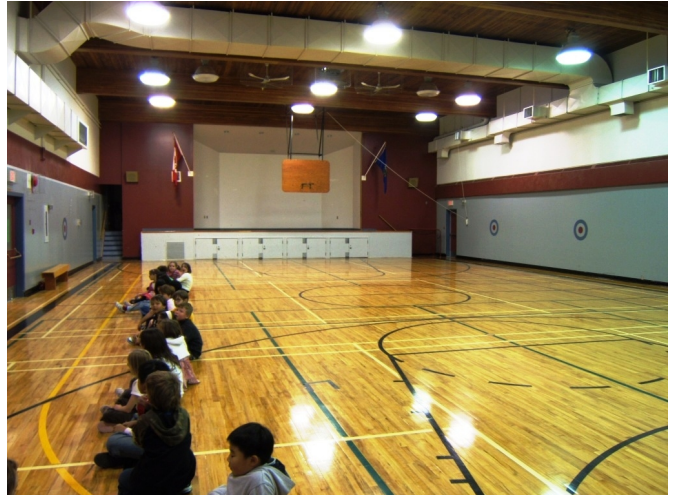
Gymnasium flooring.

<u>Rating</u>	<u>Installed</u>	<u>Design Life</u>	<u>Updated</u>
4 - Acceptable	1998	30	MAR-08

Gymnasium finishes.

Event: Replace 358 sq. M Wood Flooring - 1958 Section

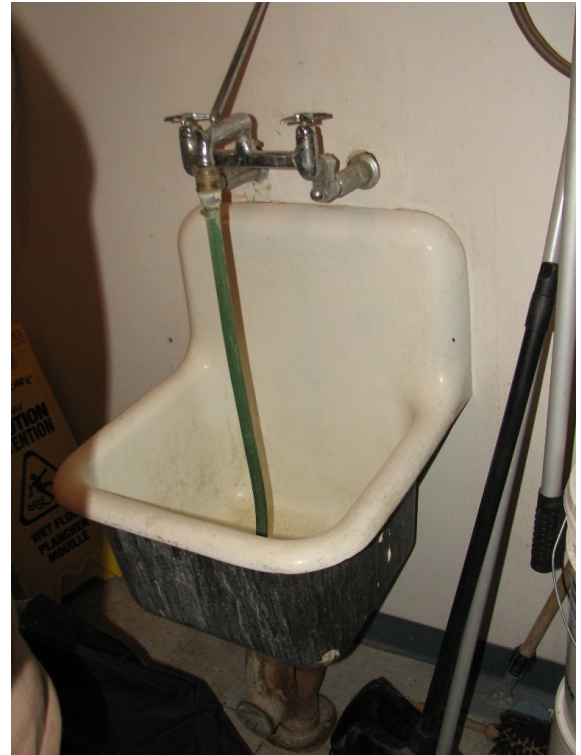
mop sink - wall hung.jpg

Two (2) wall hung mop sinks complete with hot/cold metering faucet, show signs of corrosion and leak.

Wall hung mop sinks are corroded and leak water.

Event: Replace Two (2) Wall Hung Mop Sinks

Replace wall hung mop sinks with molded stone, floor mounted mop sinks complete with valve breakers.

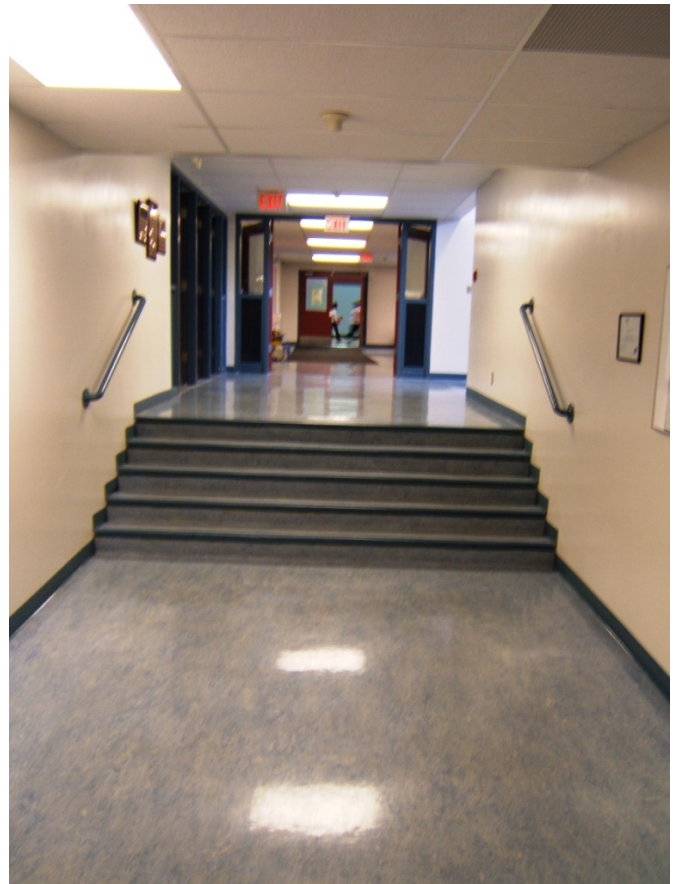
Stair access only from main floor to second floor and between floor areas of 1958 section.
Elevator required plus corridor and main entry BFA stair lifts required.

<u>Rating</u>	<u>Installed</u>	<u>Design Life</u>	<u>Updated</u>
4 - Acceptable	1958	0	MAR-08

Corridor stairs located in 198 section.

Event: Barrier Free Access Upgrade

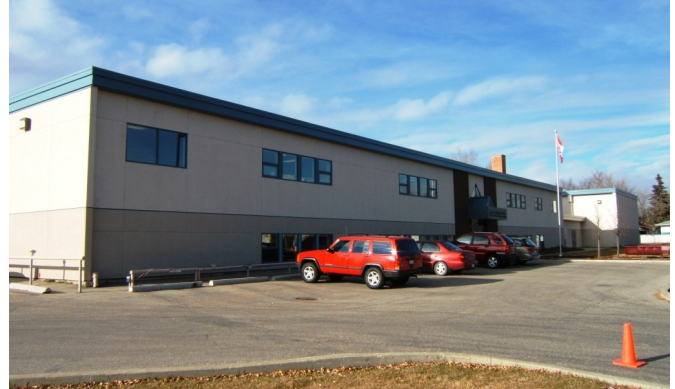
Staff parking only.
Visitor parking on street.

<u>Rating</u>	<u>Installed</u>	<u>Design Life</u>	<u>Updated</u>
4 - Acceptable	1988	25	MAR-08

**Event: Replace 220 sq. M Flexible Paving Parking Lots(Asphalt)****

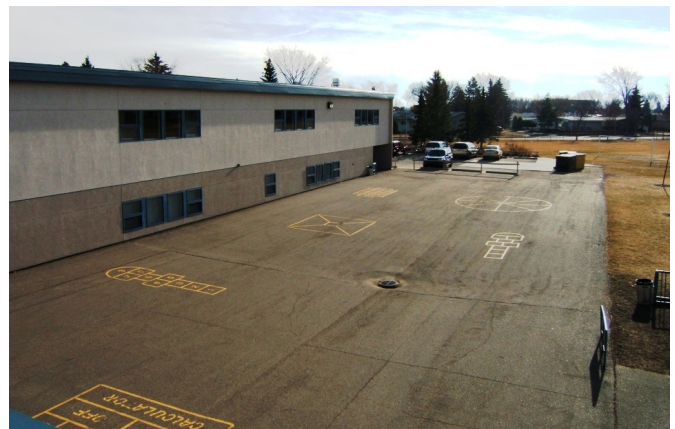
Located on west side of 1958 section.
Catch basin requires lowering.

<u>Rating</u>	<u>Installed</u>	<u>Design Life</u>	<u>Updated</u>
5 - Good	2002	25	MAR-08

Event: Replace 180 sq. M Athletic and Recreational Surfaces**
