RECAPP Facility Evaluation Report

Edmonton School District No. 7

Princeton Elementary School

B3252A
Edmonton

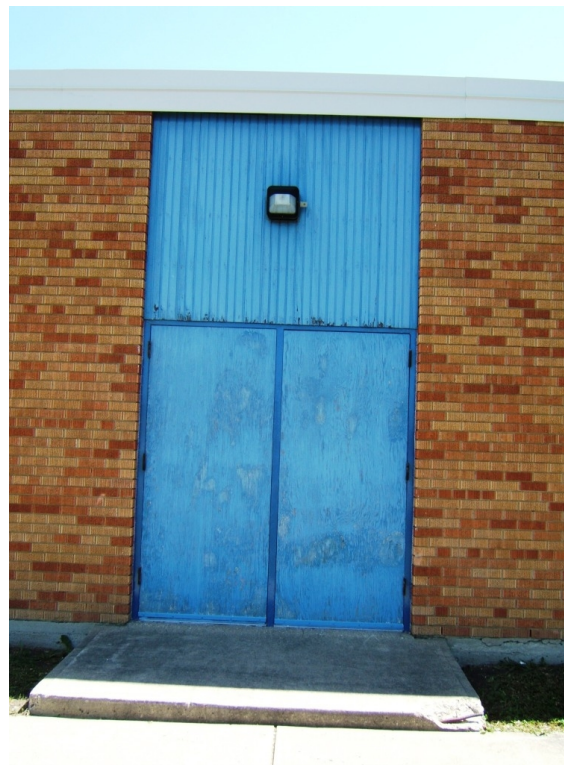
B2010.01.06.04 Wood Siding - Both Sections**

<u>Rating</u>	<u>Installed</u>	<u>Design Life</u>	<u>Updated</u>
3 - Marginal	0	40	MAR-09

Deteriorated panels may lead to damaged substrate.

Painted wood panels over exterior doors.

Replace painted wood panels.

<u>Type</u>	<u>Year</u>	<u>Cost</u>	<u>Priority</u>
Failure Replacement	2009	\$16,000	High
