RECAPP Facility Evaluation Report

Grande Yellowhead Reg Div #35

Sheldon Coates Elementary School

Evaluation Details	
Evaluation Company:	Wade Engineering
Evaluation Date:	October 24 2007
Evaluator Name:	Mike Pangman/Ron Shannon

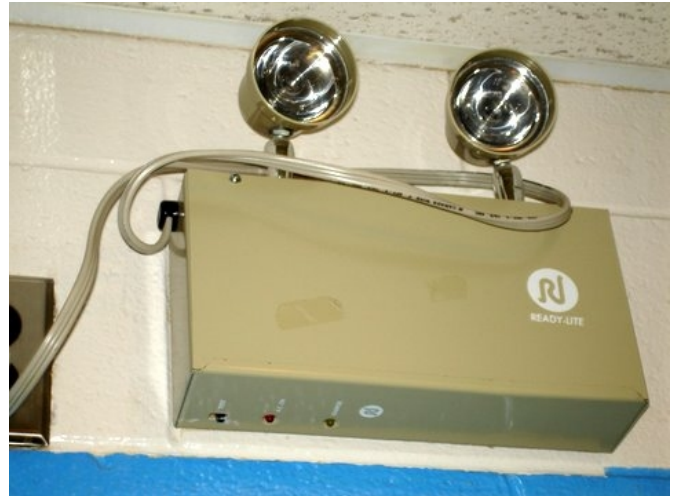
DSC01939.jpg

Old ReadyLite ('77) and new Lumacell lights ('92) installed throughout. Original units now beyond estimated life cycle (see pic)

<u>Rating</u>	<u>Installed</u>	<u>Design Life</u>	<u>Updated</u>
3 - Marginal	1976	20	MAR-08

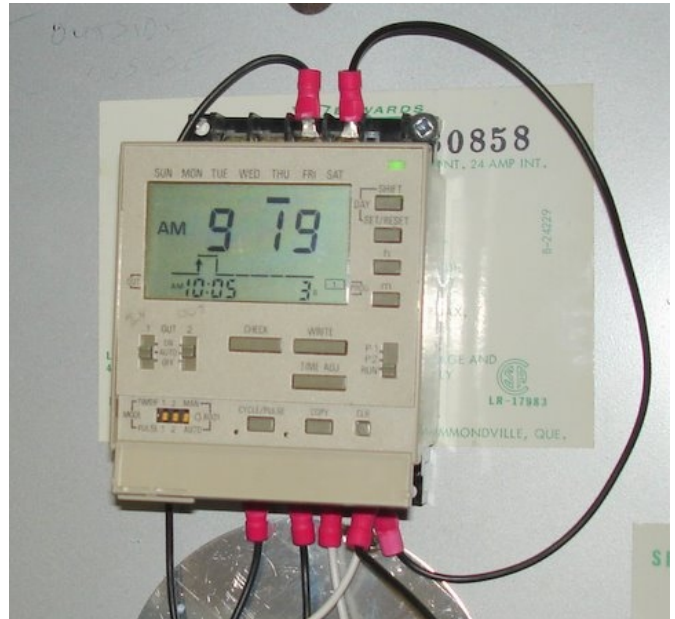
DSC01938-1.jpg

Clock system seems to have been upgraded to digital system, brand unknown, may have been installed during '92 revamp (see pic).

<u>Rating</u>	<u>Installed</u>	<u>Design Life</u>	<u>Updated</u>
4 - Acceptable	1992	25	MAR-08

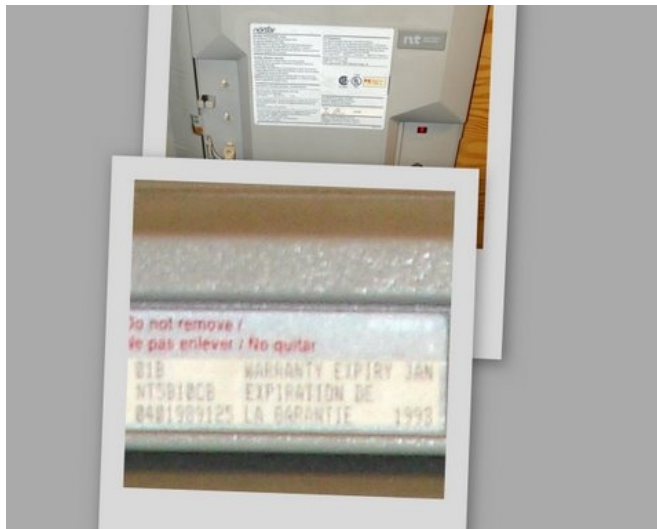
collage2.jpg

Meridian / Nortel system. Install date unknown (warranty expired 1993)

<u>Rating</u>	<u>Installed</u>	<u>Design Life</u>	<u>Updated</u>
4 - Acceptable	1991	25	MAR-08
