RECAPP Facility Evaluation Report

Racette Junior High School

B4092A

Evaluation Company: Burgess Bredo Architect
Evaluation Date: August 9 2007
Evaluator Name: Mr. Burgess Bredo

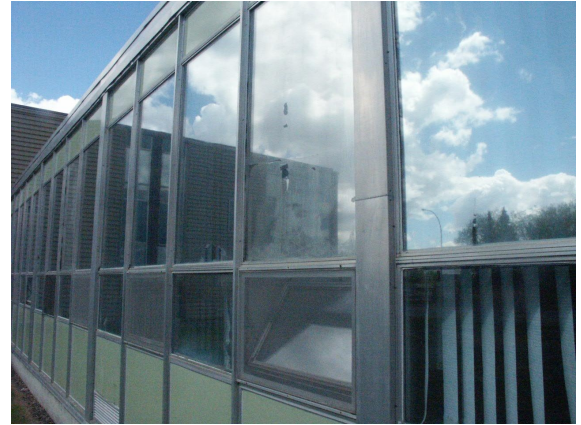
Windows reported to be cold, draft and leak under certain wind driven conditions. Thermal bridging at concrete sills. Portions of east elevation of two story wing have already been replaced with EIFS, metal siding and aluminum windows.

Replace curtain wall with aluminum windows. Introduce EIFS and metal cladding to match portion already replaced (400 sq.m.)

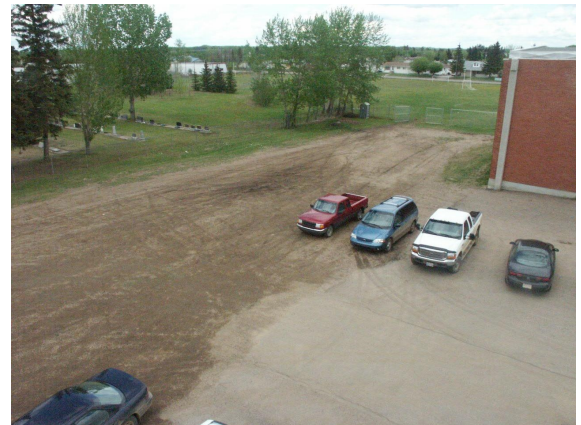
G2020.02.02 Flexible Paving Parking Lots(Asphalt)**

Asphalt parking lot for approximately 22 cars located in north courtyard of school.
