RECAPP Facility Evaluation Report

Daysland School

B2990A
Daysland

Evaluation Company: Wade Engineering Ltd.
Evaluation Date: November 21 2006
Evaluator Name: Ron Shannon

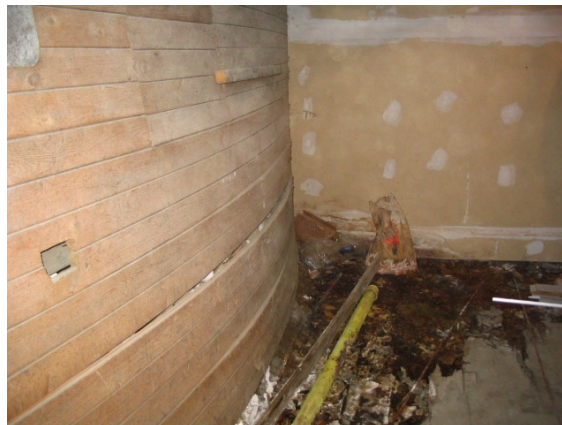
1927 - A localized failure of exterior foundation wall under main entry, backfill movement has caused significant deflection in wood framing of foundation under ramp to east entrance with visual evidence of fungal activity and wood rot in the wood flooring at the same location, due to water entry.

Also, settling of crawl space soil has bowed wood frame, load bearing partition wall adjacent to above location.

Potential structural collapse and safety concern

Excavate surrounding grade and complete repairs to foundation walls, and replace damaged wood sub-floor in mechanical room. Dig back settled soils in adjacent crawl space, and restore wood framing supports under main hallway and replace sub-soils in crawlspace.
