RECAPP Facility Evaluation Report

Elizabeth Seton Catholic Elementary / Junior High School

B3109A
Edmonton

Evaluation Company: VFA Canada Corporation
Evaluation Date: September 14 2006
Evaluator Name: David S. Greeley, P.Eng.; VFA

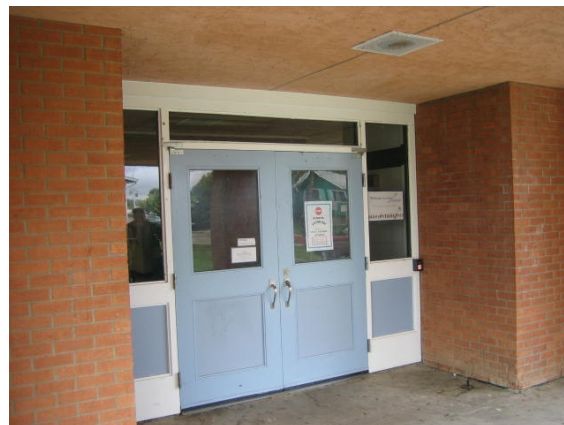
The wood entry doors are original to the building and are worn.

Replace existing aged entry doors. One set of double doors.

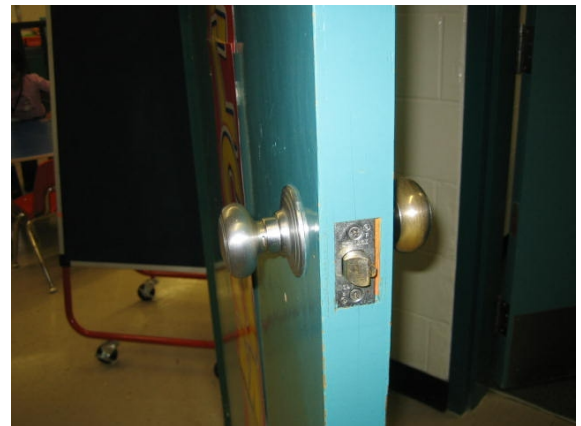
The older knob hardware on the interior swing doors in the 1977 original Elizabeth Seton Elementary/Junior High School are aged and worn, requiring alot of maintenance.

Replace the swing door hardware on all interior doors in the 1977 original Elizabeth Seton Elementary and Junior High School building. Assume 120 interior swing doors. Cost estimate assumes lever hardware to improve accessibility.

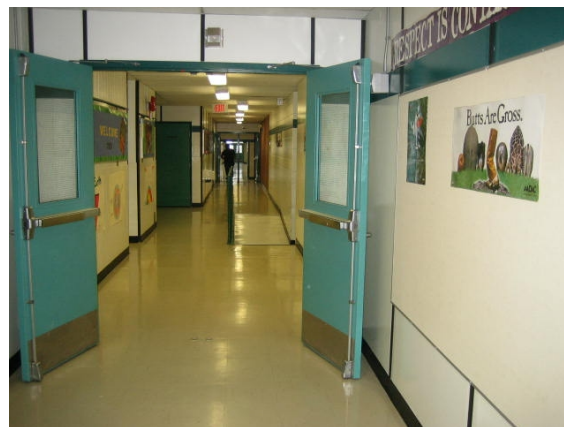
Replacement of doors warranted.

The wrong direction of swing for the subject door is an impediment to egress in the event of emergency.

Remove and replace interior fire doors changing the direction of swing (1 set double doors).

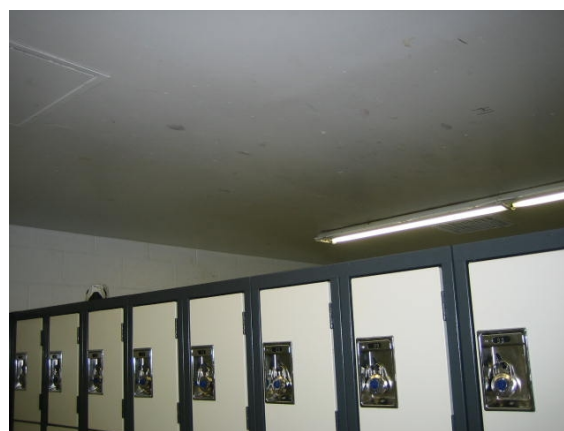
The lockers located in the girls dressing room adjacent the gymnasium exhibit substantial surface degradation and warrant replacement to improve the visual appeal of the facility.

Remove the existing storage lockers at the indicated locations and replace with new assemblies.

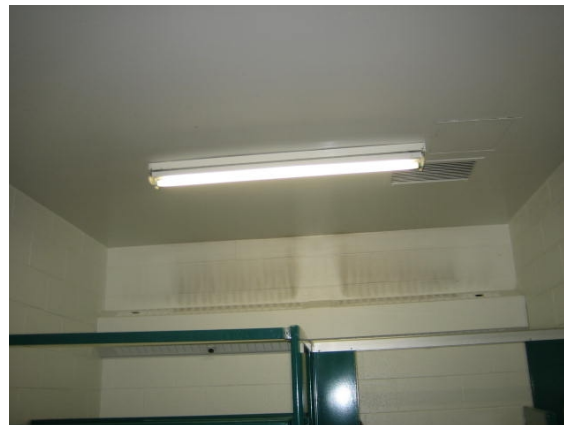
The painted wall finish in the Elizabeth Seton Elementary and Junior High School was last refinished in 1996. It is worn and is at the end of its lifespan; especially in some of the portable classrooms.

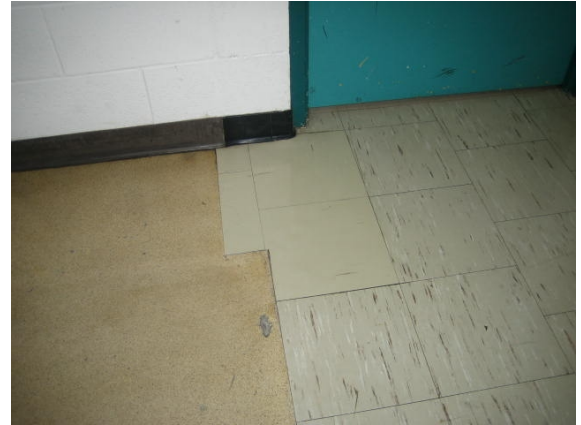
The vinyl resilient flooring in the corridors throughout the school is aged and worn. It will shortly reach the end of its lifespan.

Replace the VCT flooring in the computer room 117. Area estimate is 70m2. \$3,500.

Remove and replace the VCT resilient flooring in the corridors throughout the entire Elizabeth Seton Elementary and Junior High School. Area estimate is 748m2. \$36,500.

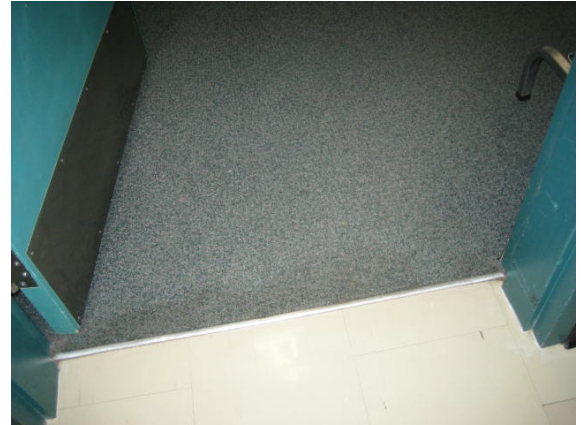
The carpet in the conference room is approximately 10 years old and is showing signs of wear due to heavy traffic and should be replaced.

The carpet in lecture room (adjacent CTS Labs) is showing signs of wear due to heavy traffic and should be replaced. The carpet has exceeded its expected useful life.

The carpet in the library was installed 7-8 years ago and is showing signs of wear due to heavy traffic.

The carpet in the counselor's office 149 is aged and worn and approaching the end of its lifespan.

Replace the carpet in the conference area. Provide allowance for staged removal and replacement of furnishings. Area is 38.5m². \$3,000.00.

Replace the carpet in the lecture room adjacent to CTS Labs. Provide allowance for staged removal and replacement of furnishings. Area is 42.4m². \$3,300.00.

Plan for the replacement of the carpet in the library. Provide allowance for staged removal and replacement of furnishings. Area is 144m². \$8,700.00.

Remove and replace the carpeting in the counselor's office. Area is 44.7m². Provide allowance for staged removal and replacement of furnishings. \$3,300.

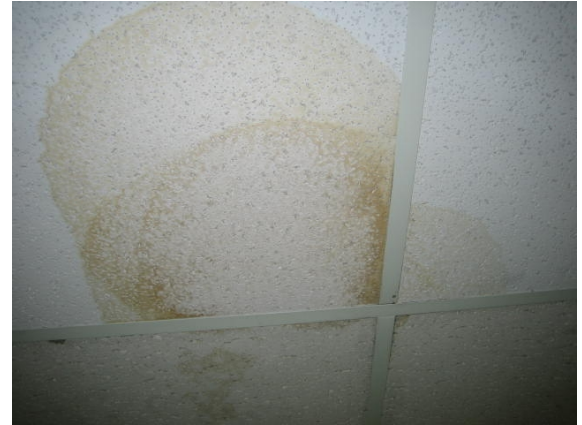
The existing acoustical ceiling tiles (ACT) throughout the building's corridors exhibit high levels of staining.

The suspended acoustical tile ceiling treatment in classroom 107 is stained and worn. Replacement warranted.

Remove and replace the ceiling tiles in the corridors of Elizabeth Seton Elementary and Junior High School. Replace tiles only not suspension grid. Area estimate is 748m2. \$13,600.

Replace the ACT ceiling in classroom 107. Area estimate is 70.3m2. Estimate assumes removal and replacement of tiles only and not replacement of the suspension grid. \$1,400.

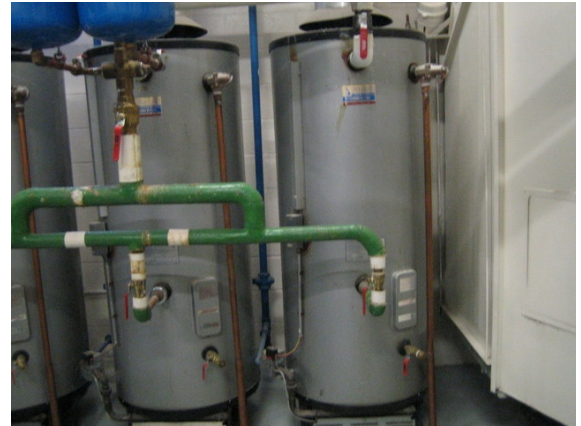
DHW is provided by three 75 gallon, 324,000 BTU gas fired heaters. Two of these heaters are original to the building, one has been replaced.

Event: Replace Water Heaters (two units)

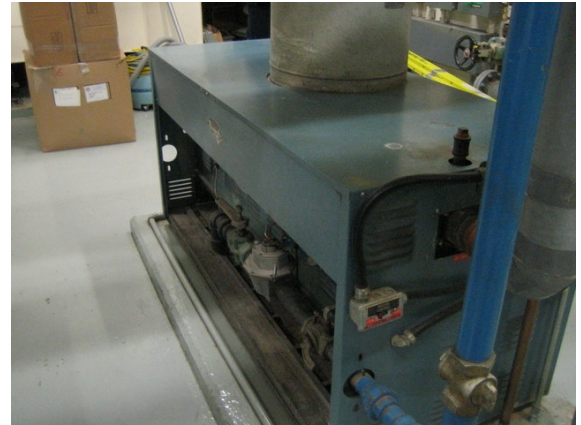
The building is heated by two older (original construction) Raypack 1.46MMBTU/Hr. Gas fired boilers and one newer Raypack boiler of the same size installed in 1994. All appear to be in operating condition, but the older boilers have reached their theoretic life.

Event: Replace Boilers

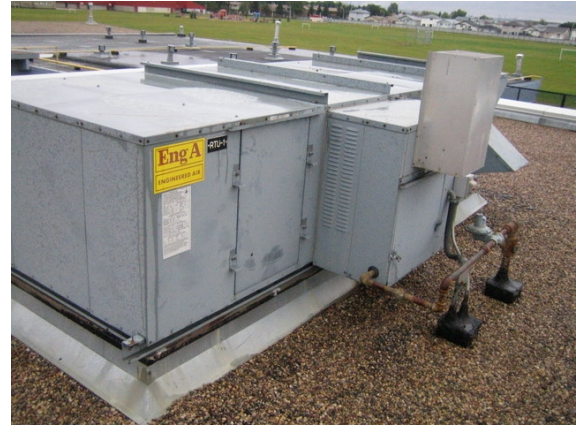
RTU's are problematic and have had repeated failures.

Replace with newer RTU's

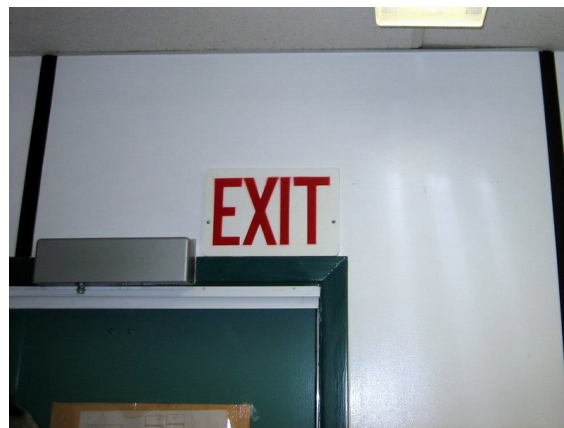
Exit signs in certain areas and classrooms are not placed properly or illuminated in the event of power outage. Many signs are observed to be non-functional.

Replace non-illuminated signs and existing illuminated signs with modern battery backed LED style signs located according to code. Replace entire system.

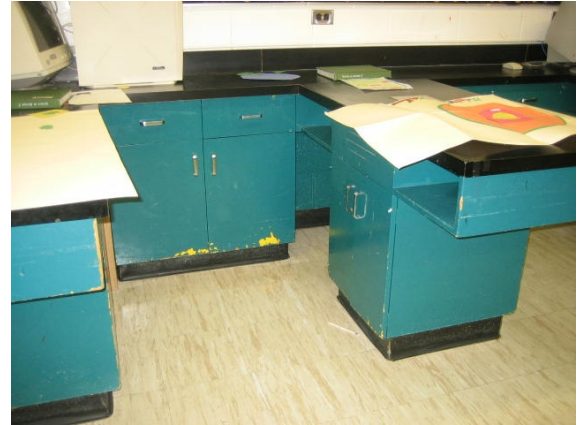
The cabinets and fixtures in the Ancillary Room 105 are aged and worn. Replacement warranted.

The cabinets and fixtures in the ECS room 108 are aged and worn. Replacement warranted.

The cabinets and fixtures in the kitchen are aged and worn. Replacement warranted.

Remove and replace approximately 21 meters of lower and 9 meters of upper casework, one countertop and two sinks. Painter to make good. \$54,600.

Remove and replace approximately of upper and lower casework, one countertop and one sink. Painter to make good. \$35,600.

Remove and replace approximately 30 LF of upper and 40LF of lower casework, one countertop and one sink. Painter to make good. \$14,700.

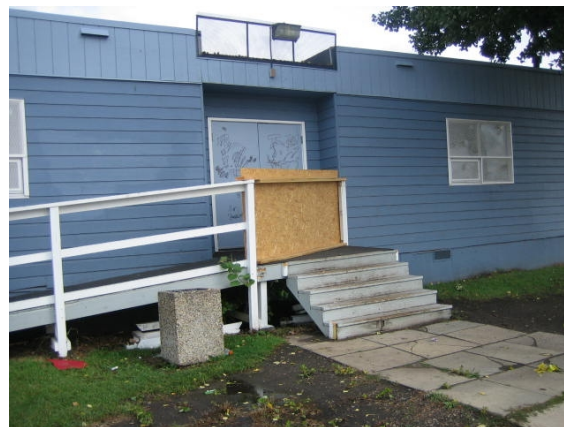
The exterior access stairs on the south facade of the school, at the portables installed in 1981 has missing protective handrails.

A consequence of deferral is a potential accident due to missing protective railing.

Replace the missing handrail/guardrail at the access stairs to the 1981 portables, south facade.

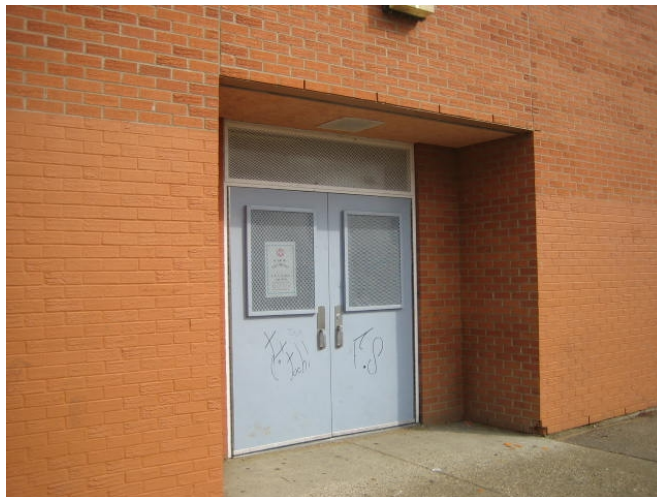
Not all entrances to the facility are barrier free. Entrances to the main facility have no height changes while entrances to the portable clusters have ramps in some cases but just exterior stairs in others.
