RECAPP Facility Evaluation Report

Elmwood Elementary School

B3112A
Edmonton

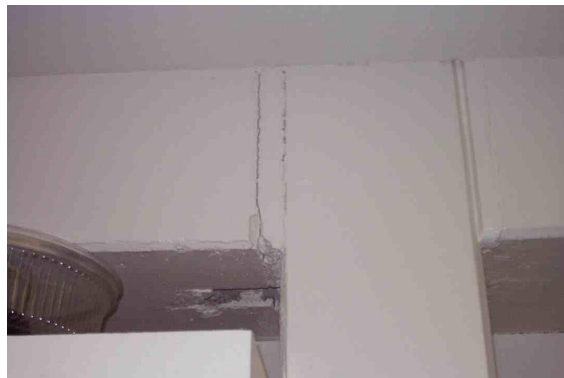
A1030 Slab on Grade*

1960 building- main floor

Heaving due to moisture cycle in high plastic clay.

Structural study must be conducted to determine direct cause and possible solutions to movement problems.

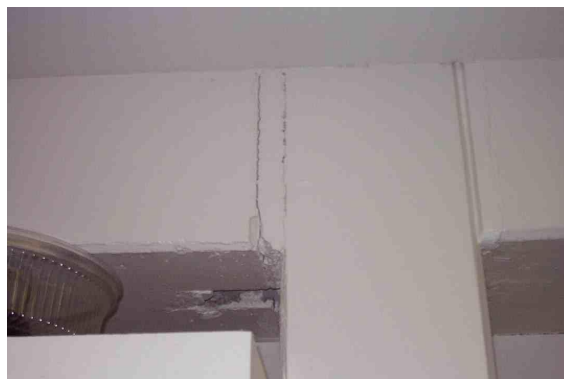
B1010.01 Floor Structural Frame*(Building Frame)

1960 building - Concrete post and beam frame.

Beams are cracking in areas of heaving slab.

Repair cracks in beams. Coordinate with structural study.

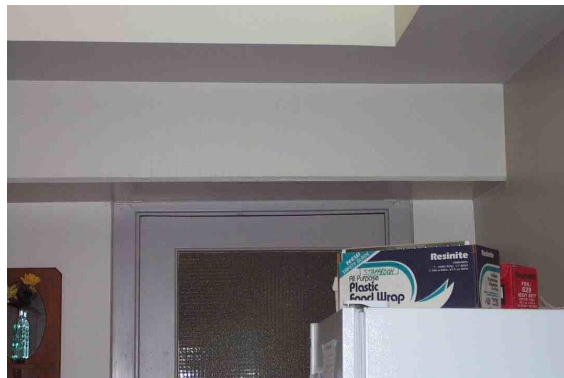
C1010.01 Interior Fixed Partitions*

Concrete block and gypsum walls shifted more than an 1" independently from concrete post and beam frame on both levels due to slab on grade problems.

Repair walls once slab has been stabilized.

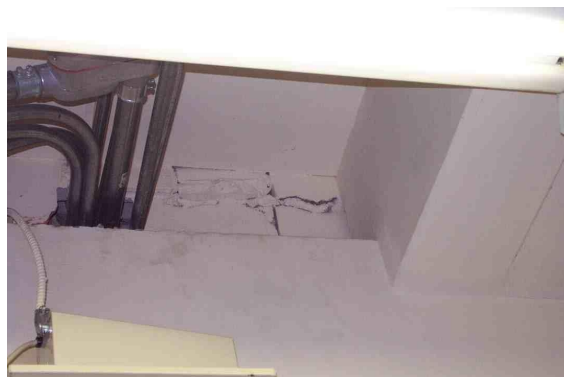
C1010.07 Interior Partition Firestopping*

Unsealed penetrations (conduit and pipe) through ceiling and walls compromising fire separations.

Fill and seal ceiling and wall penetrations with firestopping material to meet code.

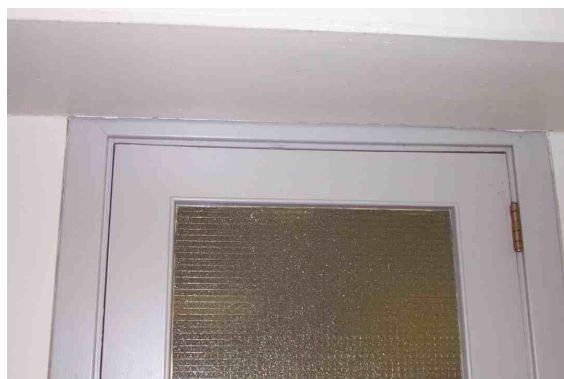
**C1020.01.07 Wood Doors**

Doors and frames on both levels have been compressed by heaving concrete slab lifting corridor wall assembly into fixed concrete beams above.

Repair and replace doors and frames that have been damaged once slab has been stabilized. (10 doors and frames)

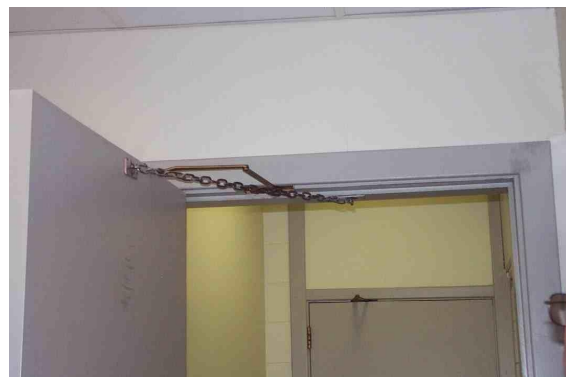
C1020.01.07 Wood Doors

Hardware on doors are old and have a chain to reduce door opening.

Replace hardware on girls and boys vestibule and entrance doors to washrooms. (4 doors)

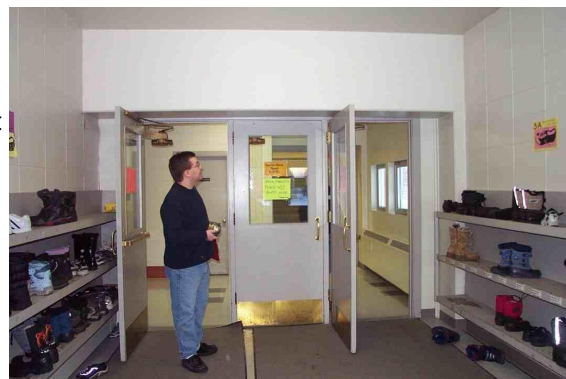
**C1020.02 Interior Entrance Doors***

Interior entrance door assemblies are wood framed. The don't latch and have old hardware. Also due to the structural issues in this building the door frames have been compressed by heaving concrete slab lifting corridor wall assembly into fixed concrete beams above.

Remove and install aluminum framed assembly with new doors and hardware (3 doors in each assembly; 3 assemblies in total). Replace once slab has been stabilized.

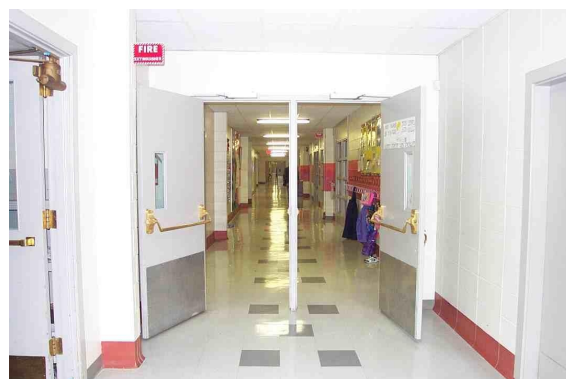
C1020.03 Interior Fire Doors*

1960 building- Doesn't have hold open devices.

1968 building- Doesn't have hold open devices

1960 building- Install hold open devices for 2 doors

1968 building- Requires hold open devices for 2 doors.

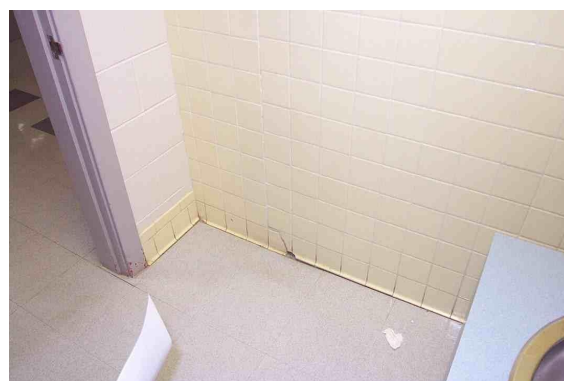
Tile in boys and girls washrooms on the lower and upper have sections of walls with existing yellow tile and other walls with new white tile. Mismatched color and cracking of tile due to structure movement is apparent on both floors.

Replace tiles in boys and girls washrooms on the lower and upper floor with tiles that match the existing newer white ones. Replace once structure of building has been stabilized. (approx. 25m²)

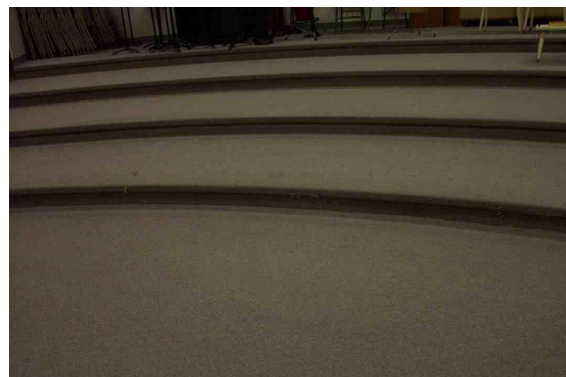
Carpet in areas is stained, fraying at seams and worn in high traffic areas.

Replace carpet in areas where large stains have occurred (approx. 140m²), fraying carpet should be repaired.

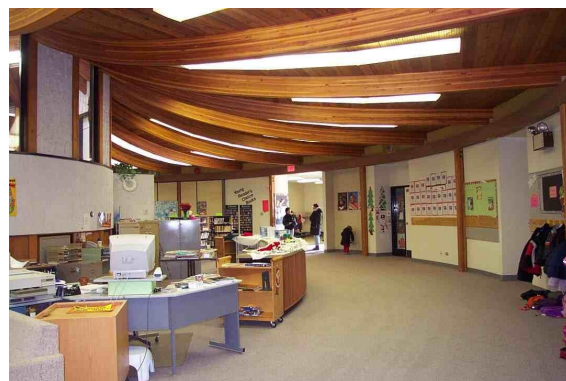
Library carpet due to its round floor area is hard to carpet and has many seams showing. Music room carpet is also an irregular arrangement for carpet, with large stairs and ramps. With high traffic these carpeted areas will wear out sooner than other applications.

Replace carpet. (approx. 400m²)

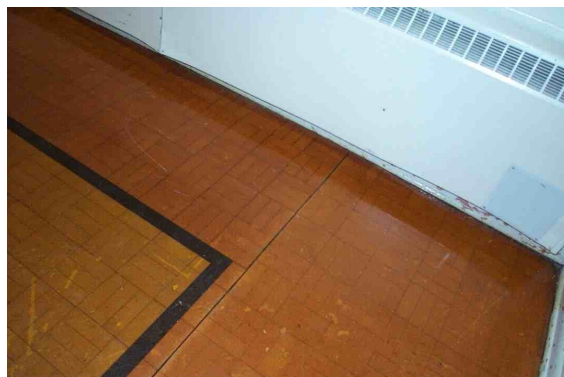
C3020.14 Other Floor Finishes*

Gym flooring is grandwood, floor has been worn down in areas and due to slab problems the flooring has sunken in both corners.

Remove grandwood, repair and releve subflooring. (solution to sinkage will be incorporated in structural study) Install appropriate gym wood flooring, install proper court floor assemblies and paint athletic lines. (364.2 m²)

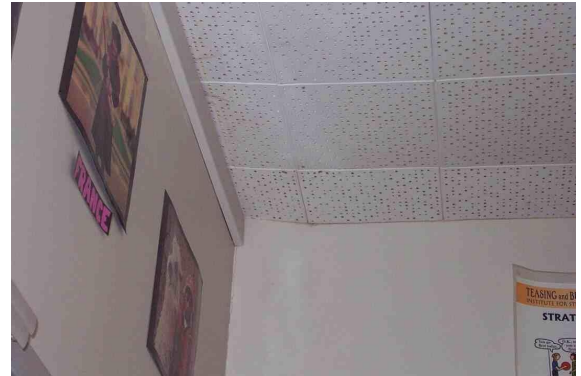
12x12 ceiling tiles in classrooms are sagging, discolored, stained and some are coming loose.

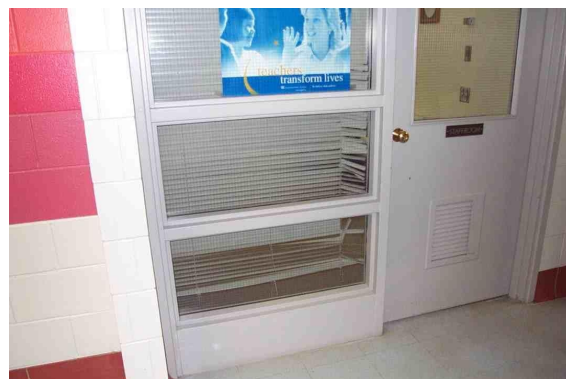
Venetian blinds have been bent and broken.

Replace blinds in staff room and staff work room with frosted window film. Roll down blinds are better suited for staff office areas. (4 roll down blinds)
