RECAPP Facility Evaluation Report

Florence MacDougall Community School

B3539A

Evaluation Details	
Evaluation Company:	PGA Architects Ltd.
Evaluation Date:	November 30 2006
Evaluator Name:	Peter Komuniecki B. Mngt

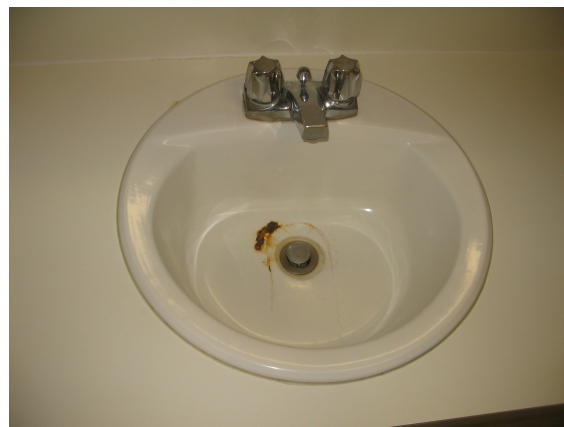
D2010.04 Lavatories ** 1983

Single compartment, vitreous china sinks equal to American Standard complete with polished chrome faucets (standard or push-button type).

<u>Rating</u>	<u>Installed</u>	<u>Design Life</u>	<u>Updated</u>
2 - Poor	1983	30	MAR-07

Concern:

The existing lavatories are old and pass expected life.

Recommendation:

Replace existing lavatories with new complete with all faucets. Approximately 6 units.

<u>Type</u>	<u>Year</u>	<u>Cost</u>	<u>Priority</u>
Failure Replacement	2007	\$8,000	Medium

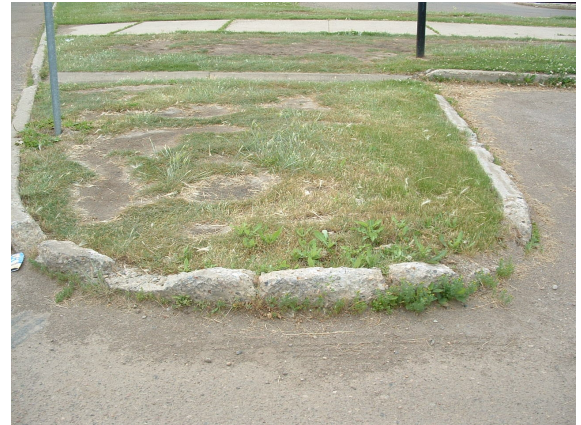
Event: Repair Parking Lot Curbs

Parking lot and roadway curbs are extremely worn out and damaged creating traffic hazard.

Recommendation:

Remove and replace approximately 1500 feet of curbs

<u>Type</u>	<u>Year</u>	<u>Cost</u>	<u>Priority</u>
Repair	2008	\$60,000	Low
