RECAPP Facility Evaluation Report

Glenmary School

B3857A
Peace River

Evaluation Company: Francis Ng Architect
Evaluation Date: December 1 2004
Evaluator Name: Mr. Francis Ng

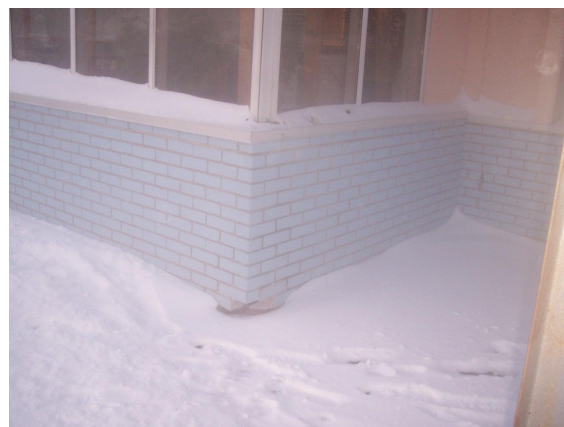
Face bricks at all building corners (1964 original building, 1966 addition, 1970 addition and 1980 addition) have broken caused by machinery.

Removed broken face bricks. Provide new face brick to match colour and sizes.

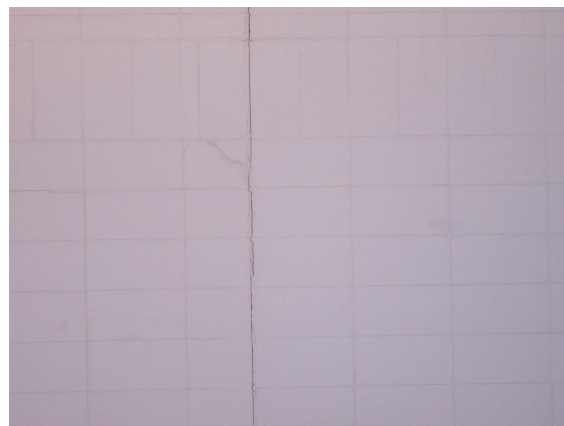
Cracked concrete block walls and open joints of mortar. (approx. 110 square metres)

Repair concrete block wall. Provide rigid insulation and stucco.

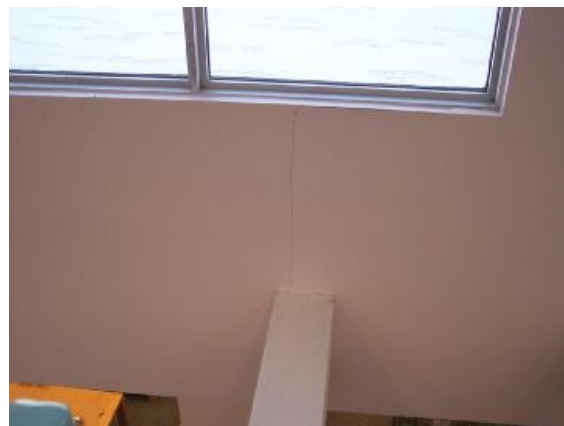
Crack found along the metal stair support beam.

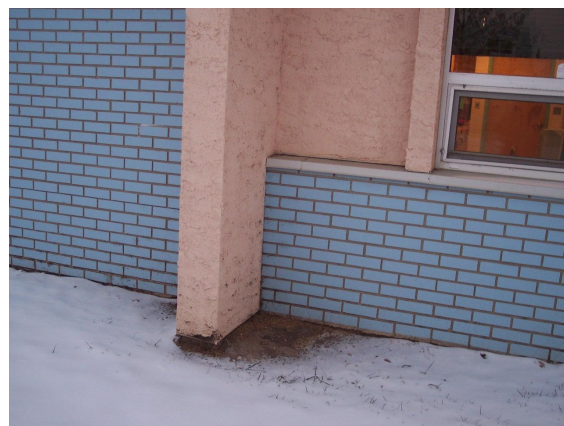
Stucco at Gymnasium corners has been damaged due to machinery. Holes in stucco walls. Cracked stucco wall on east side of Gymnasium.

Repair stucco wall and required insulation.

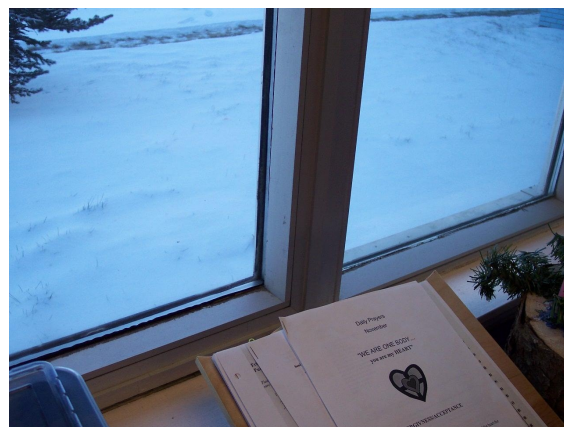
1970 addition has poor caulking around aluminum window openings at 1200mm wide x 1523mm high. (approx. 10 windows) 1980 addition has loose rubber gaskets of aluminum window openings at 1200mm wide x 1523mm high. (approx. 17 windows)

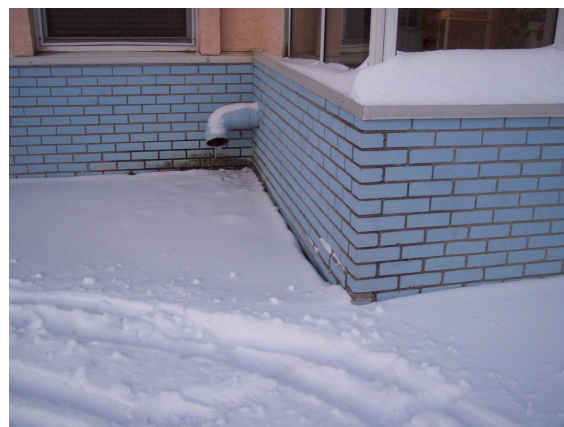
Concrete splashpads and surface drains either missing or broken.

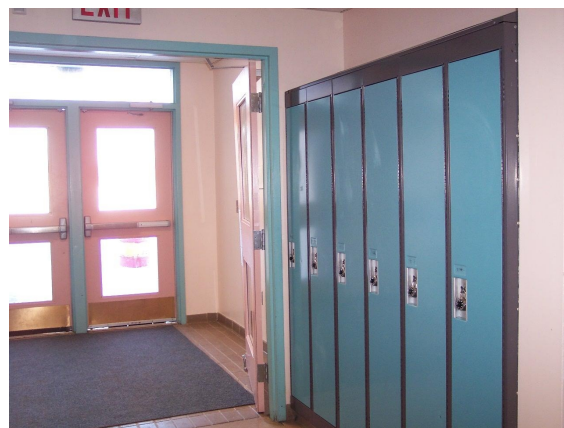
1980 addition (north Vestibule) has warped doors. (2 doors)
 Scratched metal doors and frames. Worn out hardware
 scratching flooring. (3 doors)
 Mutes are required for doors.

Replace with new metal doors and hardware.

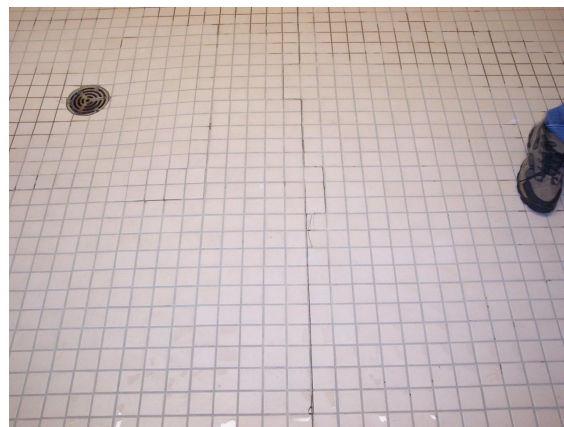
Cracked ceramic tile flooring in shower areas in SDA 105 and SDA 107. Water infiltration and health hazard.(approx. 60 square metres)

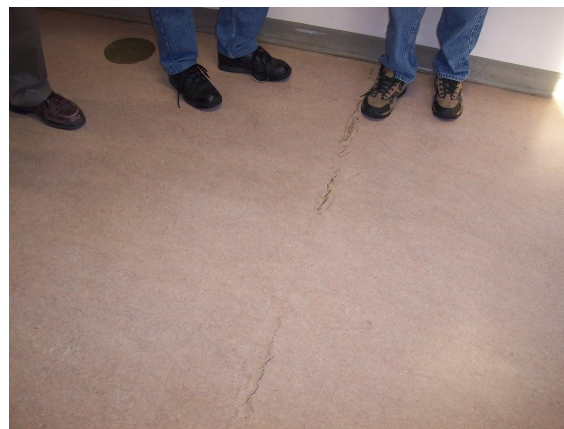
1964 original building (Corridor in front of Administration Area) has uneven floor. 1988 addition (Foyer near south entrance) has cracks found on vinyl sheet flooring due to movement of floor slab. (approx. 60 square metres)

Vinyl sheet flooring cracked by movement of floor or scratched by Corridor doors. 1966 addition (SCI 29) has discoloured flooring. (approx. 1000 square metres)

Repair floor slab and provide new vinyl sheet flooring.

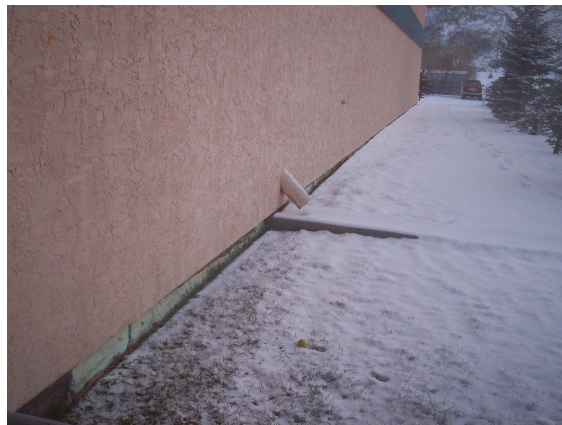
Soil along the perimeter of schools buildings has settled. Concrete splashpads are broken or slope towards school building.

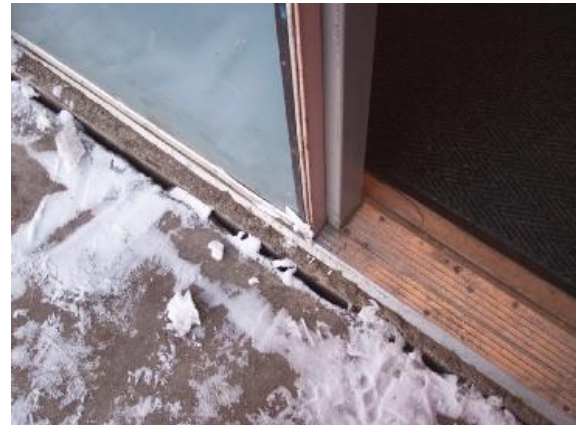
Cracks at north Exit door of 1988 addition (Gymnasium); south Exit of 1966 addition; north Exit of 1970 addition. (approx. 8 square metres)

Replace concrete sidewalk.
