# RECAPP Facility Evaluation Report

**Paddle Prairie School**

B3853A

**Evaluation Company:** Denzil Lobo Architect  
**Evaluation Date:** June 2 2005  
**Evaluator Name:** Mr. Denzil Lobo

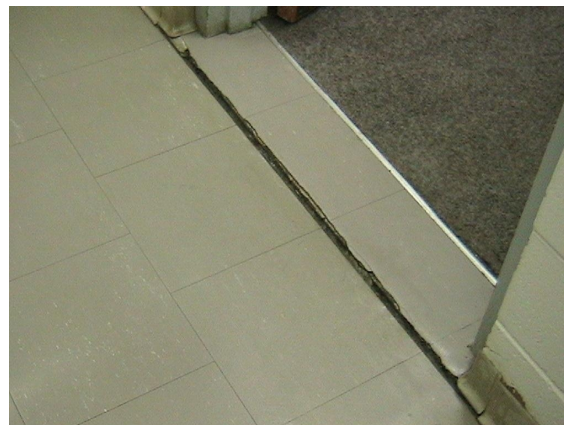
<u>Rating</u>	<u>Installed</u>	<u>Design Life</u>	<u>Updated</u>
2 - Poor	0	100	JUN-05

Concrete slab in 1983 addition has settled in relation to the 1976 floor slab and has affected the floor and wall finishes at numerous locations. 20 to 25mm floor settlement and separation is noted in corridor at joint between 1976 and 1983 additions. Severe movement of Gymnasium floor at N.E. corner and in Kitchen around perimeter was noted. Correction of problem is expensive and may need to be done on an as required ongoing basis

**Event:** Mudjack concrete floor slab around perimeter of building.

Mudjack concrete slab around building perimeter wherever critical and as required.

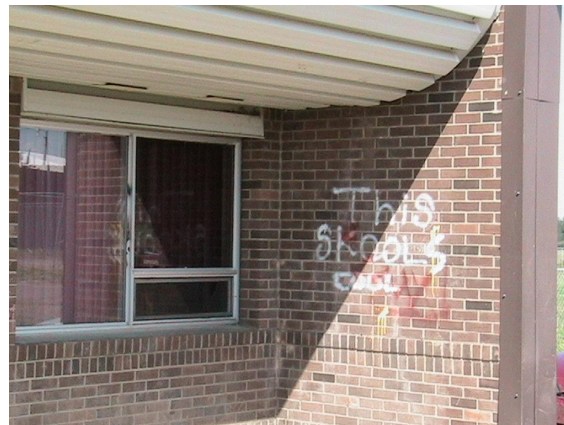
<u>Rating</u>	<u>Installed</u>	<u>Design Life</u>	<u>Updated</u>
3 - Marginal	0	75	JUN-05

Brick faces have been defaced with graffiti

Pressure wash graffiti off brick face.

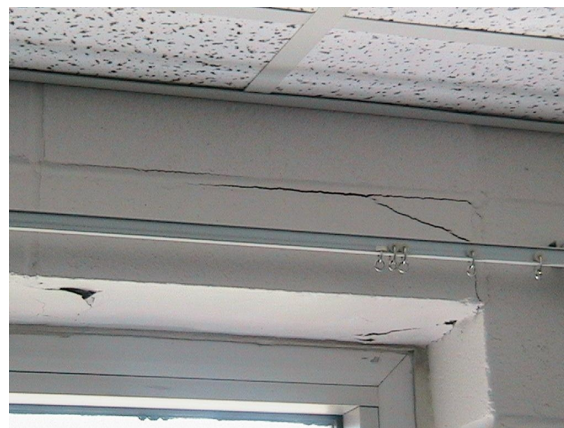
<u>Rating</u>	<u>Installed</u>	<u>Design Life</u>	<u>Updated</u>
3 - Marginal	0	100	JUN-05

Excessive movement of the building structure has caused horizontal cracks in the concrete block exterior walls.

Allow for ongoing application of joint sealants in cracks of block walls until Structural instability issues are resolved.

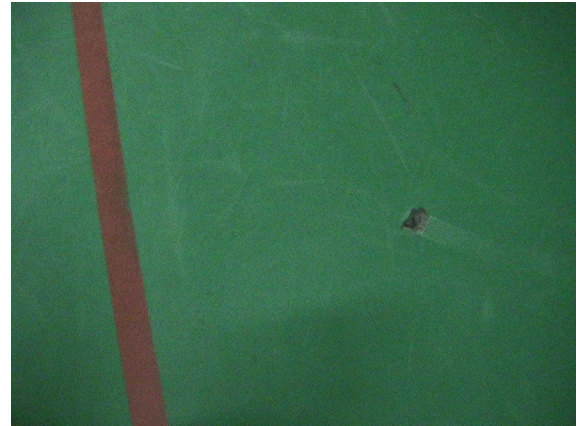
<u>Rating</u>	<u>Installed</u>	<u>Design Life</u>	<u>Updated</u>
3 - Marginal	0	5	JUN-05

Gymnasium floor is begining to wear down and chip . Holes in floor surface.

Resurface gymnasium floor.
