# RECAPP Facility Evaluation Report

**St. Alphonsus Catholic Elementary / Junior High School**

B3278A  
Edmonton

**Evaluation Company:** Koliger Schmidt  
**Evaluation Date:** December 1 2004  
**Evaluator Name:** Mr. Mario Macchione

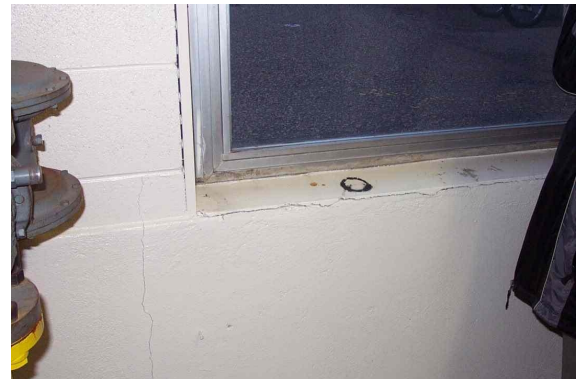
#### **Event: Repair cracks in concrete wall- Boiler Room**

Water infiltration has been reported as being a problem; water entering from courtyard.

Repair cracks in wall, regrade courtyard. Refer to G2020.02.02 Court Yard

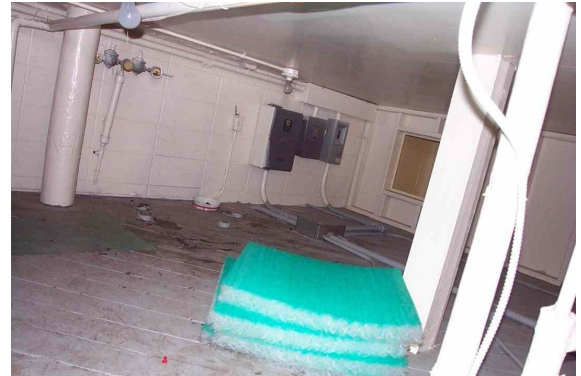
**Event:** **Upgrade fire rating and fire stop holes in mezzanine floor and walls.**

Mechanical space is not fire rated. A number of unprotected penetrations were noted through walls and floor.

Upgrade mezzanine floor and wall fire rating. Floor area is approximately 25m2

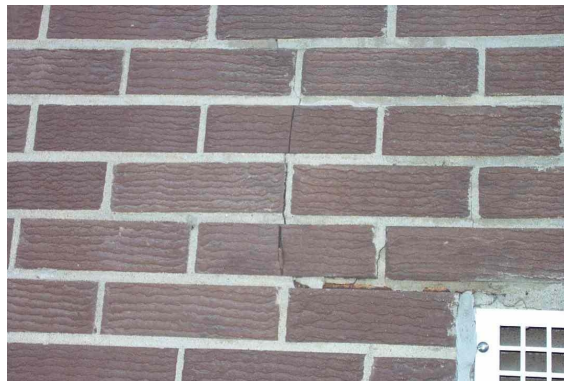
**Event: Repair and repoint brick veneer.****Concern:**

Brick veneer and mortar joints have cracked in a few locations, Loose bricks in courtyard area.

Seal cracked brick faces, and repoint mortar joints (approximate area 20m2) as required.

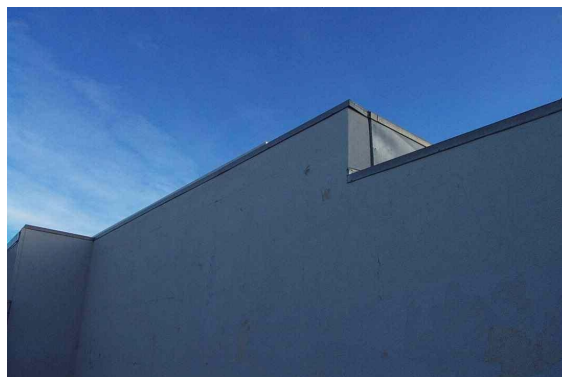
**Event: Paint exterior stucco finish**

Paint finish has deteriorated and is unsightly.

Paint stucco - (approx. 130m2).

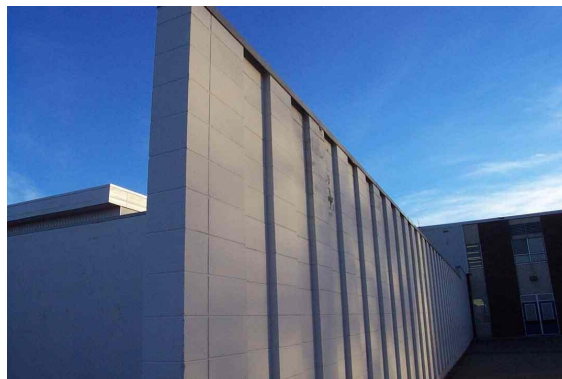
Painted exterior concrete block wall - Screen

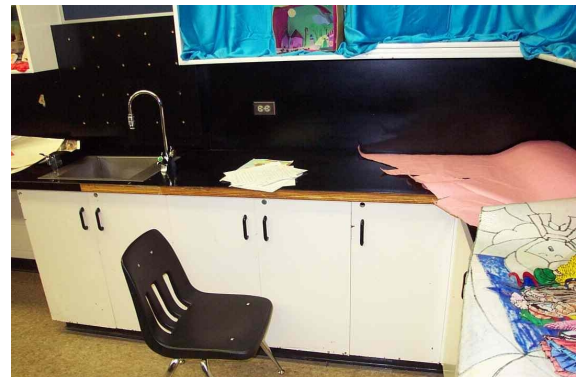
**Event: Repair Laboratory Casework.**

Countertops are damaged; edge trims broken.

Repair countertops. Make minor repairs.

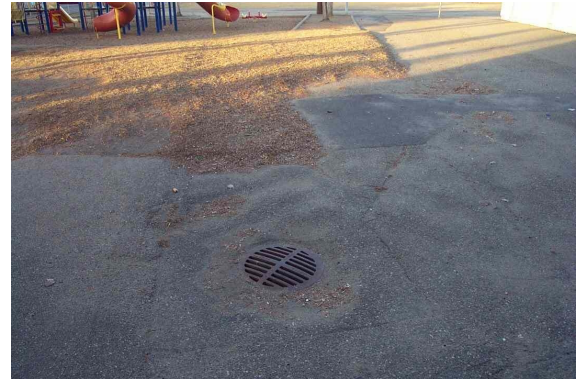
35 % of asphalt paved was not upgraded in 2002 - a number of poorly patched and deteriorating asphalt remains.

Upgrade deteriorating and poorly patched asphalt.

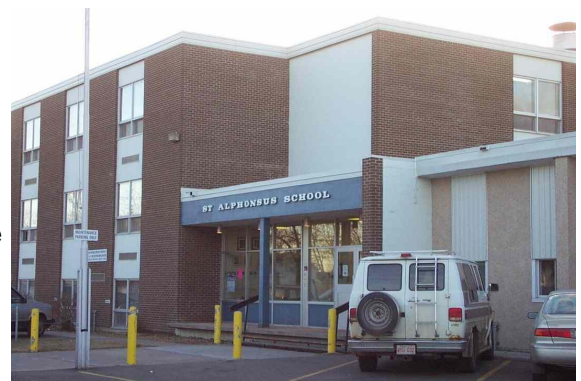
**Event: Repair / refinish traffic barriers**

Frost fencing is used for barrier - easily damaged  
 Concrete filled steel bollards - damaged.

Repair damaged bollards and fencing - provide adequate protection for fencing

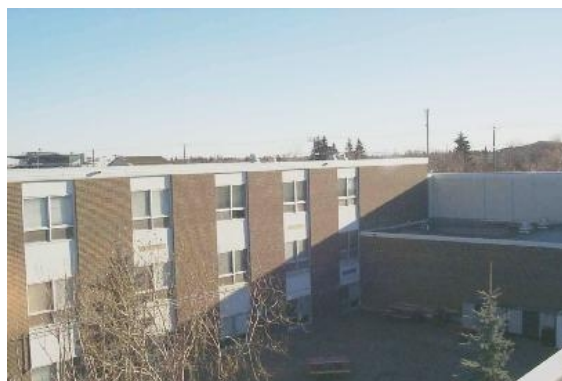
1968 asphalt paved courtyard - undulating asphalt has deteriorated and needs regrading.

The courtyard tarmac is in poor condition and does not drain to the intended catch basin, but rather towards the buildings foundation.

Remove asphalt paving, (approximately 380m2) grade courtyard area to drain to catch basins. Landscape with concrete pavers, concrete walks, shrubs etc.
