School Name: Jasper Place Composite High School
Location: Edmonton, AB

School Code: 7071
Facility Code: 1152

Evaluator's Name: Wesley Sims, M.E.DES.
& Company: Manasc Isaac Architects Ltd.

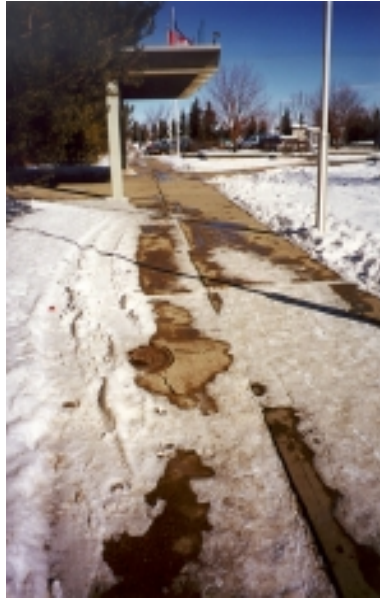
East Sidewalk

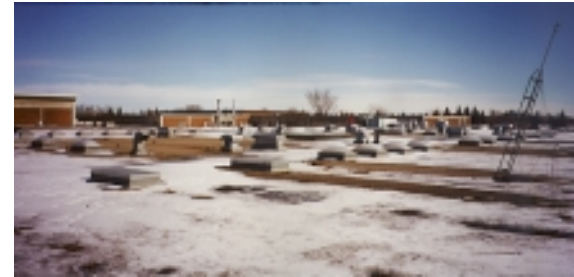
Industrial Arts Roof

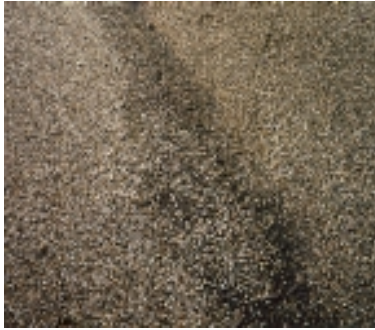
Heaving Roof Membrane
at Industrial Arts

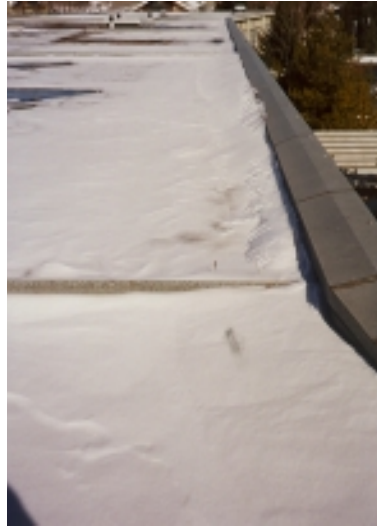
Roof Parapet at East Façade

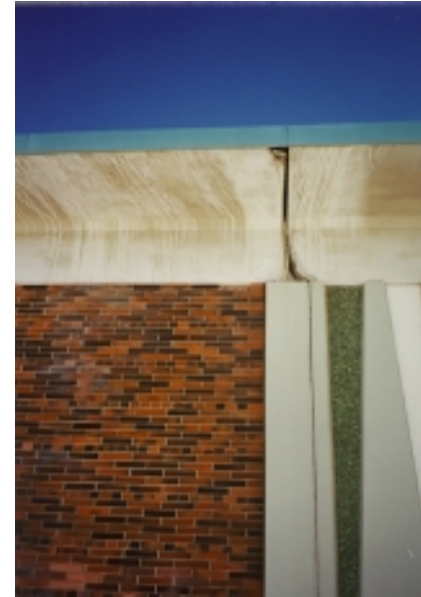
Roof Tees at Column Location

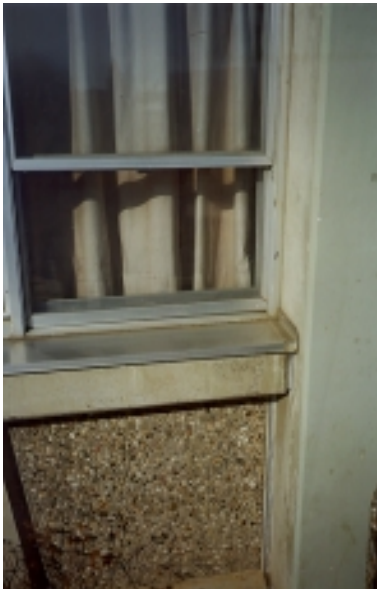
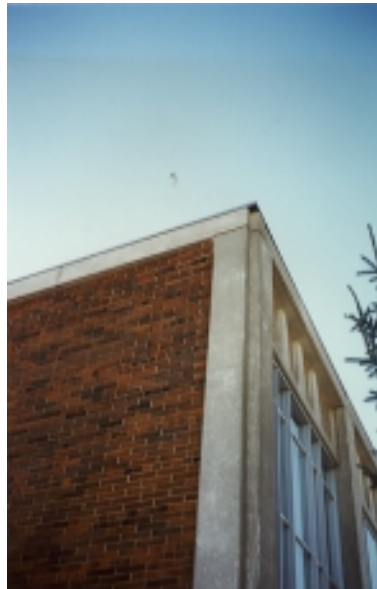
Typical Window/Precast Interface

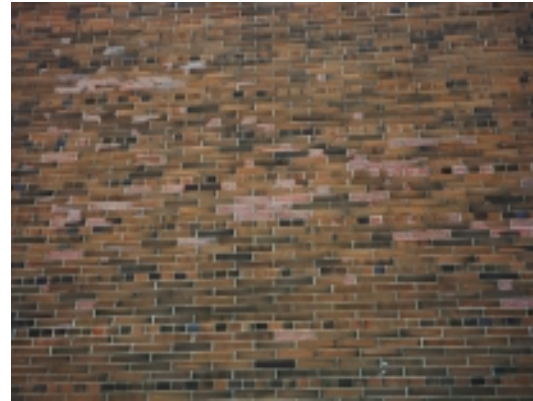
Efflorescence/Spalling at
North Walls

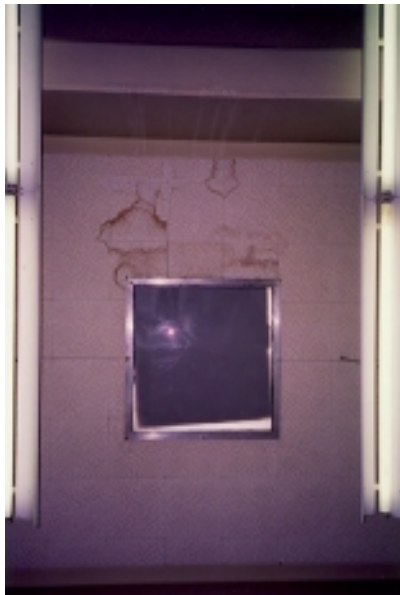
Leaking Skylight

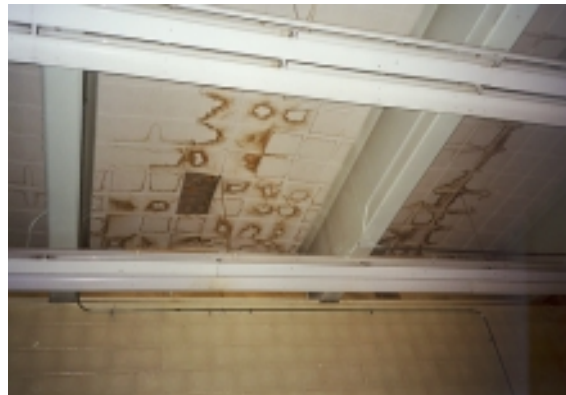
2.2.1	Based on the inspection report (and to the extent possible, direct observation), assess and rate roof conditions and estimate costs for required improvements (i.e., covering materials, membrane,	2	1960 East gym roof continually leaks, needs resurfacing. Interface of roof and wall along east facade of building is leaking. Signs of water leakage is evident at interior wall. All classroom wings have random roof leakage at roof penetrations evident in water stained ceiling tiles. Resurfacing required, reseal/flash at	\$ 425,000.00
		2	1962 Evidence of ice damming along south parapet of Industrial Arts Rooms. Appears as it membrane has failed causing air exfiltration from building. Soffit/underside of roof tees along this wall shows areas of water staining and water penetrations into exterior wall has begun to occur. Brick efflorescence and spalling. This area requires re-roofing to prevent further damage to exterior south and west wall	\$ 210,000.00

Roof Leaking at South Wall of Industrial Arts

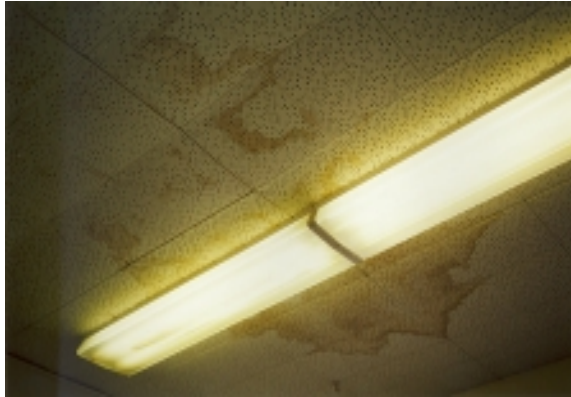
Roof Leakage at Classrooms - 1960 Wing

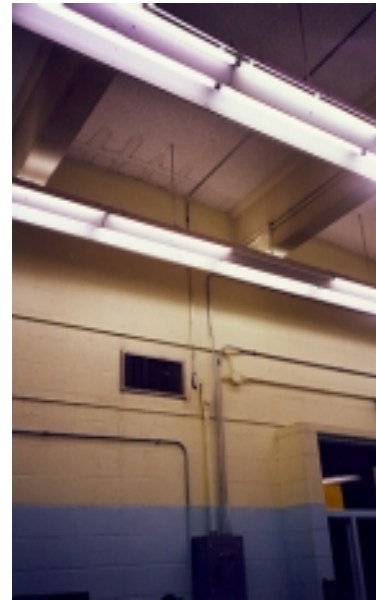
2.2.3	Control of ice and snow falling from roof.	4	1960 Good. Interior roof drains. 1962 1969	
2.2.4	Skylights (i.e., signs of distress, leaks, ice build-up, condensation, deteriorated materials/seals).	2	Skylights need to be resealed/reflashed. Some units leak and need replacement. Skylight at Graphics Art Room 153 leaks directly above electrical panel. Repair immediately.	\$ 35,000.00
Other

Roof Leak Above Electrical Panel, Room 153

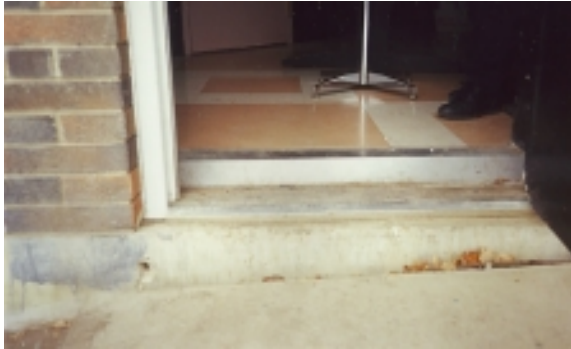
Settlement Outside South Façade, 1962 Portion

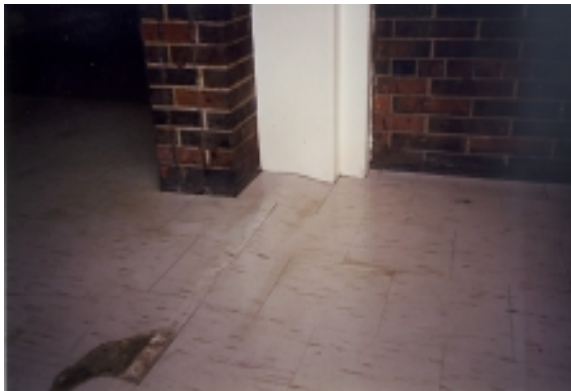
3.1.2	Floors (i.e., signs of cracks, heaving, settlement).	3	1960	Floors heaving in 1960 and 1962 sections due to highly plastic soils condition, slab heaving. Levelling of larger level changes recommended to avoid tripping. Use concrete topping to avoid exposed edge conditions in these areas.	\$ 9,000.00
		4	1969	Floor areas in 1969 addition are more level, no evidence of major slab heaving.	
	Other

Floor heaving at 1960 Structure

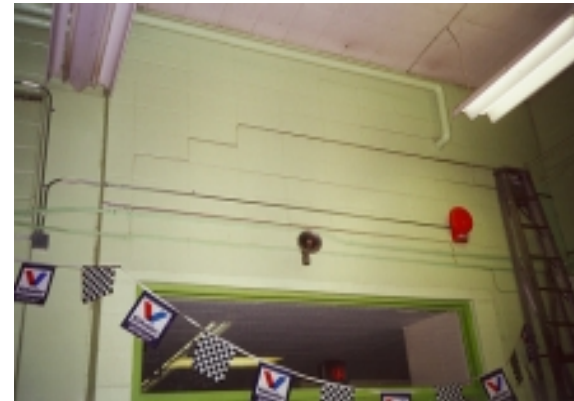
Wall Cracking at Automotives

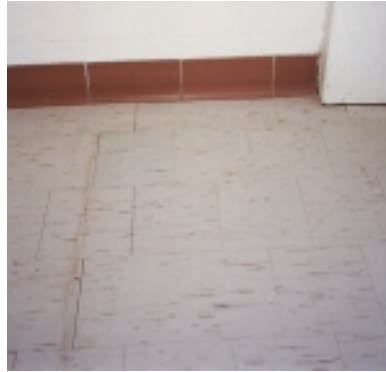
Typical Corridor Floor Heaving, 1960 Corridors

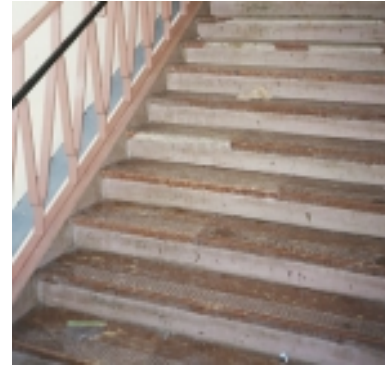
Typical Condition of Stairwells

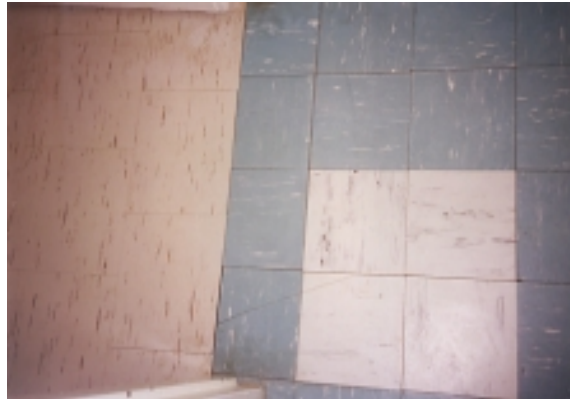
Loose Asbestos Tiles at 1960 Classrooms

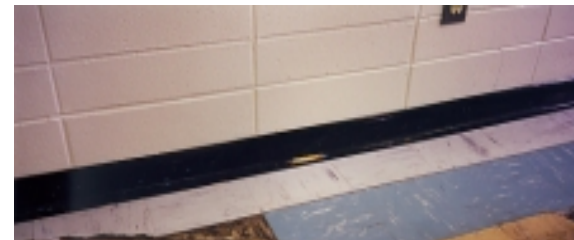
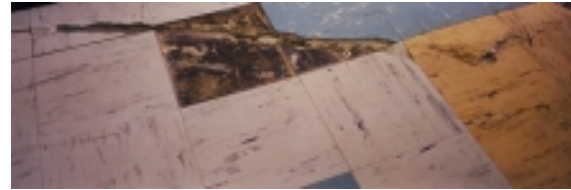
Floor Displacement at Room 204

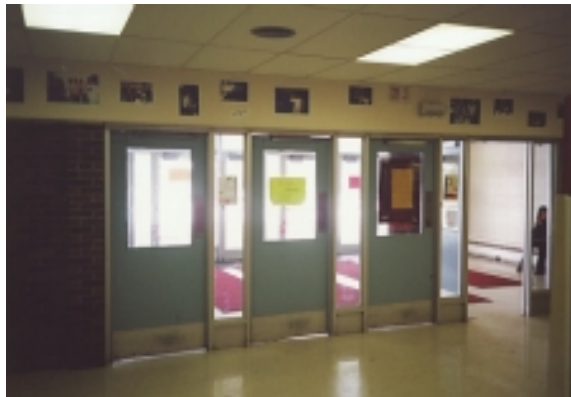
3.2.4	Interior doors and hardware.	2	1960 Door frames and hardware need replacing where slab heaving has deframed frames. On-going problem. East exit doors need immediate repair or replacement. Fire rating of all doors needs to be confirmed contingency upon results of recommended code analysis. Doors at stair wells do not appear to be General repair/replacement of door hardware required in next five years as it is worn +/- 35%.	\$ 40,000.00
		3	1962	\$ 28,000.00
		4	1969 Doors and hardware in good condition.

Compressed Door Frame at East Entrance

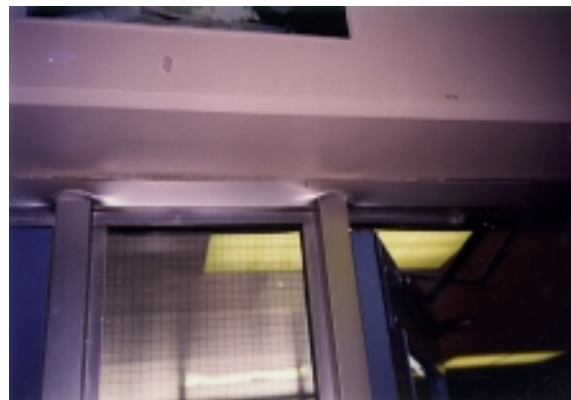
Detail - Compressed Door Frame
