# RECAPP Facility Evaluation Report

**Horse Hill Elementary / Junior High School**

B3158A  
Edmonton

**Evaluation Company:** Robert Bosnyak Architect  
**Evaluation Date:** December 1 2006  
**Evaluator Name:** Robert Bosnyak

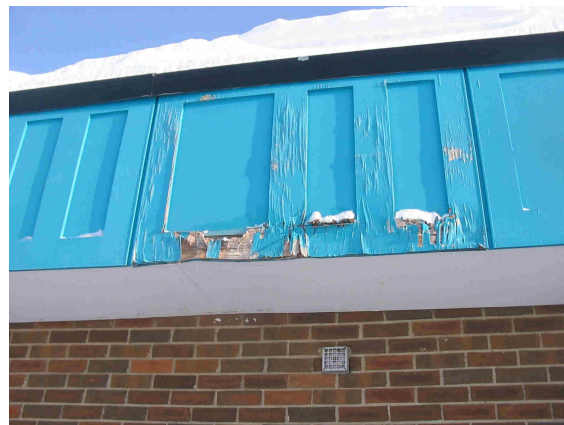
Damaged and deteriorated panel board fascias throughout the 1969 and 1977 wings.

Repair and/or replace all damaged panel board fascias. Repaint.

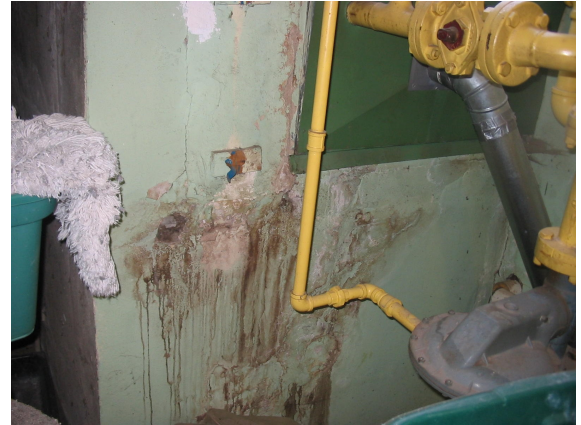
Water infiltration at Mechanical Room exterior wall below service lines. Cracks in cast-in-place concrete foundation wall apparent.

Excavate as required and patch/apply waterproof membrane at exterior of concrete foundation wall.

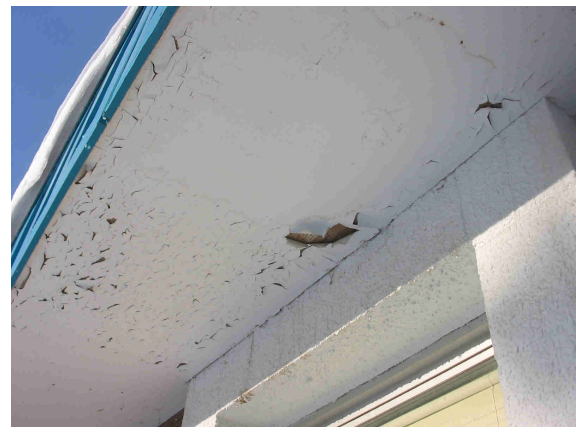
Wood soffits throughout are damaged, rotted.

Remove all existing wood soffits and replace with new pre-finished metal soffits.

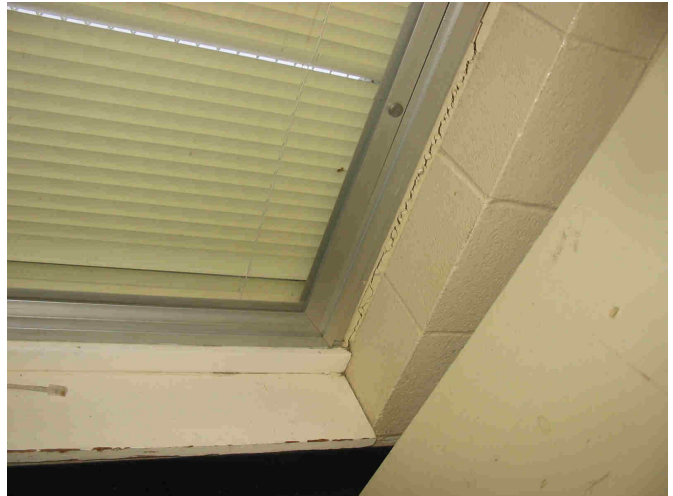
1969 aluminum windows seals are broken, integral blinds not operational, wood sills rotted and hardware parts no longer available.

Replace all 1969 aluminum windows with new PVC windows c/w operators. Replace 1977 aluminum windows (same design) concurrently (approximately 12 windows x \$1000/unit).

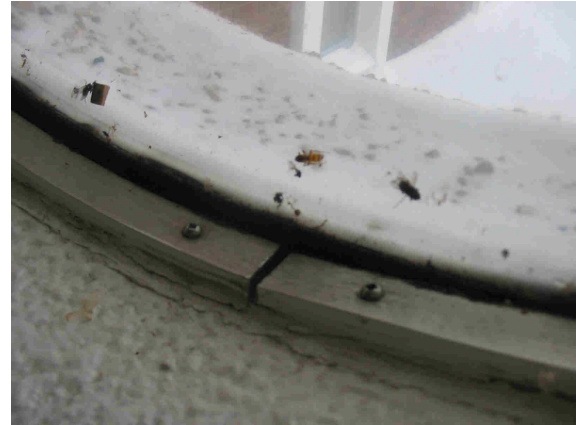
Seals broken all around acrylic window. Insects in air space.

Remove existing round acrylic window and replace with new.

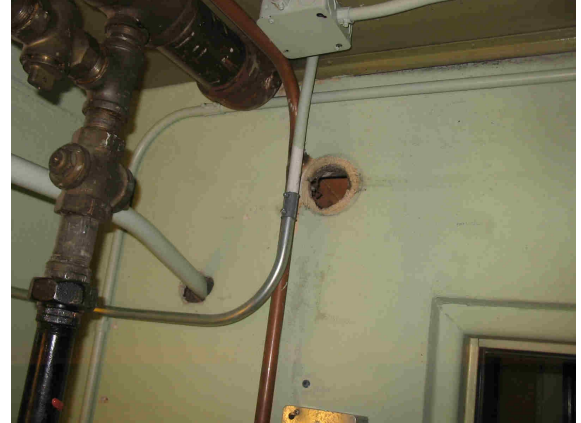
Fire safety compromised.

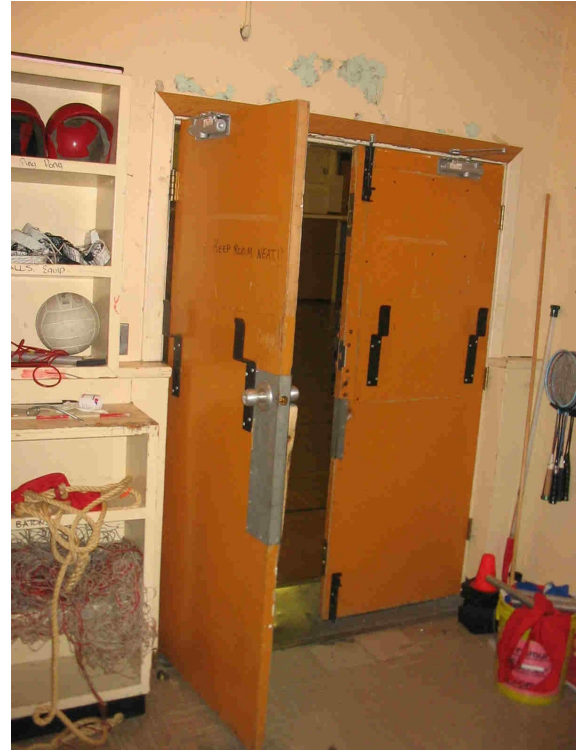
Fire rated doors at Gym Storage 114 and Community Facility Storage in poor condition. Fire rated doors throughout 1958 Wing compromised- hardware old and damaged, some holes in doors, wood frames with no labels.

Replace all fire rated doors and frames throughout 1958 Wing with new labeled SCWD or hollow metal doors and labeled hollow metal frames c/w finish hardware (approximately 5 fire doors x \$1500/door)

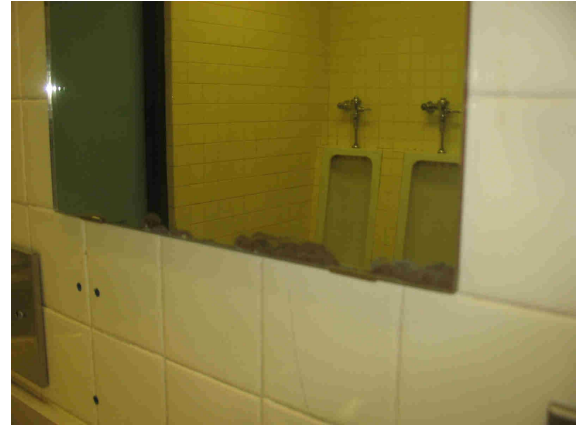
Soap dispensers and toilet paper dispensers old- some rust.

Replace mirrors, soap dispensers and w.c. stall hardware (grab bars). Replace handdryer.

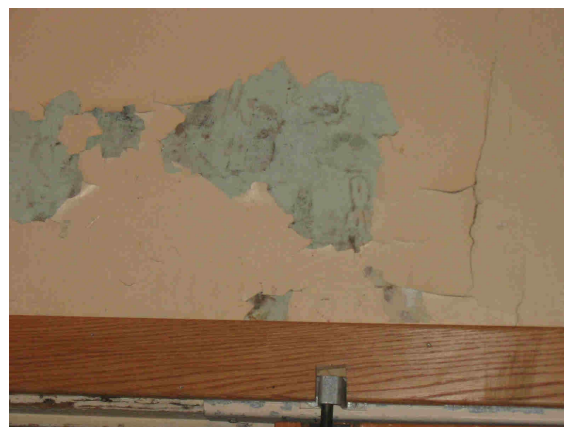
Plaster at Gymnasium Storage 114 showing cracks. Some missing-patched with GWB. Some holes through plaster and patch. Fire separation at storage room fire rated partitions compromised.

Remove all plaster and lath finishes at Gymnasium Storage 114 and replace with 16mm Type 'X' GWB. Paint.

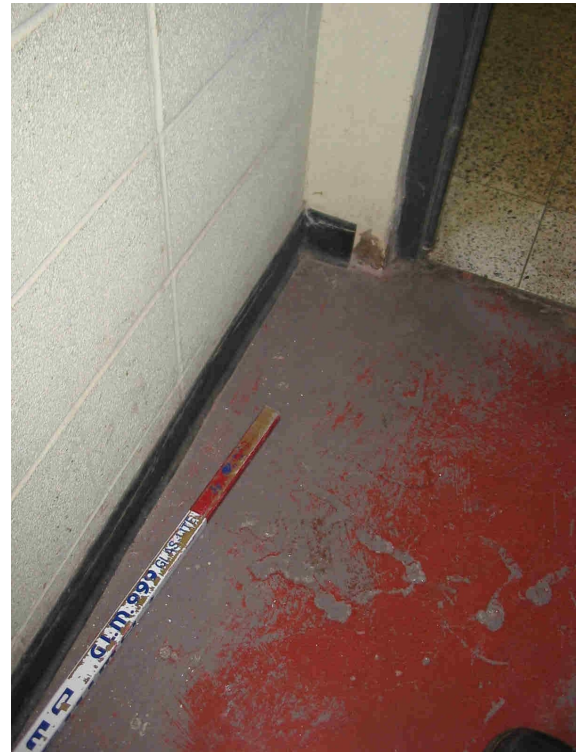
Paint finish worn at all painted concrete floors. Rubber base missing at some locations.

Repaint all painted concrete floors with paint suitable for substrate. Replace rubber base.

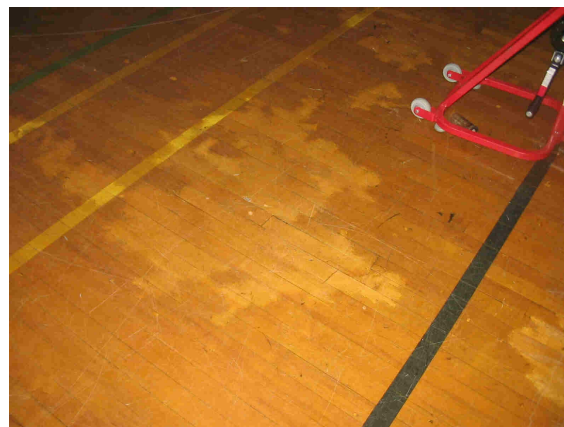
All existing sprung wood floors at Gymnasium 115 and Stage 116 in poor condition-clear finish worn, stains, surface marks and scratches, sports lines faded and seams opening up. Rubber base damaged or missing.

Re-finish all sprung wood floors and seal. Remove exiting rubber base and replace with new. Repair damaged substrate where required (approximately 480m2 x \$45/m2).

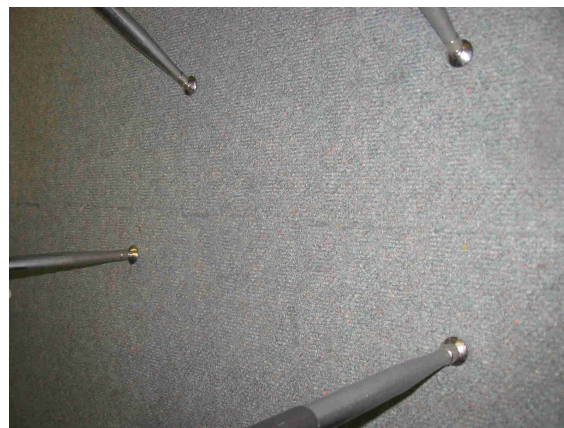
All existing carpet worn- frayed, rippling and seams opening up except at Administration Suite.

Replace carpet in the following areas with new. Include for new covered rubber base (approximately 1425m2 x \$35/m2)

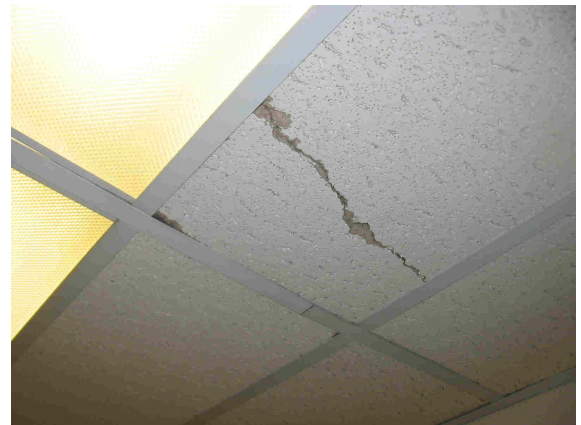
Stained, chipped acoustic ceiling panels noted in several locations.

Replace acoustic panels throughout as required.
