RECAPP Facility Evaluation Report

Alberta Health Services-Central

Centennial Centre - Dave Russell Education Complex

B0636H

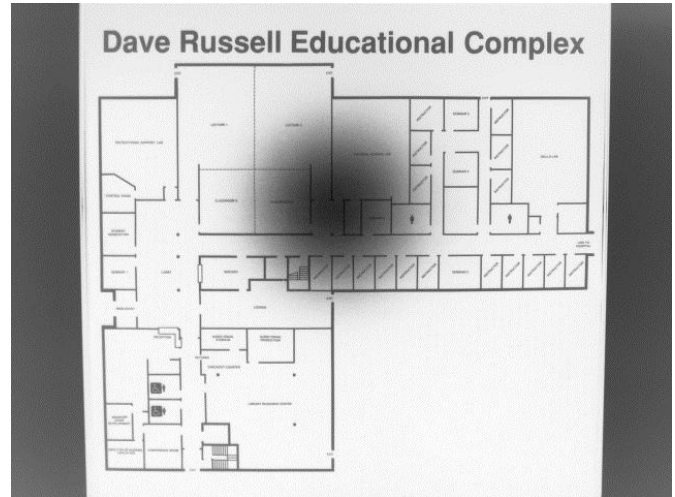
Fire escape plan viewed at the complex.
