# **RECAPP Facility Evaluation Report**

## **Northern Lights Health Region**

**Northern Lights Regional Health Centre**  
B1056A  
Fort McMurray

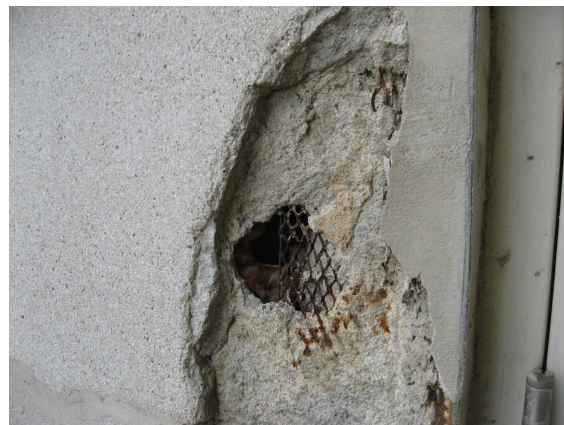
Several studies have been conducted of the last 10 years, the last was conducted by Building Sciences Engineering Ltd on March 21, 2008. The intrusive testing of the wall assembly indicated by the previous report indicated that the wall is not air tight. Several sections of the exterior finish have cracked and fallen off the face of the assembly.

Missing finish coat on exterior wall assembly observed in several locations. Smoke test was conducted in this area.

Several previous repairs have been conducted, however extensive repairs and or replacement is recommended. Repairs to coincide with windows replacement.

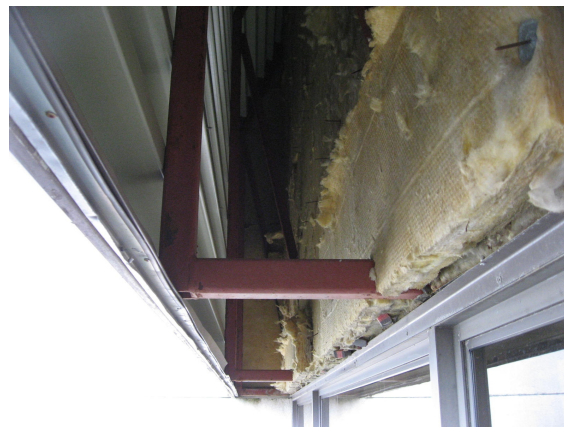
Several of the soffits are missing and damaged around the perimeter of the building. Some of the soffits were removed by contractors, however not replaced.

Missing metal soffits above windows.

Repair and replace all missing and damaged metal soffits above the window assembly.

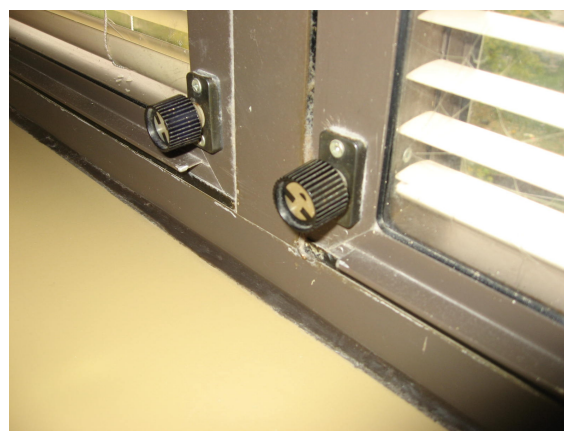
Several studies have been conducted by several consultants over the last 10 years. Due the fact the window assembly has removable panes of glass the units are not completely sealed. Condensation was observed between the outer and inner panes of glass. See study conducted November 2001 by Building Science Engineering Ltd for details.

Removable inner pane with damaged rubber gasket throughout the majority of the window units.

Replace all original window units throughout the hospital. The 10 window units in the new Ambulatory area were replaced in 2008.

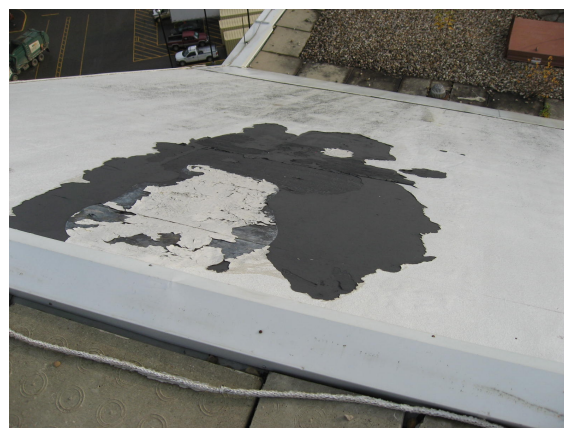
The elastomeric coating has deteriorated from the sloped roof sections.

Deteriorated elastomeric coating on sloped roof section A3.

Remove and replace elastomeric coating on roof section A3.

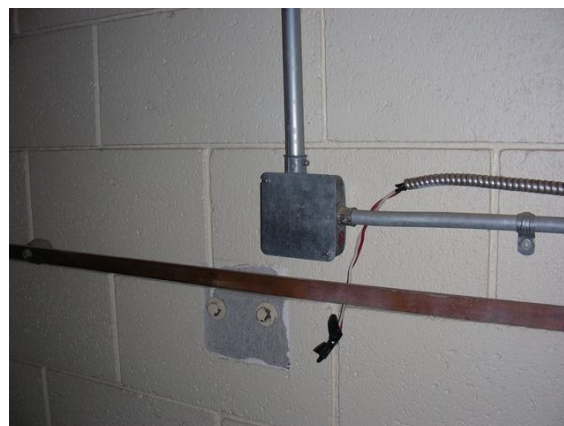
Wiring in medical gas storage area is not rated for explosion proof area.

Provide a thorough study of the area classification for this room based on the current utilization parameters to update the electrical area classification and determine which type of devices, raceways and wiring are appropriate for the current utilization of the room and what needs to be done, to the existing electrical equipment.

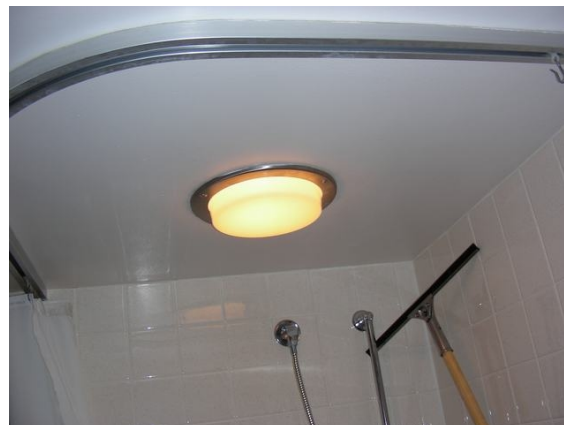
Incandescent lighting in showers is not energy efficient.

Replace incandescent lamps with equivalent output compact fluorescent spiral type bulbs.

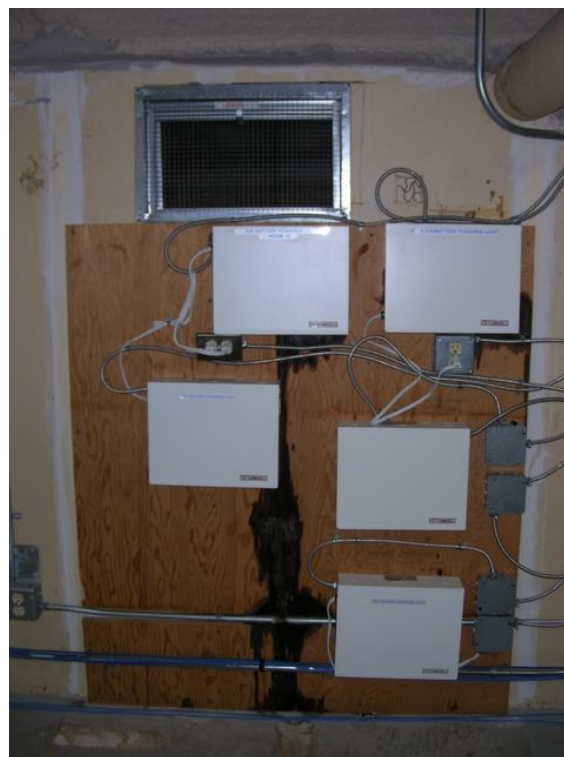
Emergency lighting battery units in Interstitial space electrical room.

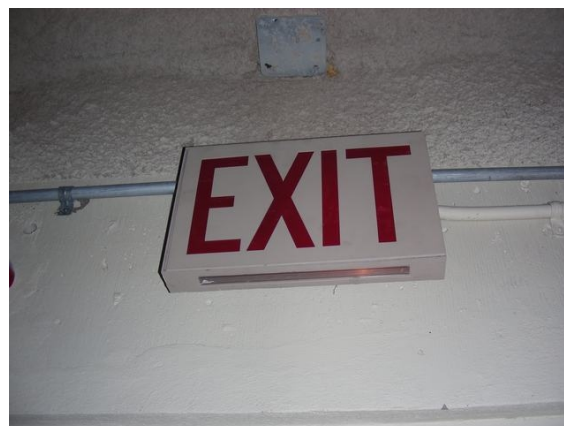
Incandescent exit sign is inefficient and has a short lamp life.

Replace the incandescent lamps in the exit signs with LED retrofit kits.

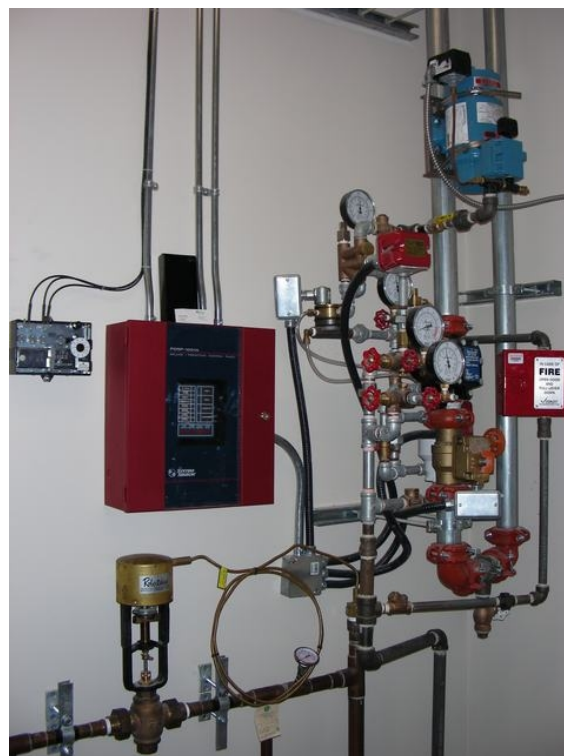
MRI Pre-action system is not tied into fire alarm system.
