RECAPP Facility Evaluation Report

Lacombe Hospital and Care Centre

B1105A
Lacombe

Evaluation Company: Francis Ng Architect Ltd.
Evaluation Date: October 9 2013
Evaluator Name: Francis Ng

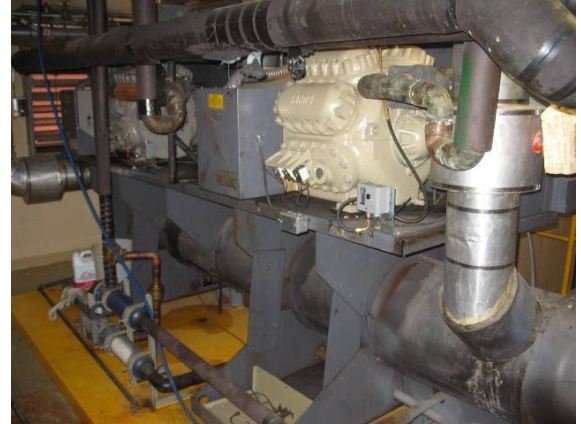
There have been numerous chiller compressor failures.

Chiller located in Mechanical Room.

Replace chiller and condenser units.

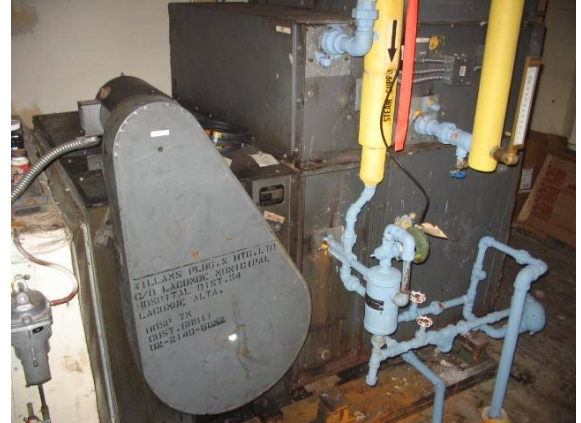
Multizone unit AS-8 serving 1966 section.

Event: Replace 6 Air Handling Units - 1966 section of building

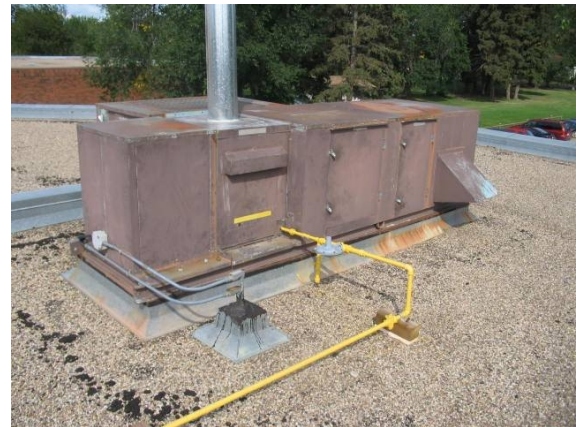
Rooftop unit serving Cafeteria.

Event: Replace 4 Package Rooftop Units
