# RECAPP Facility Evaluation Report

Alberta Health Services-South

## Big Country Hospital

B1133A

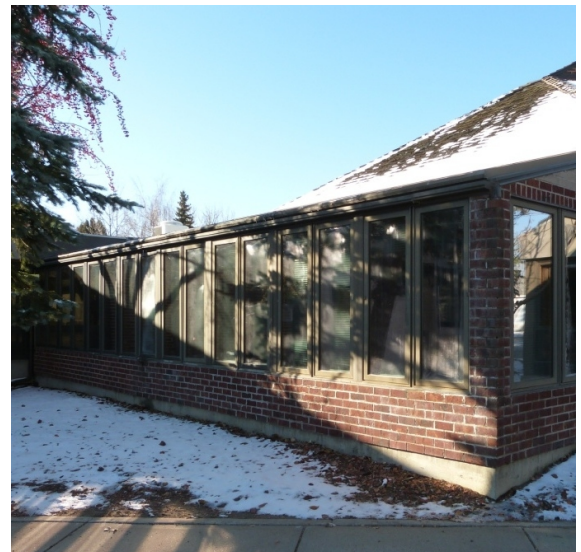
P1220769.JPG

Brick is crumbling and cracking
