RECAPP Facility Evaluation Report

St. Raymond School

B2137A

Evaluation Company: Marshall Tittamore Architects
Evaluation Date: October 10 2006
Evaluator Name: Tom Tittamore

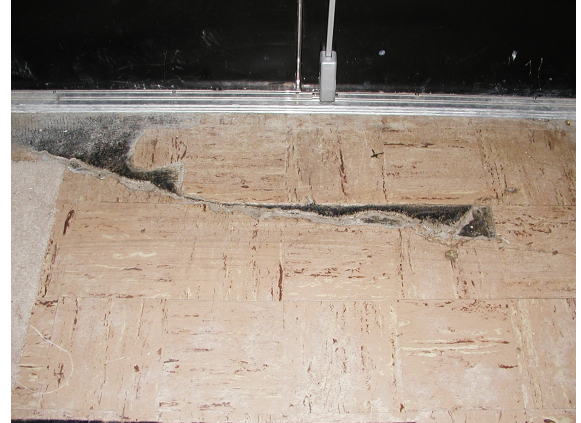
The northerly section of the gymnasium floor has shifted and has created a 'valley' at this end

Failed VAT flooring at emergency exit, due in part to shifted gym floor slab.

Repair shifted section of gym floor
