# **RECAPP Facility Evaluation Report**

**Edmonton Roman Catholic Separate School Division Head Office**

B2198A  
Edmonton

**Evaluation Company:** Burgess Bredo Architect  
**Evaluation Date:** November 4 2005  
**Evaluator Name:** Mr. Burgess Bredo

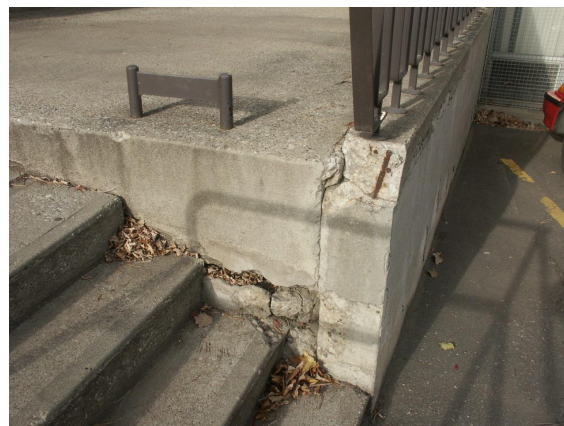
**Concern:**

Concrete retaining wall at southeast entrance is cracked and leaning.

**Recommendation:**

Repair retaining wall (5 metres)
