RECAPP Facility Evaluation Report

Edmonton School District No. 7

Abbott Elementary School

B3032A
Edmonton

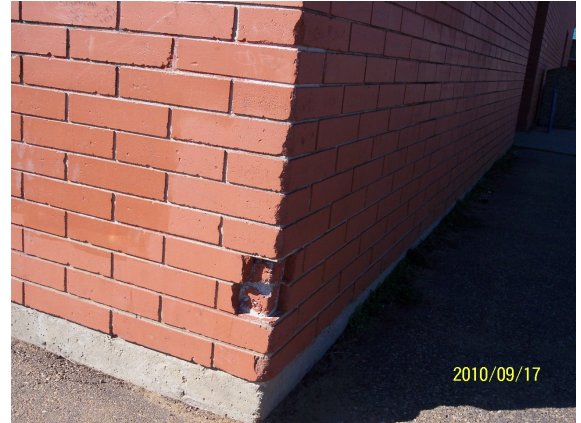
(1973) Addition (Northeast corner) - has damaged giant modular unit bricks.

Repair giant modular unit bricks. (approx. 1 square metre)

<u>Type</u>	<u>Year</u>	<u>Cost</u>	<u>Priority</u>
Repair	2011	\$5,000	Low
