RECAPP Facility Evaluation Report

Edmonton School District No. 7

Bisset Elementary School

B3059A
Edmonton

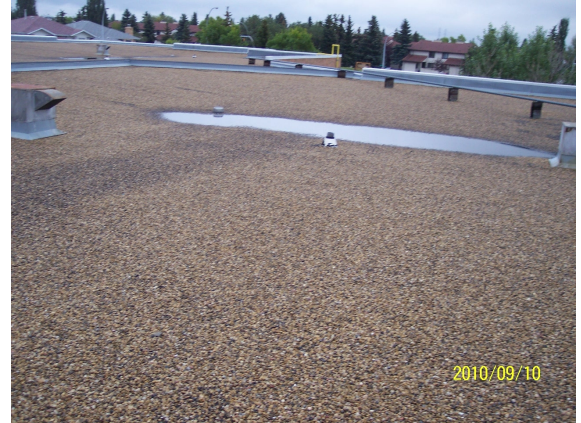
(1989) Original Building - has ponding.

Replace built-up roof. (approx. 3140 sq. m.)

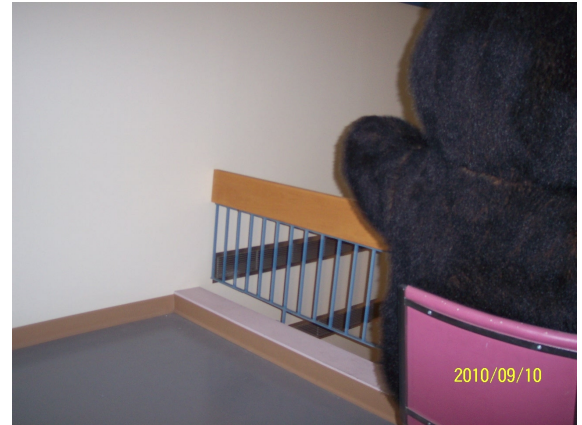
(1989) Original Building (Mezzanine 205) - railing and balustrades are too low and do not meet building code.

Replace wood railing with balustrades. (approx. 10 linear metres)

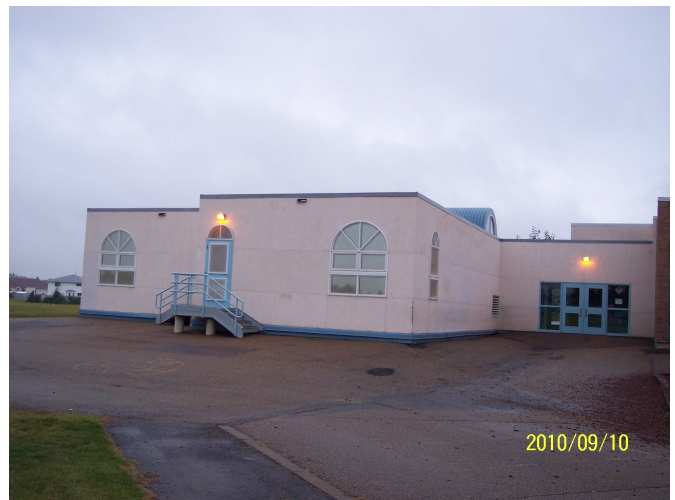
Southeast Elevation.

1. Stucco has bubbles near West wall of Classroom 26 and fire damages near Classroom 25 exit.
2. Wood exit stairs are worn out.
3. Built-up roofing has blisters and ponding.
4. Windows have condensation in Classroom 24.

1. Repair stucco. (approx. 20 square metres) \$ 3000
2. Replace wood exit stairs. (4 stairs) \$6000
3. Replace built-up roofing. (approx. 750 square metres) \$112500
4. Replace gaskets for windows. (4 windows) \$1000
