# **RECAPP Facility Evaluation Report**

**Dan Knott Junior High School**

B3086A  
Edmonton

**Evaluation Date:** November 17 2011

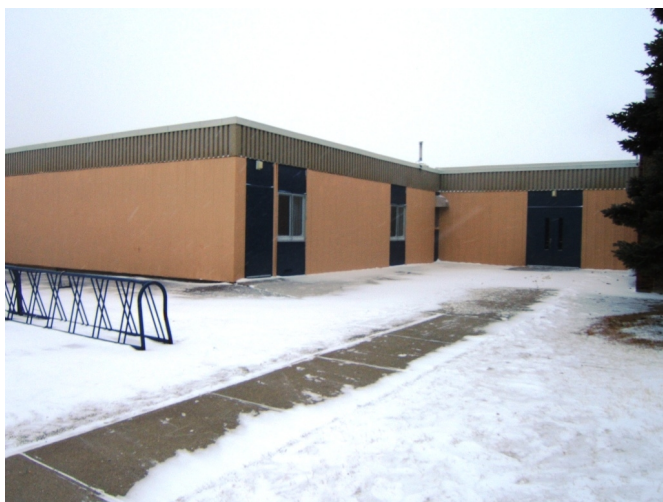
Partial View.

| <b><u>Rating</u></b> | <b><u>Installed</u></b> | <b><u>Design Life</u></b> | <b><u>Updated</u></b> |
|---|---|---|---|
| 4 - Acceptable | 1981 | 30 | MAR-12 |

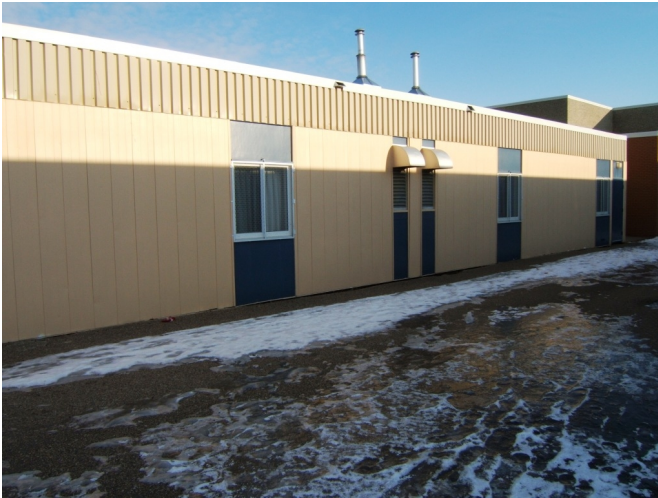
Partial View.

| <b><u>Rating</u></b> | <b><u>Installed</u></b> | <b><u>Design Life</u></b> | <b><u>Updated</u></b> |
|---|---|---|---|
| 4 - Acceptable | 1981 | 30 | MAR-12 |

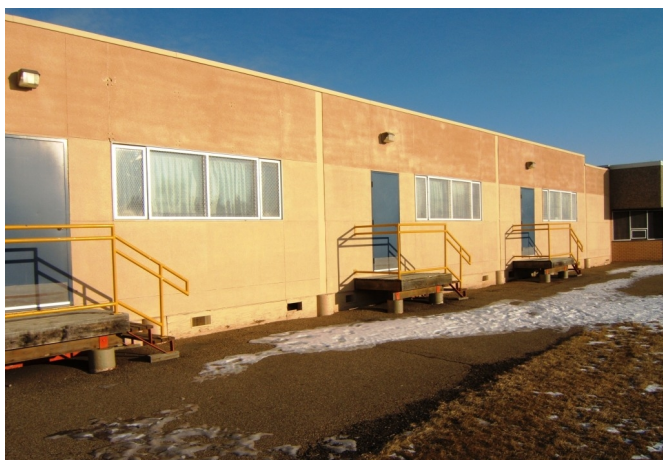
Elevation View.

| <b><u>Rating</u></b> | <b><u>Installed</u></b> | <b><u>Design Life</u></b> | <b><u>Updated</u></b> |
|---|---|---|---|
| 4 - Acceptable | 1990 | 30 | MAR-12 |
