RECAPP Facility Evaluation Report

Edmonton RCSSD #7

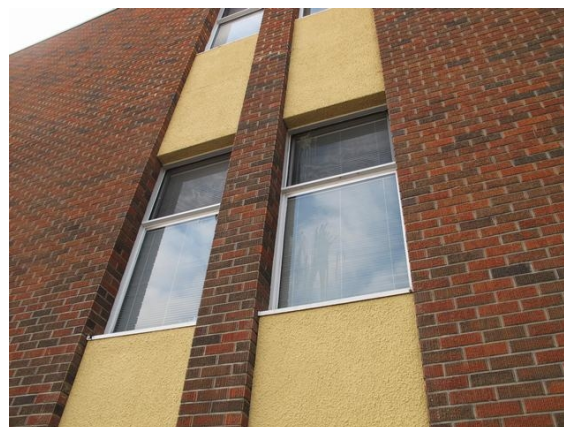
Deteriorated sealant around window assembly.

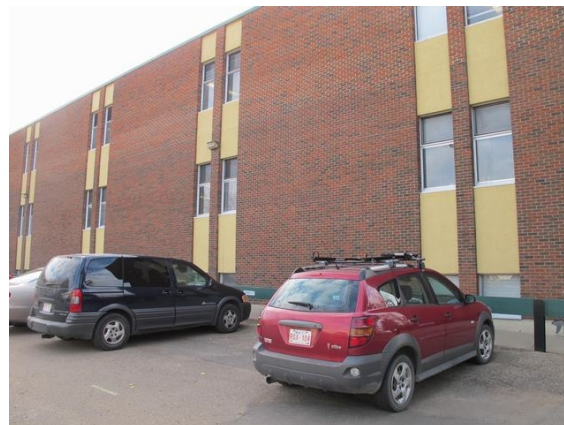
Original 1972 and 1968 Windows

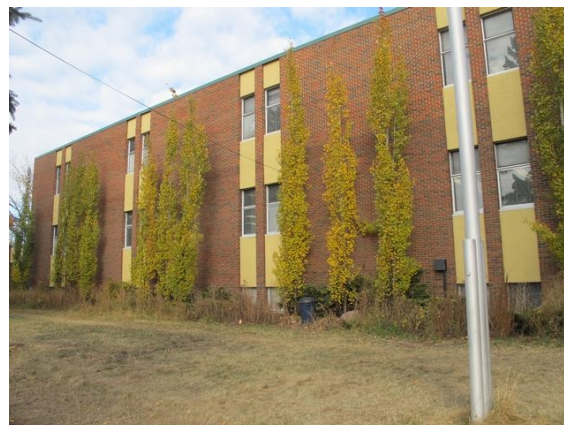
Original windows in 1972 and 1968 Section

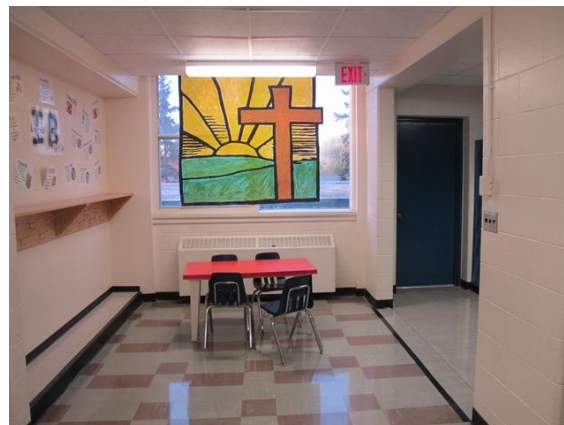
Wood framed windows in 1963 Corridors.

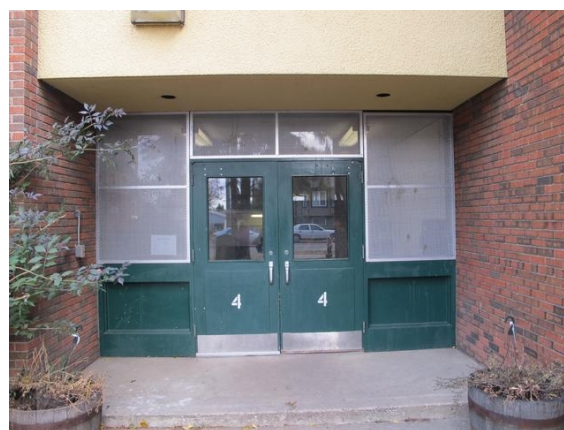
Main entrance doors - South elevation

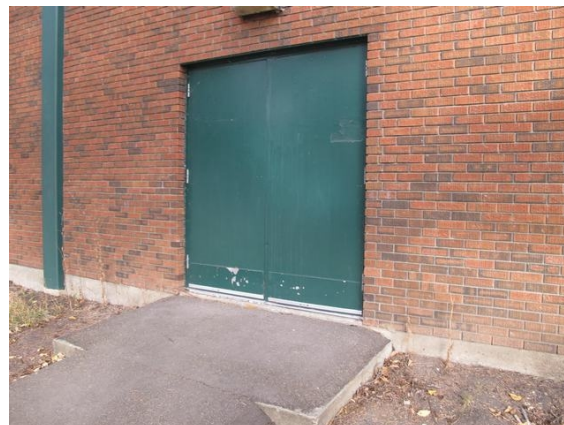
Painted wood exit doors at gym - South elevation

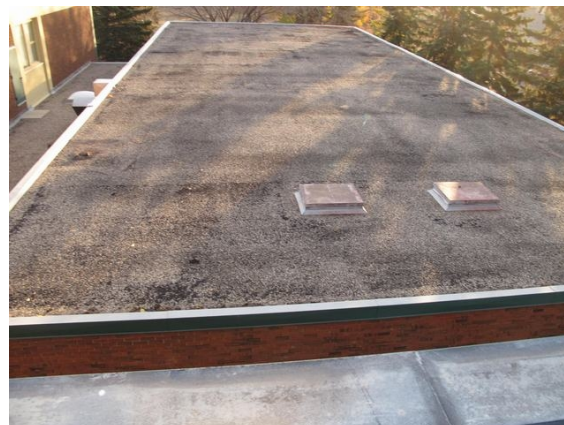
Original roof above 1963 Section

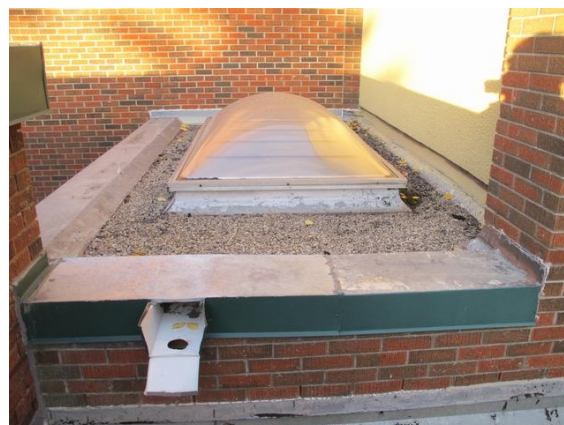
Skylight above stairwell in 1972 Addition

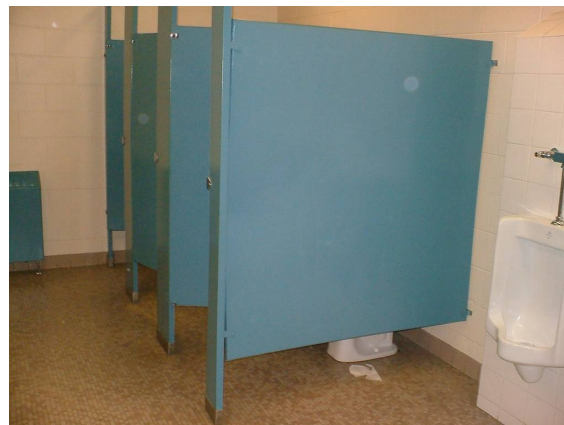
Metal toilet partitions.

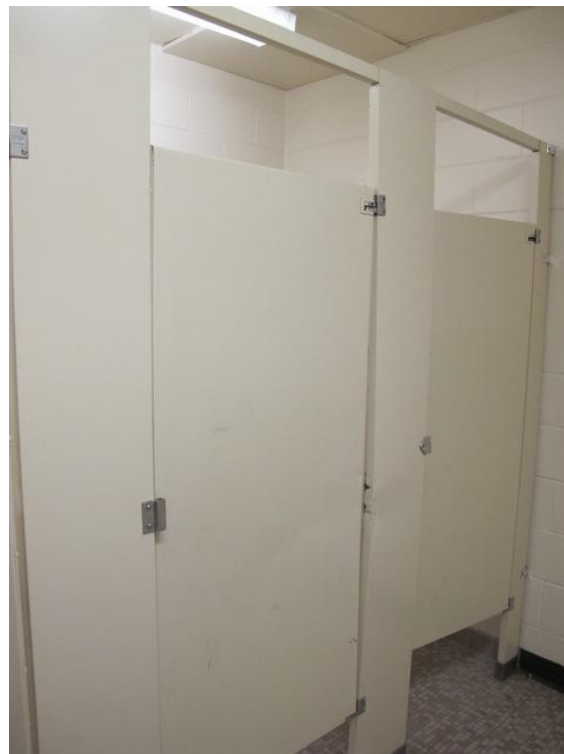
Damaged door panels in washrooms

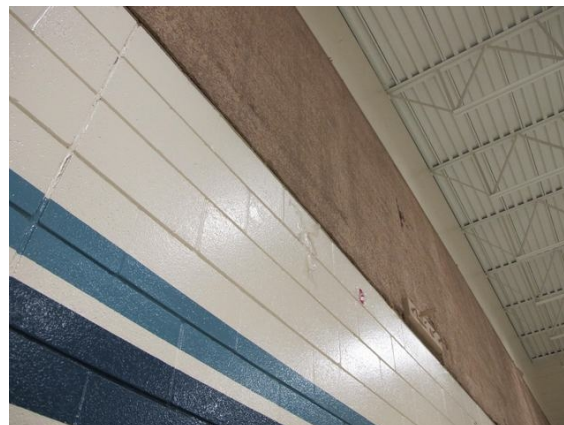
Original deteriorated acoustical panels in small gym.

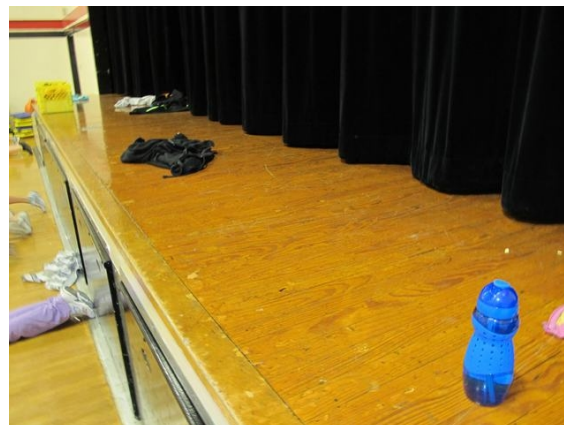
Hardwood flooring on stage area in the 1963 Section.

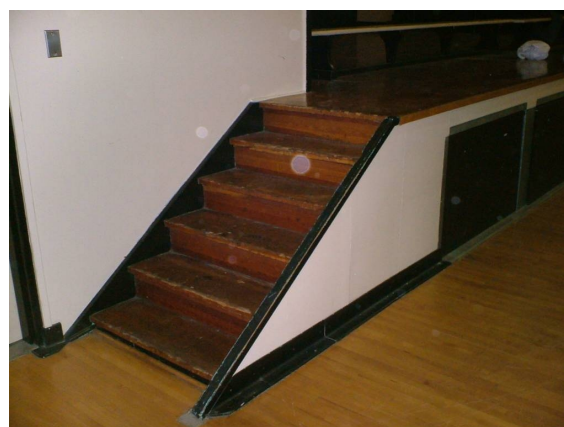
Hardwood floor in large gymnasium, stage and wood stair to stage.

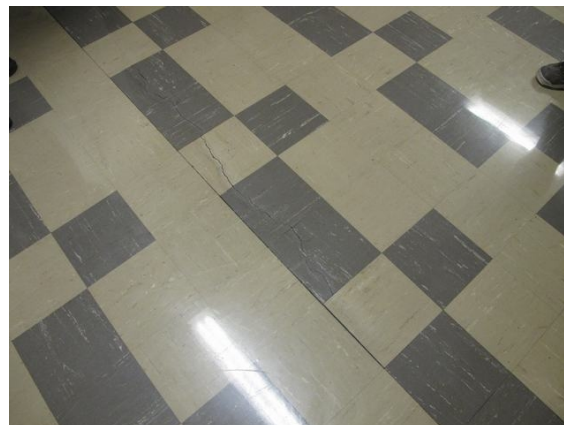
Cracked VAT flooring in original classroom.

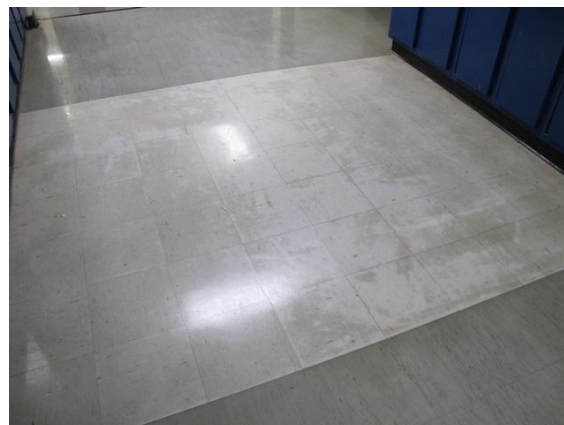
Deteriorated finish on vinyl floor tiles in corridors.

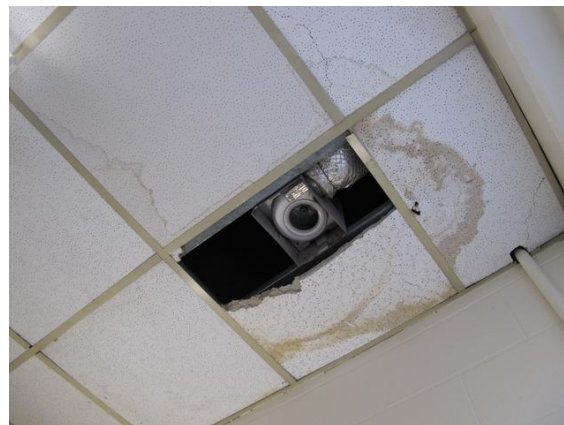
Stained ceiling tiles in the stairwell washroom in the original 1963 Section.

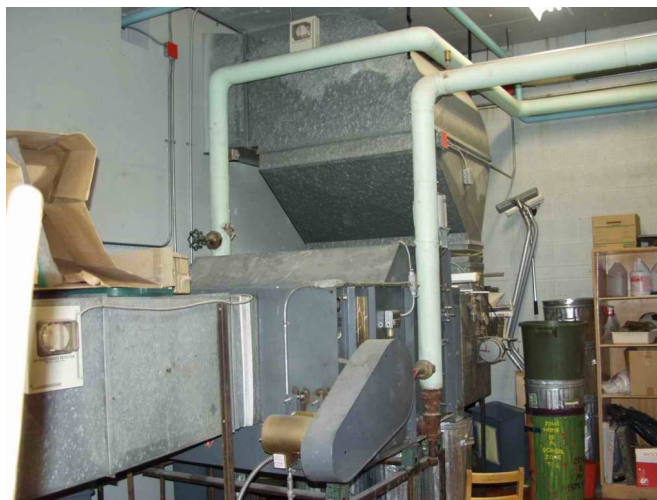
<u>Rating</u>	<u>Installed</u>	<u>Design Life</u>	<u>Updated</u>
2 - Poor	1963	30	MAR-12

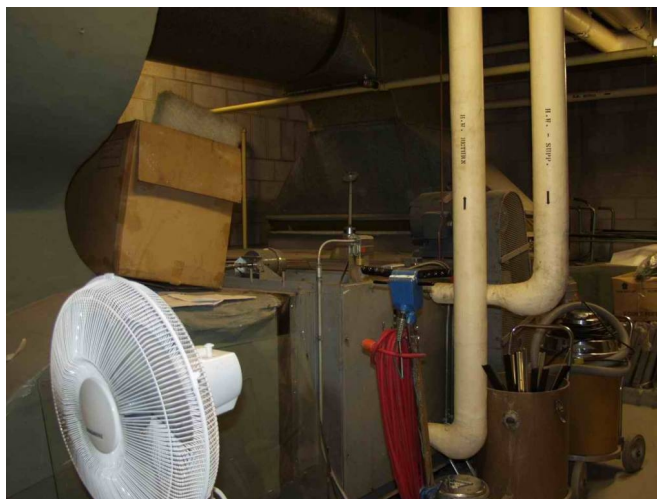
West Wing Air handling Unit. Serves Basement and Main Floor

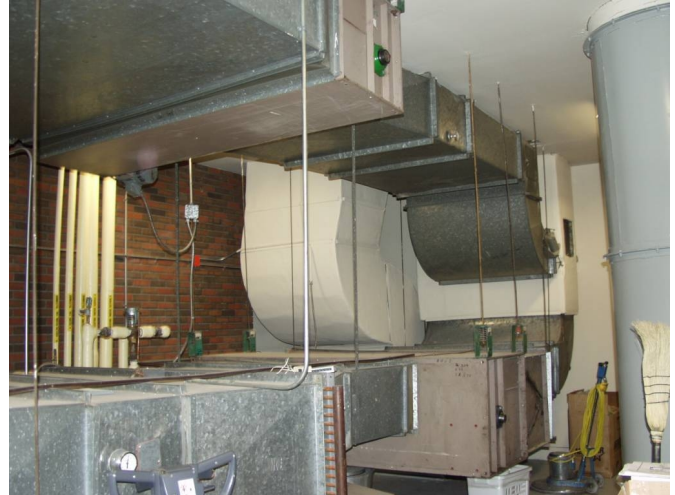
West Wing Air Handling Unit. Serves Upper Floor

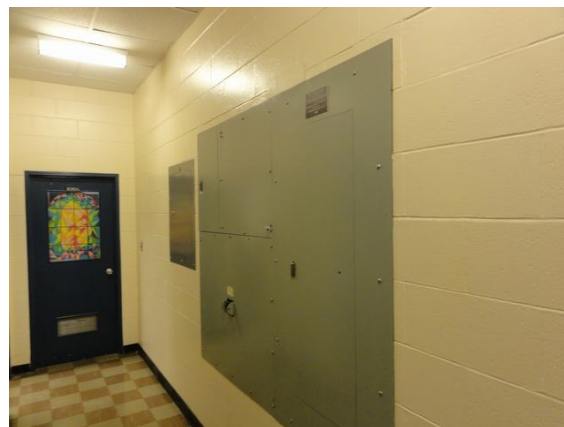
800A, 120/208V switchboard located in corridor.

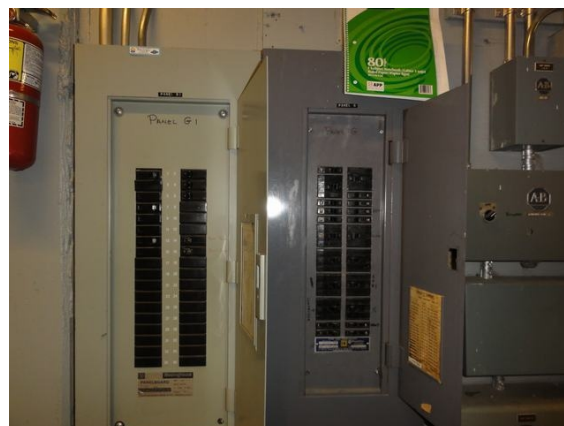
Original Square D (1963) and Westinghouse (1972) branch circuit panels.

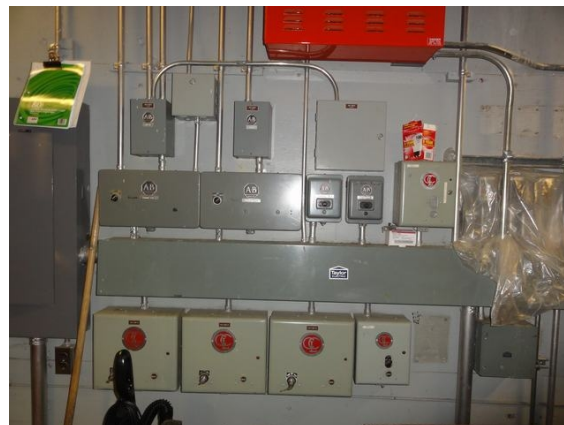
Allen Bradley and CCL motor starters in mechanical room.

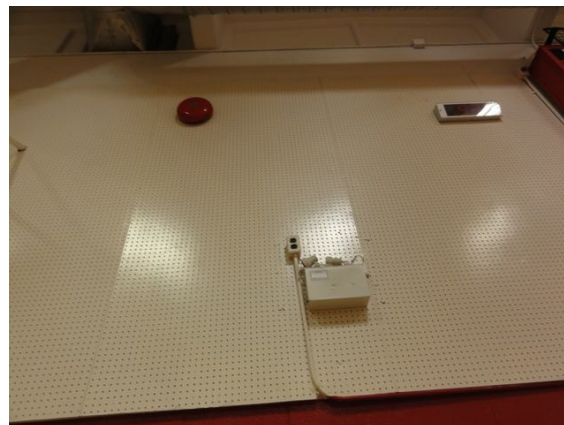
Aged emergency lighting battery unit is not plugged in. Heads are not aligned properly.

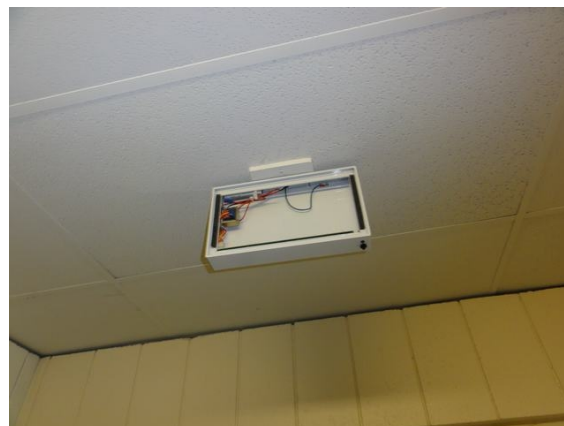
Faceplate missing on exit sign.

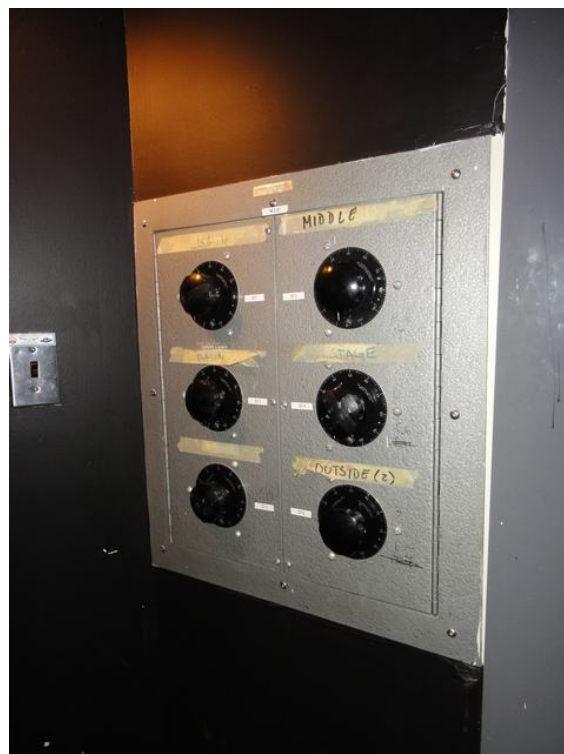
Obsolete dimmer panel on stage.

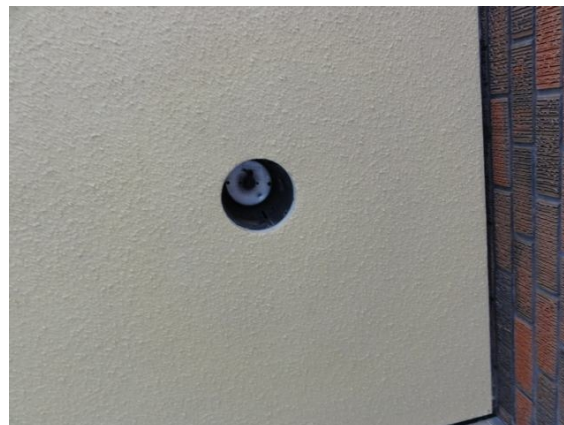
Inefficient exterior incandescent lighting fixture.

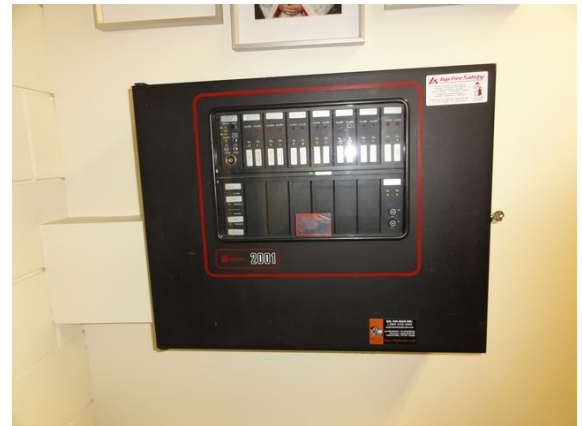
Simplex 2100 fire alarm control panel located in administration area.

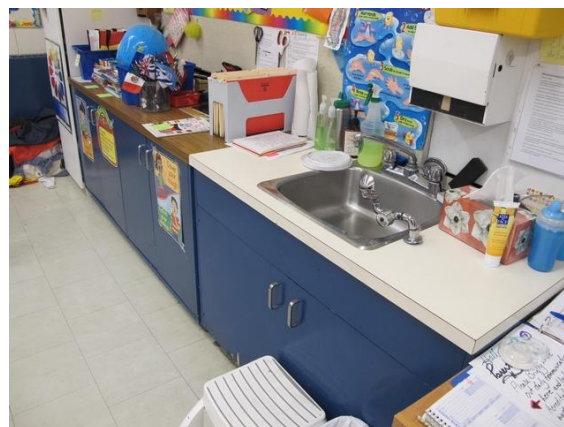
Original millwork in classroom area.
