RECAPP Facility Evaluation Report

Edmonton School District No. 7

Kate Chegwin Junior High School

B3176A
Edmonton

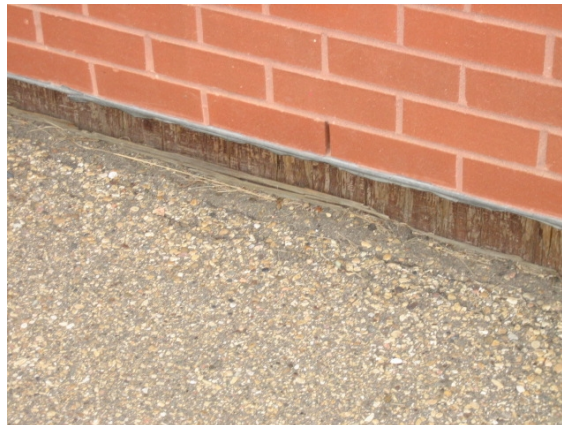
IMG_8861.jpg

Pressure treated plywood over rigid insulation along grade at foundation wall. Total 350m.

Pressure treated plywood has deteriorated and no long provides good protection from weather.

Recommend repairing and replacing pressure treated plywood with exterior cement board.

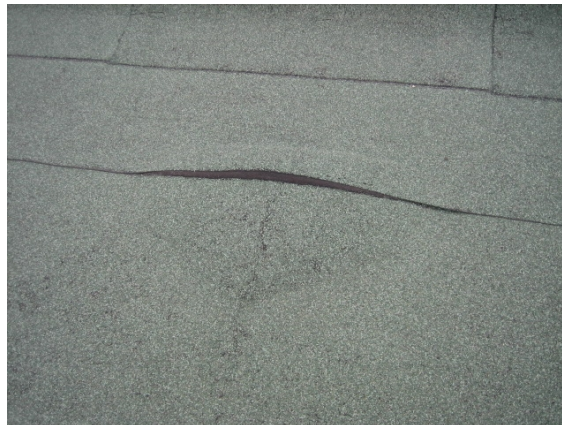
IMG_8845.jpg

Event: Repair roof membrane bubbling (500m2)

Recommend repairing portions of roof that soft spots and bubbling exists.

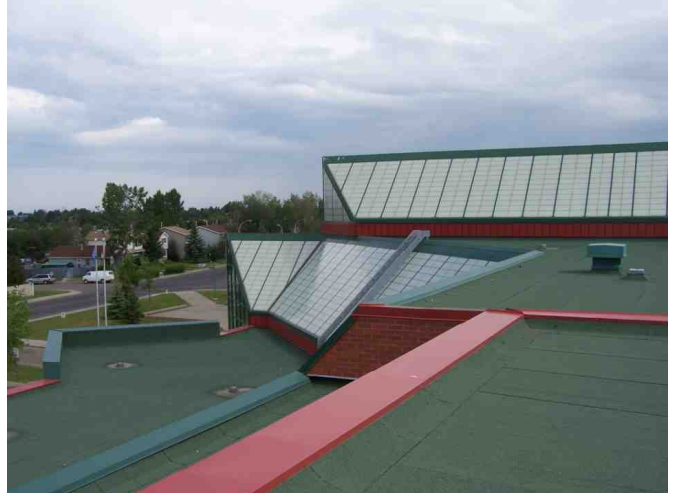
Translucent plastic sloped sandwich panels (skylight). Total 650 panels.

<u>Rating</u>	<u>Installed</u>	<u>Design Life</u>	<u>Updated</u>
4 - Acceptable	1991	25	MAR-13

Translucent roof panels

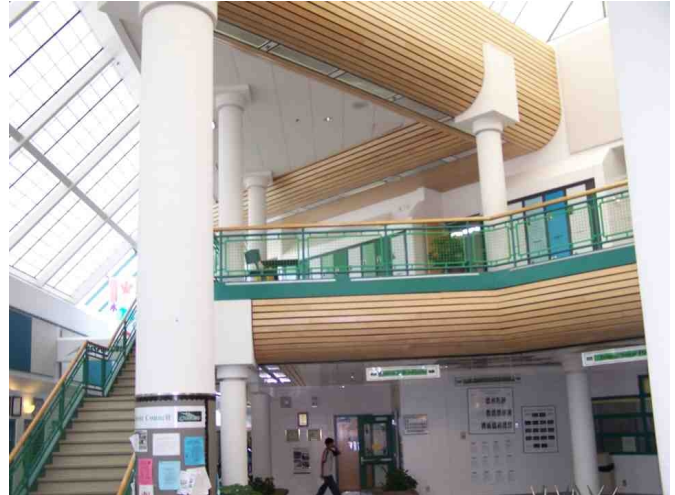
<u>Rating</u>	<u>Installed</u>	<u>Design Life</u>	<u>Updated</u>
5 - Good	1991	0	MAR-13

Wood handrails with painted pipe support and painted metal mesh inlay sections.

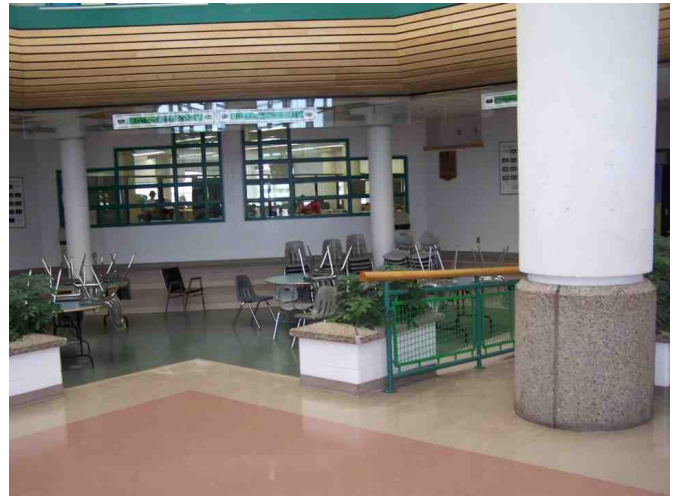
100_8119.JPG

A number of spaces include painted pressed steel frames with tempered glass.

<u>Rating</u>	<u>Installed</u>	<u>Design Life</u>	<u>Updated</u>
5 - Good	1991	0	MAR-13

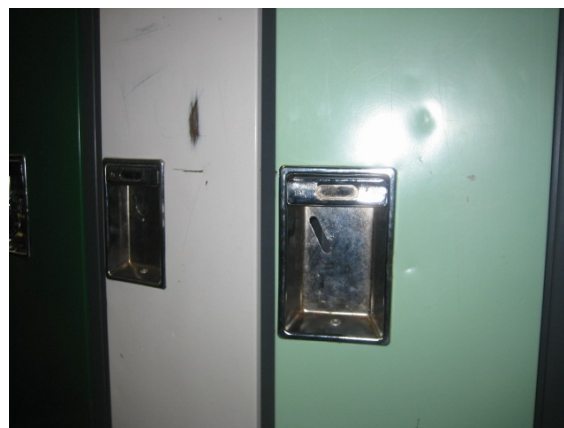
Kate Chegwin 078.jpg

Lockers in boys gym change room are damaged, dented and scratched.

Recommend replacing damaged lockers in boys change room.

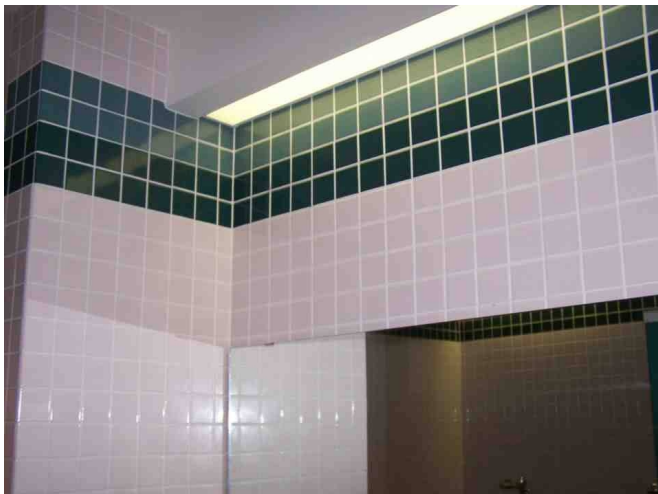
Floor to ceiling tile in washrooms, tile surround at mop sinks in janitors room. Total 550m2.

<u>Rating</u>	<u>Installed</u>	<u>Design Life</u>	<u>Updated</u>
5 - Good	1991	40	MAR-13

Wall tile -typical.

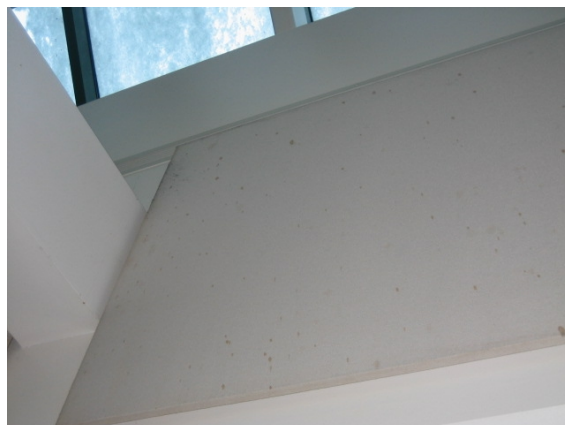
Kate Chegwin 021.jpg

Some of the acoustic wall panels in the main corridor have stain from condensation. Recommend replacing the fabric on the stained acoustic panels.

A large number of panel have water stains due to dripping condensation from skylights.

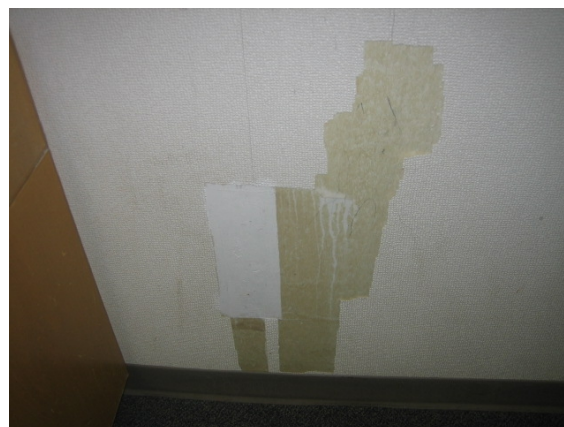
Kate Chegwin 024.jpg

The vinyl wall coverings are damaged in some areas, recommend repairing the damaged portions.

Damaged / peeling vinyl from wall surface at various locations throughout the school.

Repair damaged vinyl wall coverings, replace as required.

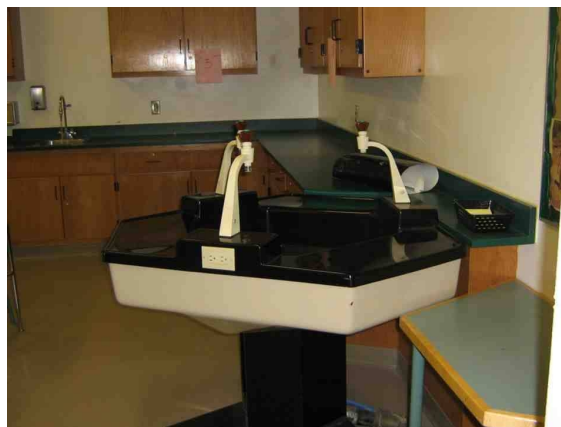
There are a total of 30 stainless steel sinks within the school. There are as follows:
 16 counter mounted, single compartment with gooseneck faucet, index handles and bubbler.
 There are 2 large single compartment with spout and handles art sinks.
 1 double compartment sink with handles.
 3 single compartment science room with gooseneck and handles.
 1 plastic molded drain board c/w sink and single lever control with mixing valve.
 1 single compartment with gooseneck control and eyewash.
 6 angles double compartment with index handles in home economics room.

Typical science room sink.

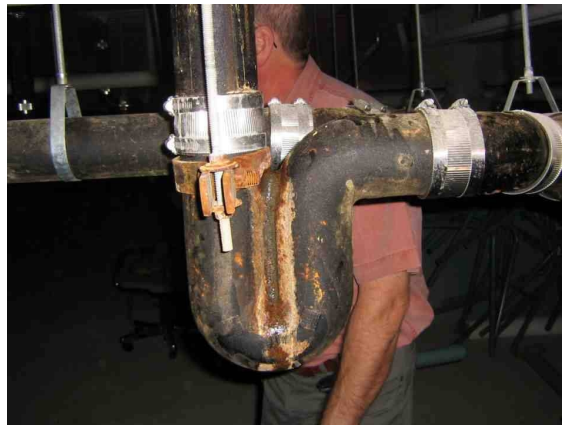
Two of the traps in the crawl space are leaking.

Trap leaking in crawl space.

Repair the two leaking traps and check all the plumbing drains in the crawl space for leaks.

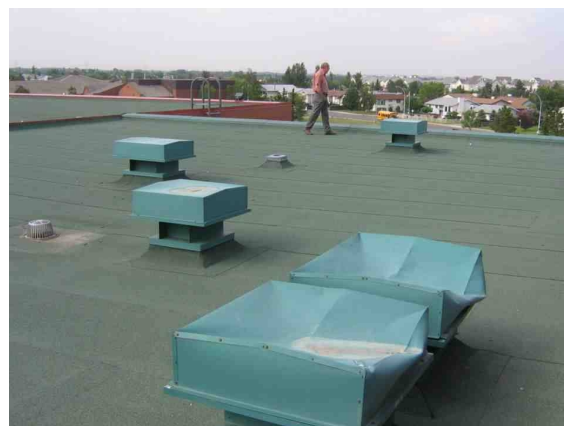
Dented roof caps.

Replace roof caps when the fans are replaced.

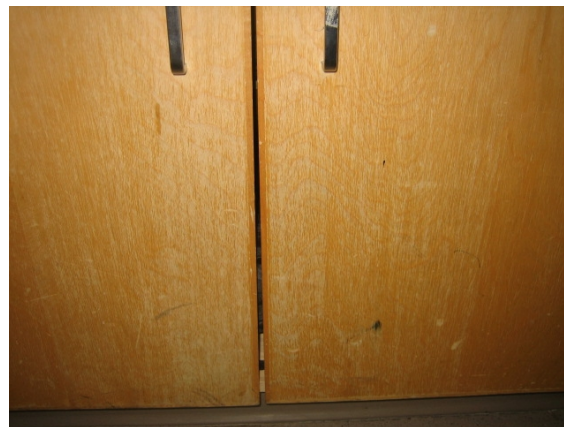
Kate Chegwin 020.jpg

The millwork finish throughout is worn and plastic laminated counter tops are starting to de-laminate. Recommend replacing the millwork.

Event: Replace damaged fixed casework (115m base cabinets 60m upper units)

Recommend replacing the damaged millwork and countertops.
