RECAPP Facility Evaluation Report

Edmonton School District No. 7

Kildare Elementary School

B3182A
Edmonton

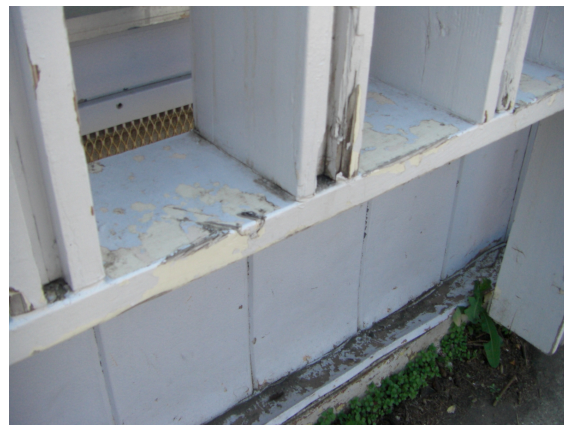
(1968) Circular Building - Classroom Windows have rotten wood sunscreens.

Repair wood sunscreens. (16 screens)

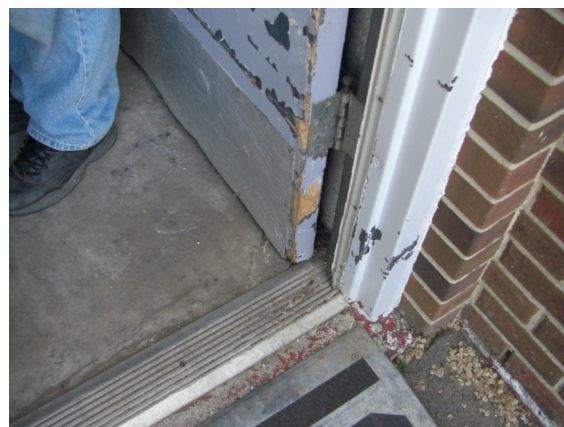
(1968) West Wing (Boiler Room, West Exit; Outdoor Gymnasium Storage) - wood doors and hardware are worn out.

(1968) West Wing (Outdoor Gymnasium Storage) - wood door and hardware are worn out.

Replace wood doors with insulated metal doors and insulated metal frames. (2 doors)

Repaint metal doors and frames. (2 doors)
