# **RECAPP Facility Evaluation Report**

**Edmonton School District No. 7**

**John A. McDougall Elementary / Junior High School**

B3210A  
Edmonton

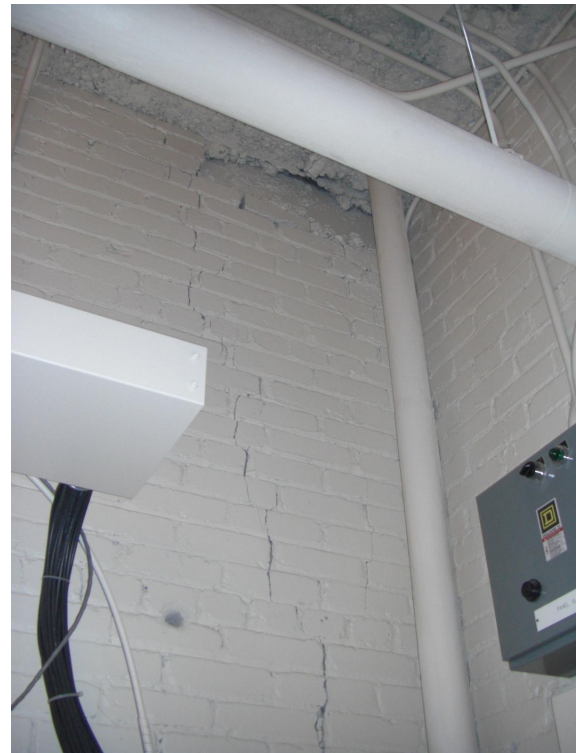
- (1930) Original Building (ELEC 029) - load bearing brick masonry walls have cracks.
- (1930) Original Building (West Exit near Classroom 109) - has damaged face brick wall.
- (1930) Original Building (exterior wall near Boiler Room 028) - has damaged brick wall.

(1930) Original Building (ELEC 029) - load bearing brick masonry walls have cracks.

Repair brick walls. (approx. 10 square metres)

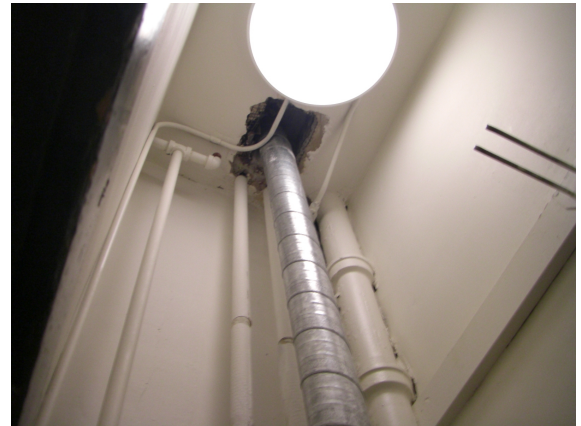
(1930 Original Building (Jan 131) has holes in ceiling.

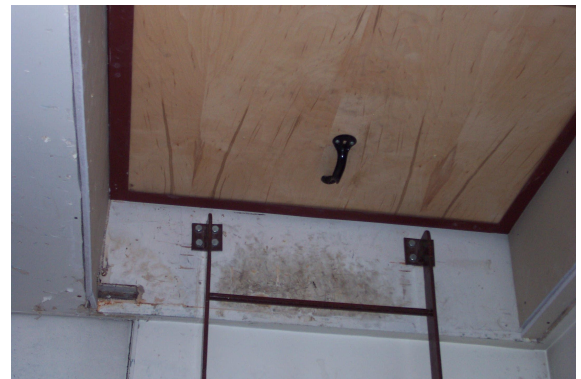
Plywood hatch from Storage Room 010 to Mechanical Room 102

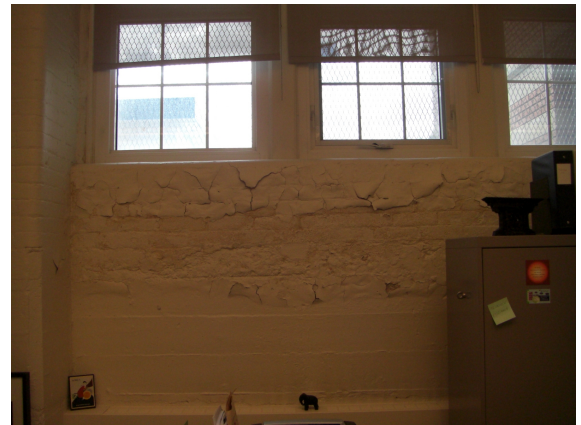
(1930) Original Building (Office 034) - paint has peeled off.

Repair walls and repaint walls. (approx. 120 square metres)
