# RECAPP Facility Evaluation Report

## Edmonton School District No. 7

### Norwood Elementary School

B3234A  
Edmonton

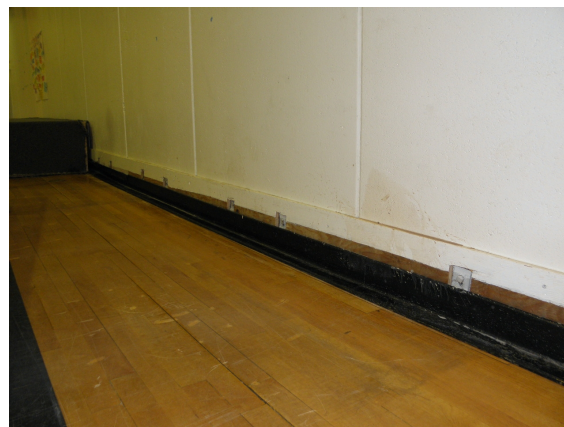
(1971) Addition (Main Floor - Gymnasium 122) - concrete slab has dropped more than 50mm.

**Event:** **Mudjack Gymnasium 122 concrete slab - 1971 Section. (approx. 110 square metres)**

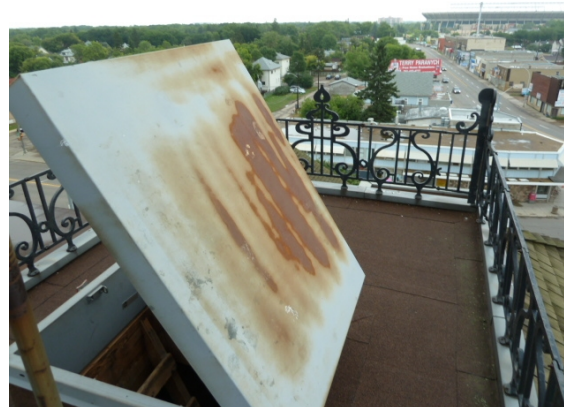
(1908) Original Building (Third Floor - Attic to Roof) - has a rusty metal roof hatch

Replace 1 hatch - 1908 Section.

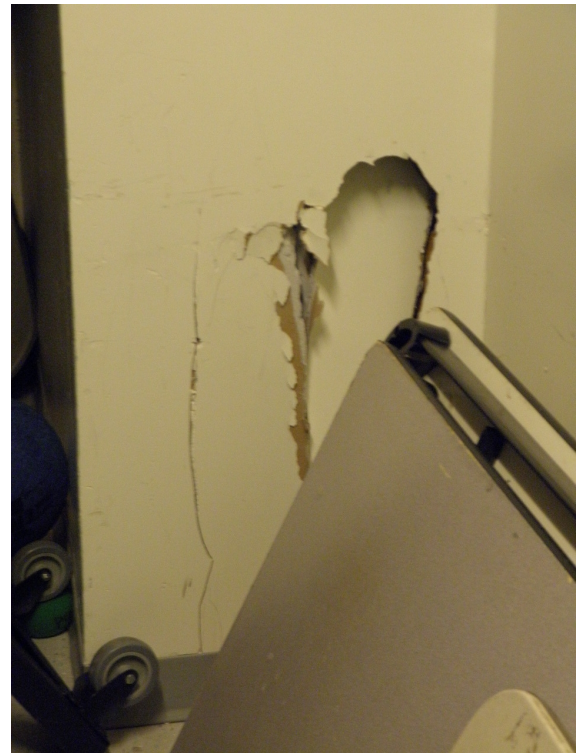
(1971) Addition (Main Floor - Gym Storage 127) - has damaged gypsum board wall.

Repair Gym Storage 127 wall - 1971 Section. (approx. 5 square metres)
