RECAPP Facility Evaluation Report

Edmonton School District No. 7

Old Scona Academic High School

B3235A
Edmonton

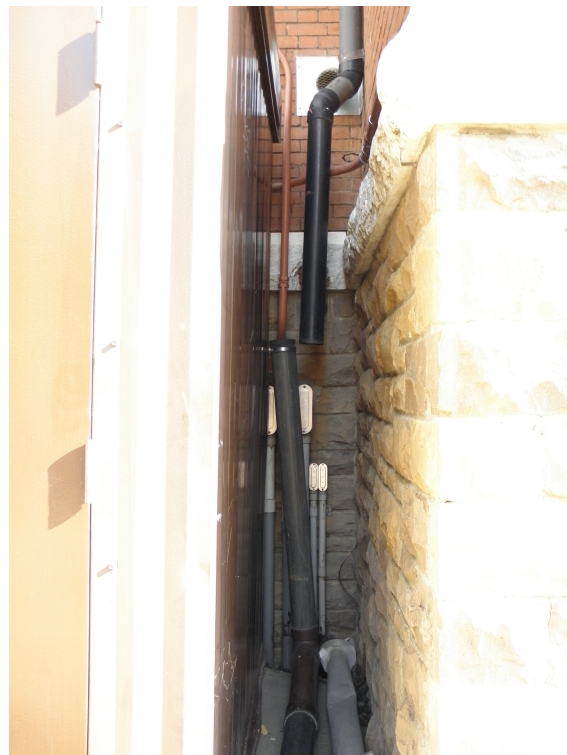
(1907) Original Building (South Wall near Mechanical Room 6) - has damaged downspout. (1 downspout)

Repair PVC downspout - 1907 Section. (approx. 15 linear metres)

<u>Type</u>	<u>Year</u>	<u>Cost</u>	<u>Priority</u>
Repair	2012	\$1,500	Low

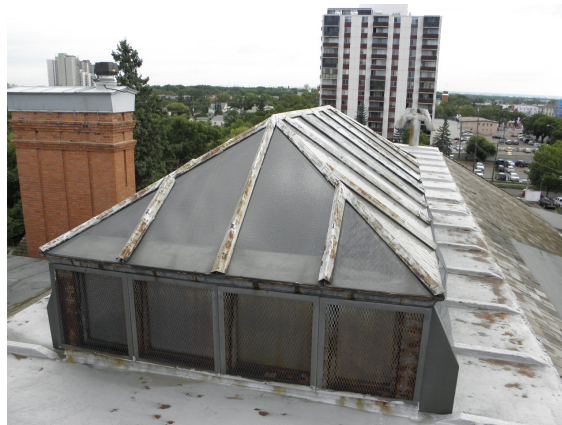
(1907) Original Building - has rusty metal framed skylight.
(size: approx. 5.4m x 2.4m)

(1907) Original Building - metal framed skylight is rusty.

Replace 1 skylight.

<u>Type</u>	<u>Year</u>	<u>Cost</u>	<u>Priority</u>
Failure Replacement	2012	\$40,000	Low
