RECAPP Facility Evaluation Report

Riverbend Junior High School

B3262A
Edmonton

Evaluation Company: A&E Architectural & Engineering Group Inc.
Evaluation Date: June 25 2008
Evaluator Name: Vic Maybroda

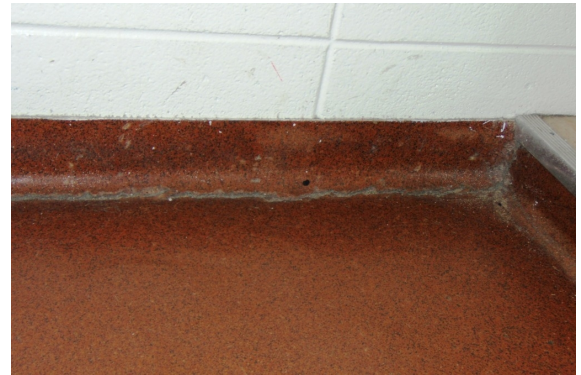
<u>Rating</u>	<u>Installed</u>	<u>Design Life</u>	<u>Updated</u>
3 - Marginal	1974	0	MAR-09

Significant settlement in various areas causing wall cracking and separation between walls and floor with significant slope in floors of south classrooms.

Separation crack located in changes rooms. Similar condition in west side washrooms along exterior wall.

Review areas of differential concrete slab movement and 'mudjack' affected areas.

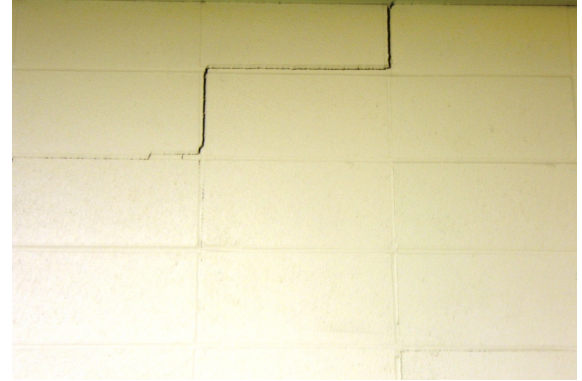
Concrete block exhibiting isolated wall cracks.

Walls cracks present concern to structural integrity of wall system.

Located in exterior wall of west wing classrooms. Adjacent washrooms present similar condition.

Remove effected mortar, install backing rod, caulk with appropriate paintable material and monitor results.
