RECAPP Facility Evaluation Report

Edmonton RCSSD #7

St. Benedict Catholic Elementary School

B3284A
Edmonton

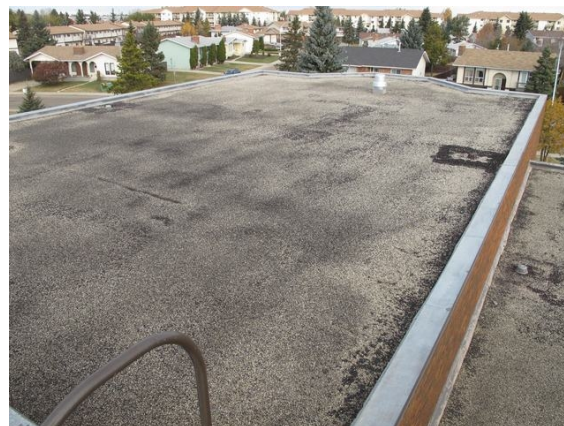
Several repairs have been conducted over recent years and the roof has surpassed its life expectancy. Roof blisters, wind scouring and evidence of ponding water was observed

Typical condition of the original 1978 Roof

Replace entire roof assembly - Area - 2690m2

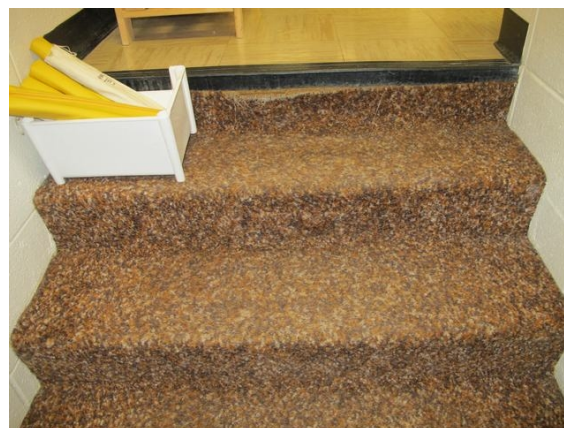
The carpet on the stairs is aged, worn and torn.

Aged and torn carpet at top of stair.

Replace carpet on the two stairs to the music room

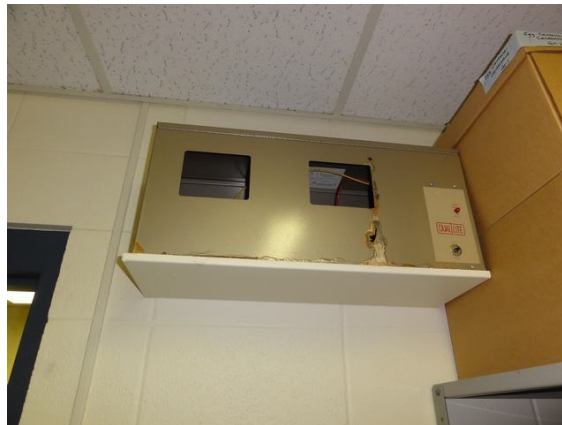
Aged emergency battery unit.

Replace emergency lighting battery units and remote heads.

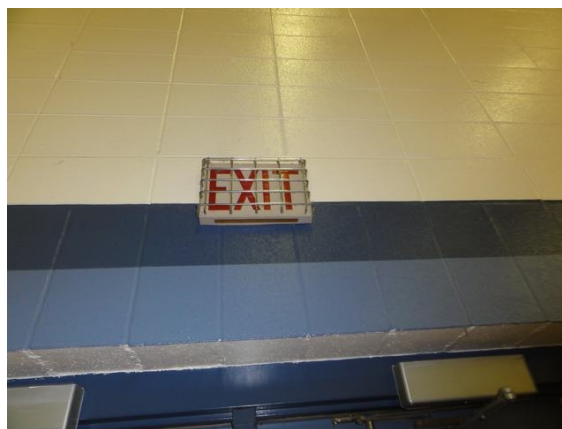
Incandescent exit sign - burned out.

Replace incandescent exit signs with energy efficient LED type exit signs.

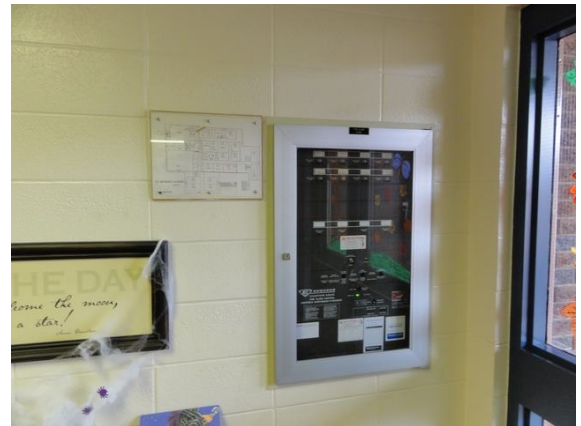
The Edwards 6500 fire alarm system is no longer manufactured. Replacement parts are not readily available and maintenance costs are high. There are no strobes in the school.

Edwards 6500 fire alarm control panel at main entrance.

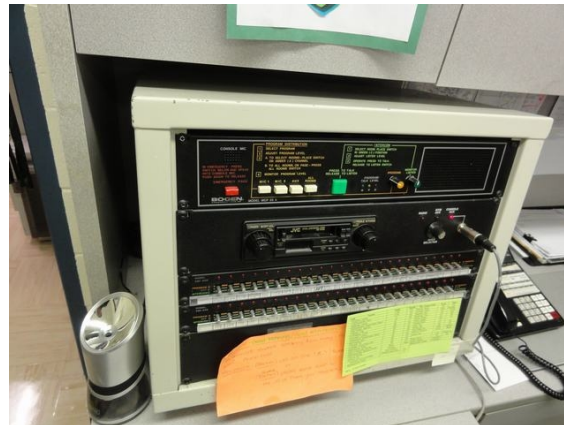
Existing Bogen P.A. System is obsolete. Replacement parts are no longer available. Standard system for schools is a microprocessor based system.

Obsolete Bogen MCP-35A P.A. system.

Replace existing P.A. System with new microprocessor based system.

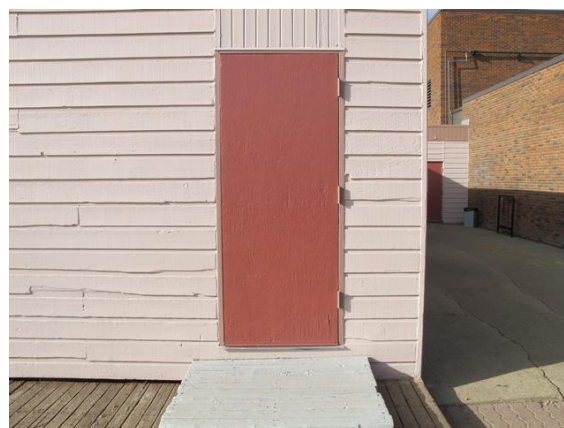
The exterior classroom doors are aged, worn and no longer secure.

Painted wood exterior doors in classrooms

Replace exterior exit doors c/w hardware in 4 classrooms

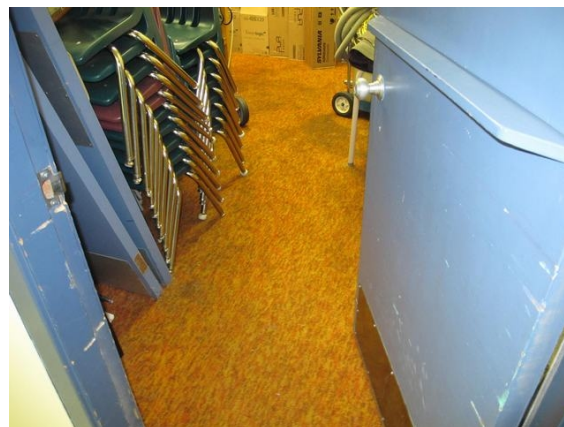
Original carpet in storage room.

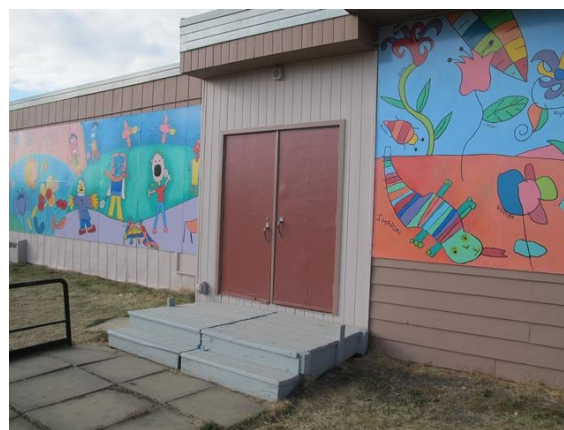
Exit doors at east link

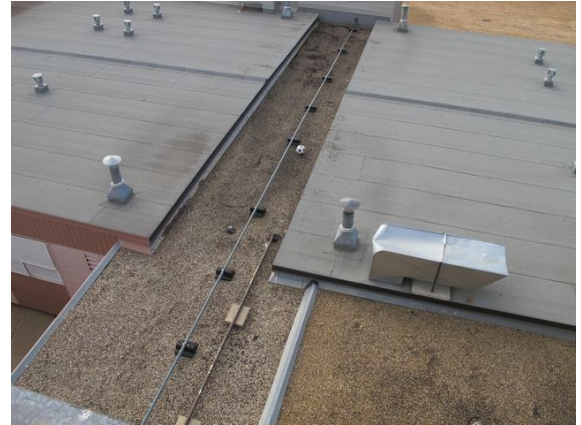
Original BUR above South Link

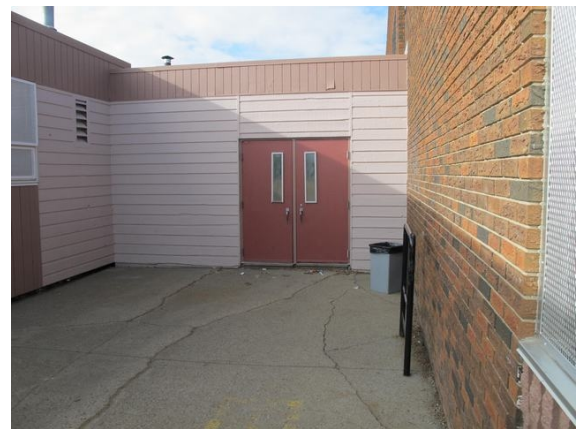
Exterior exit doors - South Link - North entry

Replace exterior doors c/w hardware at East Link - 2 Doors - North end of Link
