# **RECAPP Facility Evaluation Report**

**Edmonton RCSSD #7**

**St. Charles Catholic Elementary School**

B3291A  
Edmonton

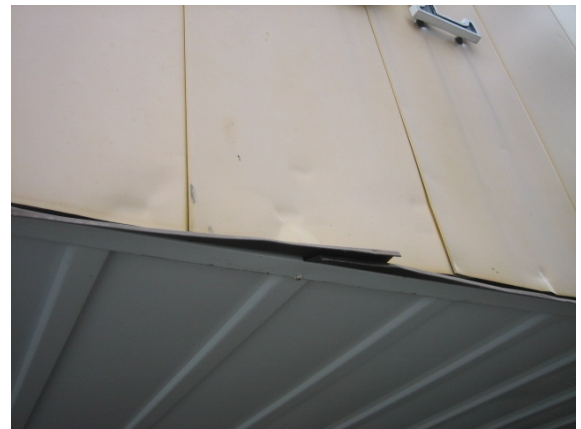
IMG\_9214.jpg

**Event: Replace damaged metal siding (10m2)****Concern:**

There are small dents throughout the metal siding. The siding is a thin gauge and damages easily from balls, etc.

Recommend replacing the damaged and dented areas of the metal siding.

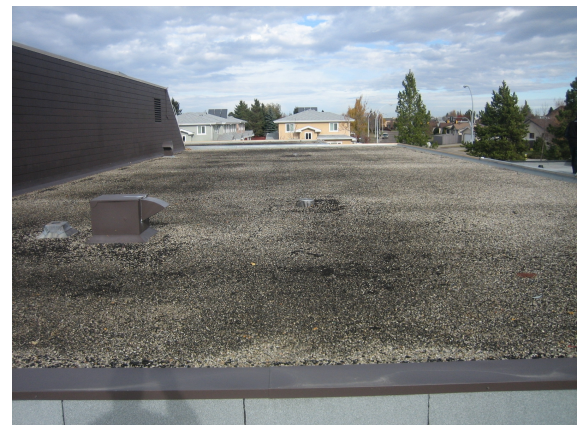
IMG\_8708.jpg

**Event: Replace BUR membrane (1,744m2)**

Evidence of ponding and reports of past leaks. Original roof is nearing end of effective life.

Replace BUR membrane with new SBS membrane roofing system.

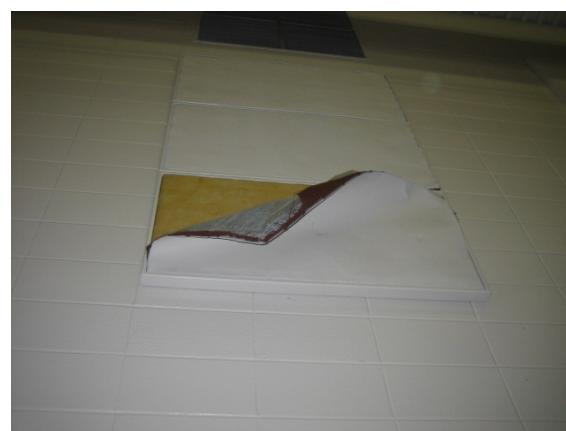
IMG\_9243.jpg

**Event: Replace gym acoustic wall panel fabric (160m2)**

Remove acoustic panels and replace fabric. Re-install acoustic panels.

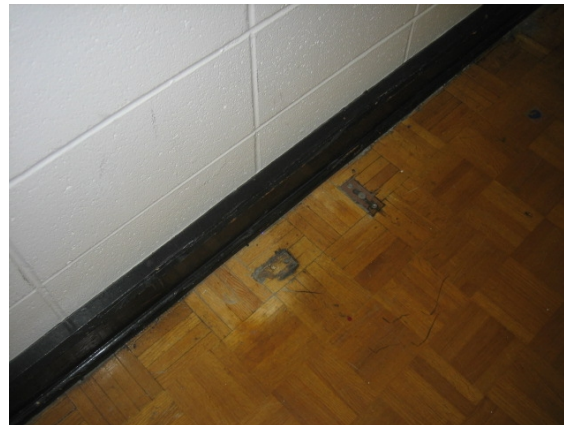
IMG\_9244.jpg

**Event: Replace gym wood flooring (395m2)**

Wood parquet flooring is worn and damaged in some areas. Gym lines are faded and worn.

Recommend providing a new gymnasium floor system.

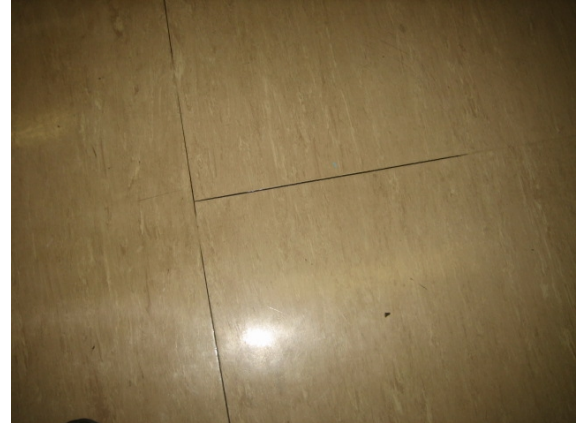
IMG\_9230.jpg

**Event: Replace sheet vinyl flooring (350m2)**

Replace sheet vinyl flooring

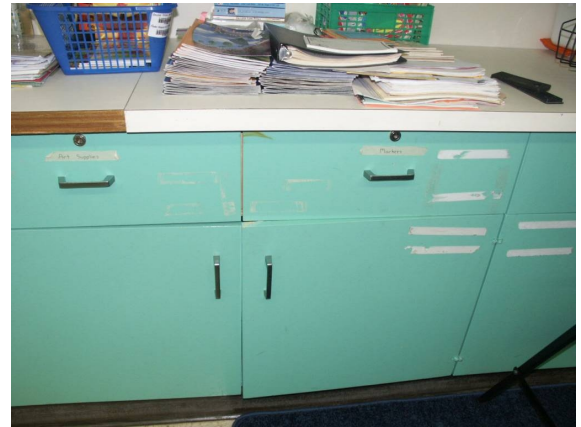
Painted wood cabinets in poor condition. Linoleum and plastic laminate peeling off in two rooms.

Damaged and mis-aligned doors, peeling plastic laminate.

Replace millwork in art room and one classroom

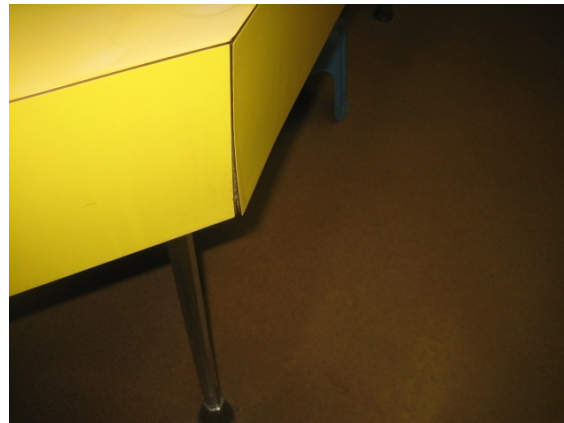
IMG\_9228.jpg

**Event: Replace washroom vanities (5m)**

Washroom vanities have damaged and delaminating plastic laminate.

Replace washroom vanities with plastic laminate vanities.
