RECAPP Facility Evaluation Report

Edmonton School District No. 7

Stratford Academic High School

Evaluation Company: Asset Evolution Incorporated (AEI)
Evaluation Date: May 21 2008
Evaluator Name: Mario Plastina

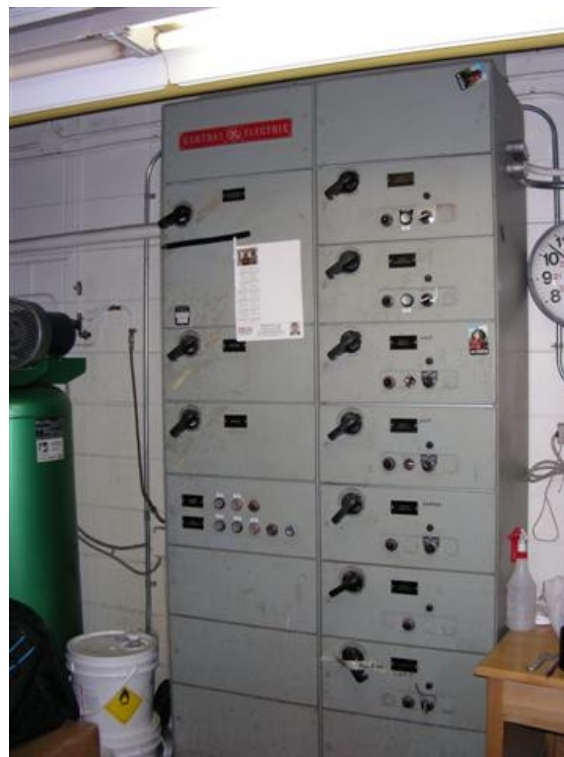
- The distribution equipment is approximately 44 years old - the MCC's should be replaced.
- The lighting controls
- Original T12 lighting fixtures
- Incandescent exterior lighting
- Emergency lighting
- Clock System
- Emergency power system

Aged MCC-1.

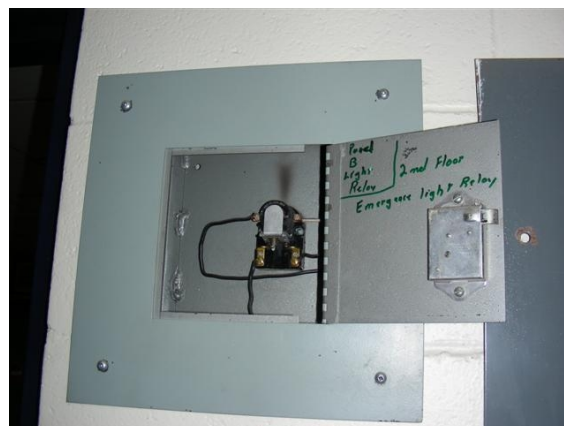
Emergency light relay.

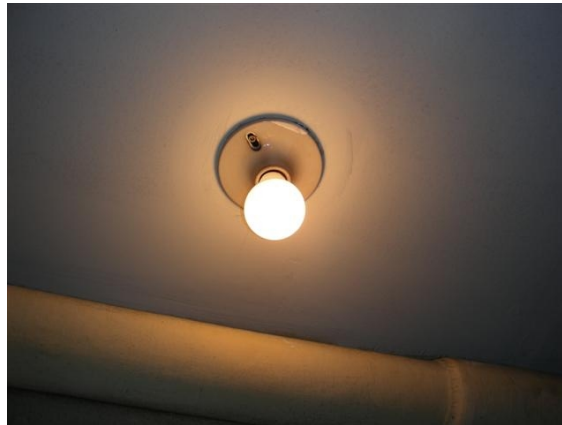
Incandescent lighting in mechanical room.

Replace incandescent fixtures with T8 fluorescent lighting c/w wire guards.

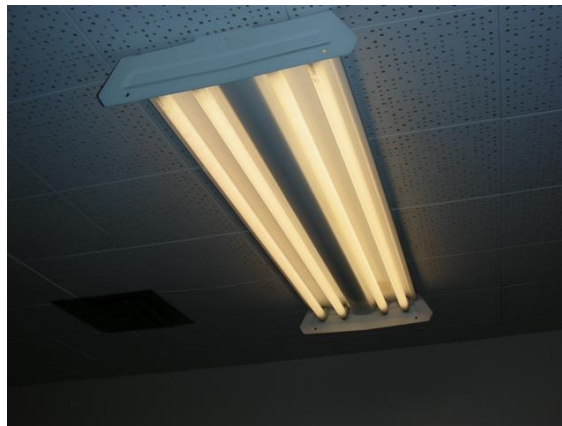
High maintenance and operating costs.

Aged inefficient 4-lamp T12 fluorescent lighting.

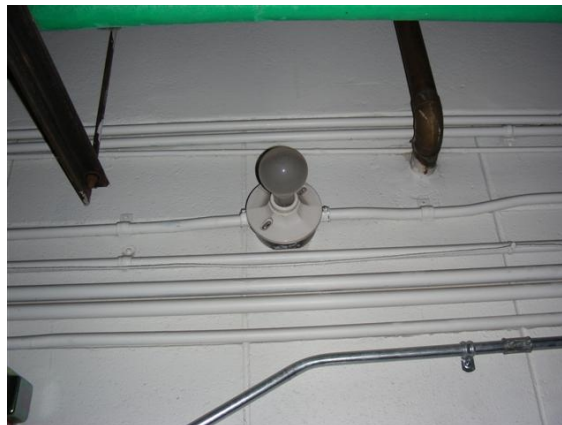
Life safety concern.

Incandescent emergency lighting fixture.

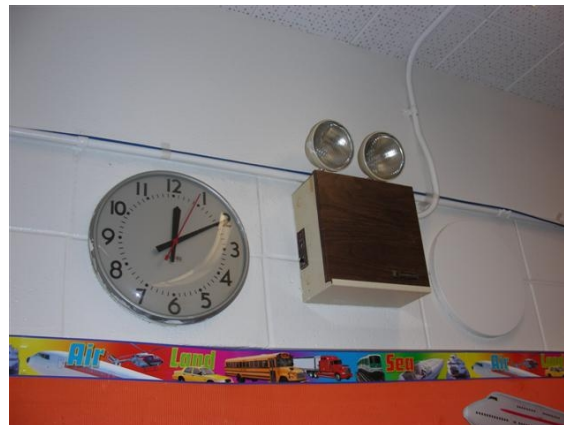
Aged emergency lighting battery unit - not operational.

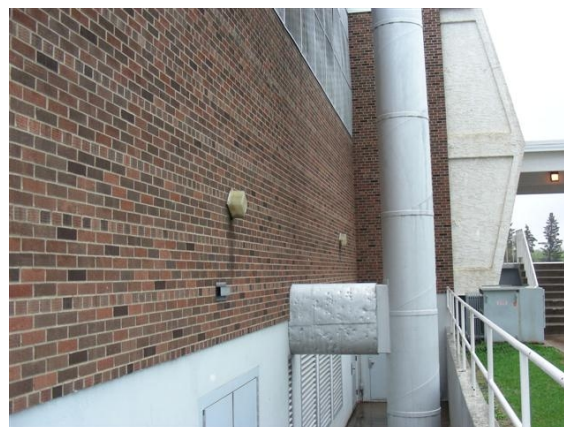
Incandescent exterior lighting.

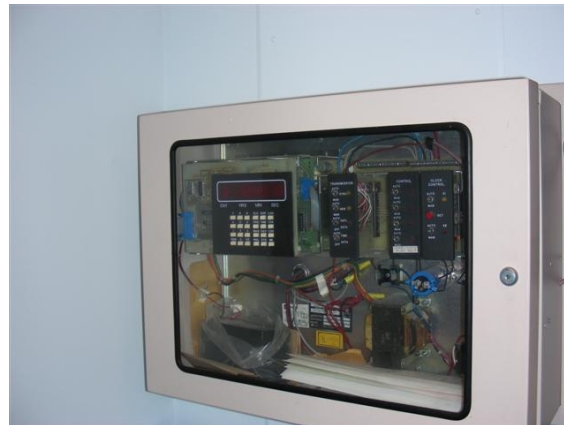
Aged Simplex clock system.

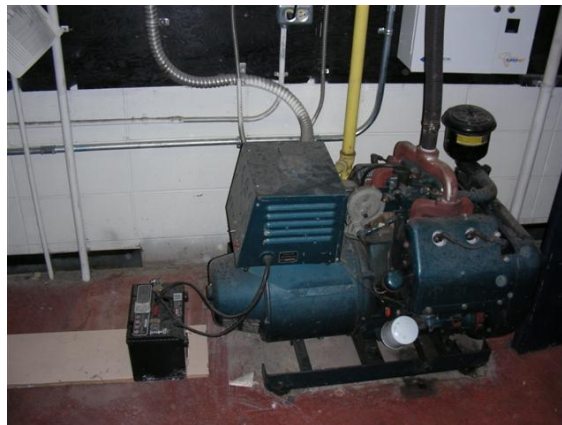
Natural gas emergency generator.
