RECAPP Facility Evaluation Report

Irma School

B3597A

Evaluation Date: June 15 2009

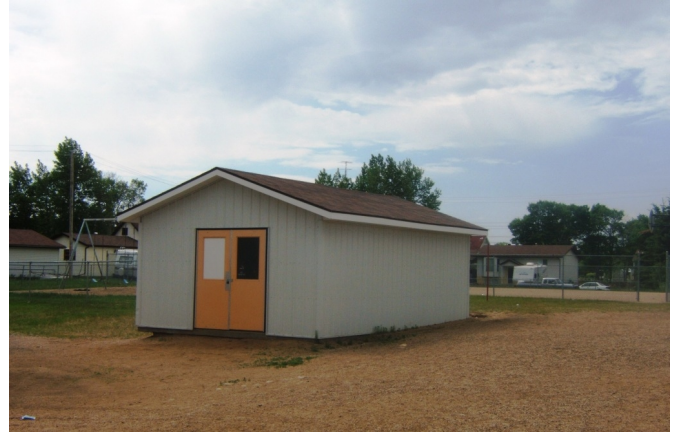
Wood framed shed on wood skids with prefinished metal cladding, painted metal doors and asphalt shingles. No services connected.

<u>Rating</u>	<u>Installed</u>	<u>Design Life</u>	<u>Updated</u>
5 - Good	1984	30	JAN-10

View of storage shed.
