RECAPP Facility Evaluation Report

Lamont Jr. / Sr. High School

B3645A

Evaluation Date: November 22 2011

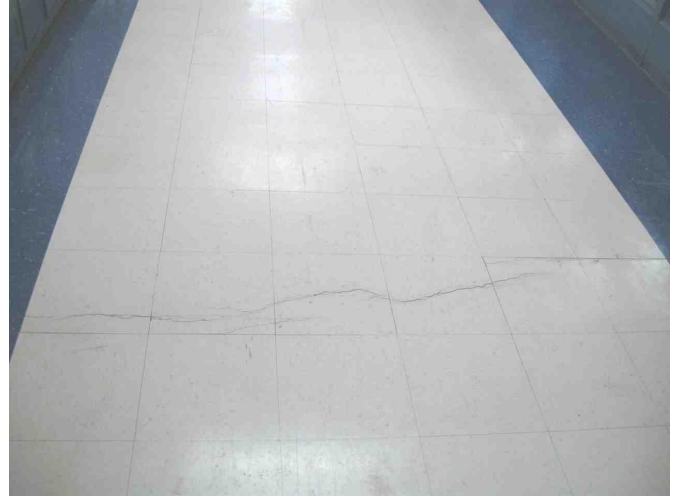
Crack in floor slab near student common area.

Deflection in the floor slab between 1957 and 1998 student common area renovation causing cracks in slab and floor finish. Block wall mortar joint opening marginally at roof due to slab deflection on the east side of the common area.

Mud jack interior and exterior sections of the 1998 slab to stabilize the slab and restore alignment and repair slab joint. Monitor yearly for any additional deflection. Interior flooring repair is shown in C3020.07

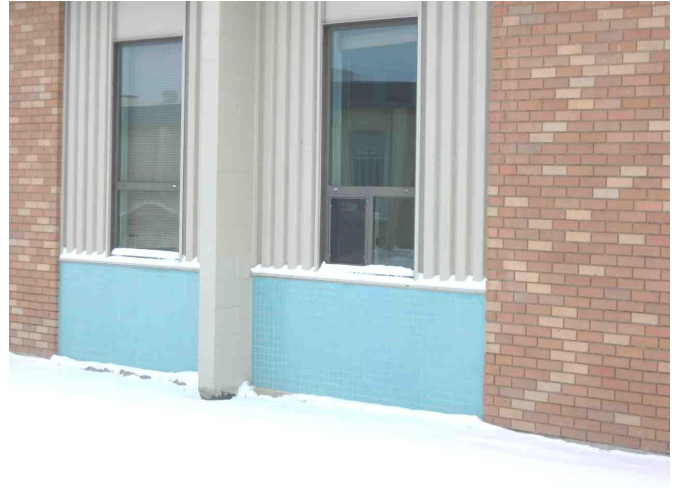
Ceramic tiles under windows and vertical metal siding highlights; 1964 building.

Tiles are falling off and are damaged.

Potential moisture damage to underlying components.

Remove loose tiles and install new cementitious panels or steel siding over existing materials.

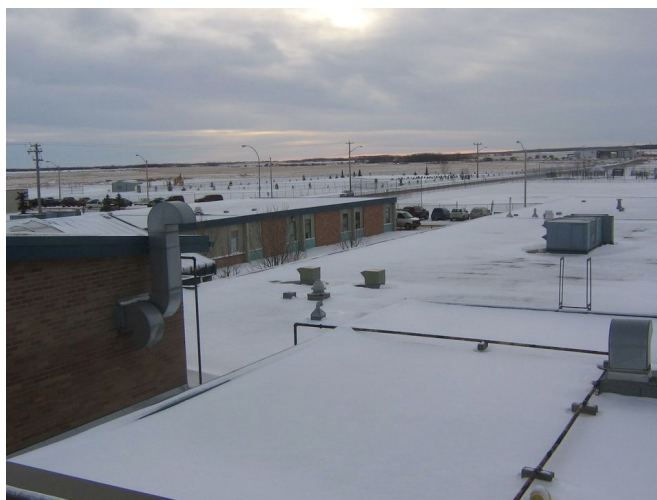
Rusting gas lines on roof.

The gas piping is rusting. As per the natural gas code section 5.16.1 piping exposed to the atmospheres shall be painted.

Further corrosion of the piping.
