# **RECAPP Facility Evaluation Report**

**Matthew Halton Community School**

**B3874A**

**Evaluation Company:** Jacques Whitford Stantec AXYS Limited  
**Evaluation Date:** June 3 2009  
**Evaluator Name:** Mike Plomske

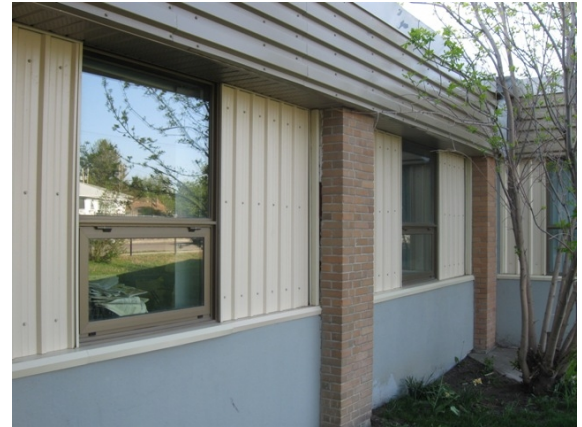
Voids between exterior metal siding and section of brick veneer.

Review and repair exterior metal siding panels as necessary.
