RECAPP Facility Evaluation Report

Westwind School Division #74

Stirling School

Evaluation Details

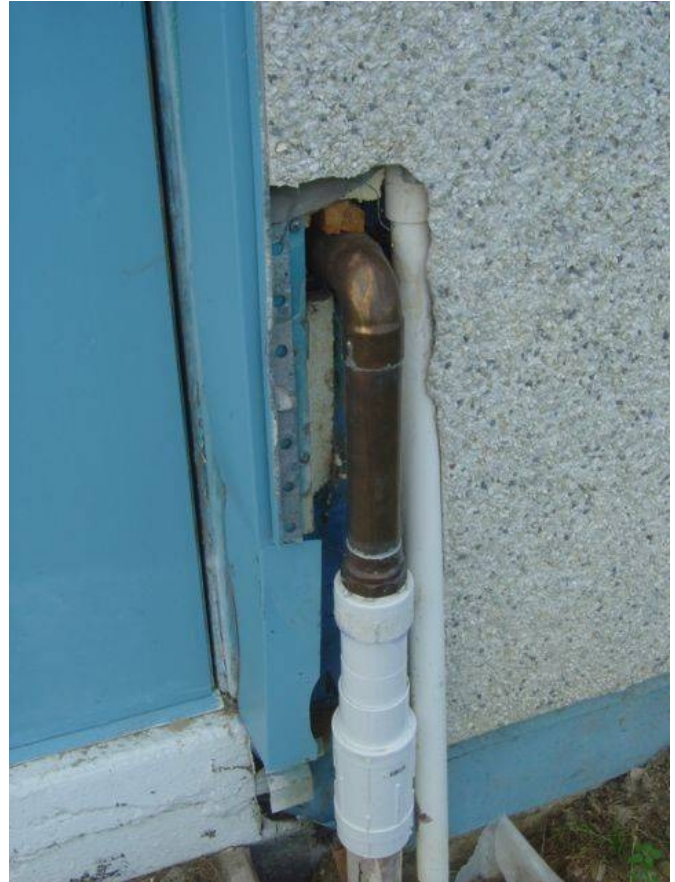
Repair hole by door on the east side of school where rock dash is damaged by pipe. Cost is under \$1,000.

Rock dash stucco needs to be repaired and closed up.

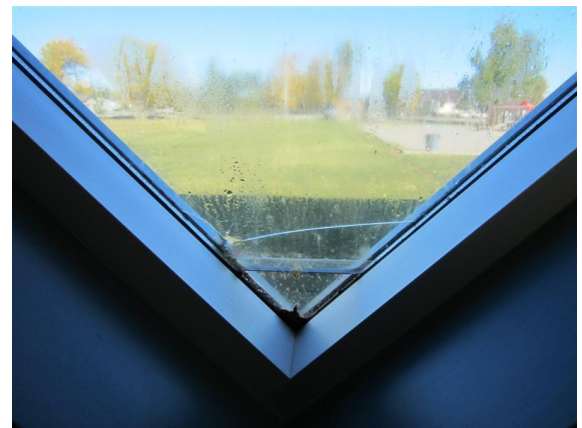
2011-10-12 AI Sterling 094 (Medium).jpg

Window is cracked and there is moisture damage.

Replace window.

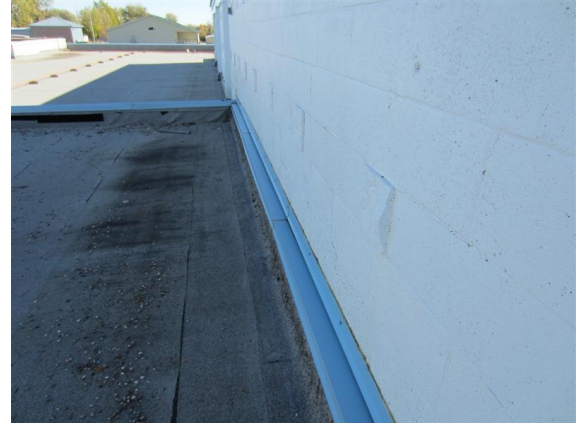
2011-10-12 AI Sterling 314 (Medium).jpg

Portions of the 1992 addition and the 1957 building have failed SBS roofing.

Further water infiltration into the building.

Replace with new white PVC roofing to match recent renovations.

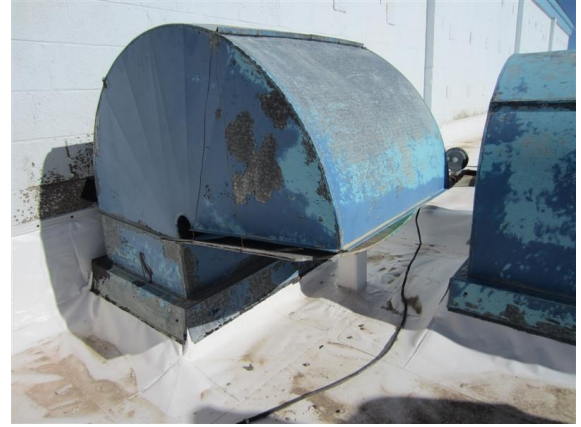
2011-10-12 AI Sterling 335 (Medium).jpg

Roof vent on the south side of gymnasium does not appear to be functional. Vent material is failing.

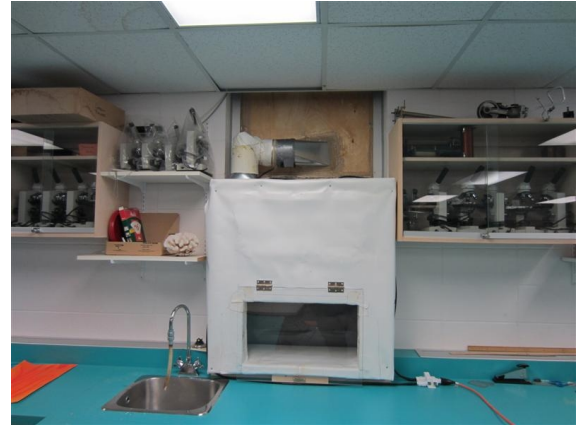
2011-10-12 AI Sterling 248 (Medium).jpg

Event: Replace chemical fume hood (1).
