RECAPP Facility Evaluation Report

Elizabeth Seton Catholic Elementary / Junior High School

B3109A
Edmonton

Evaluation Company: VFA Canada Corporation
Evaluation Date: September 14 2006
Evaluator Name: David S. Greeley, P.Eng.; VFA

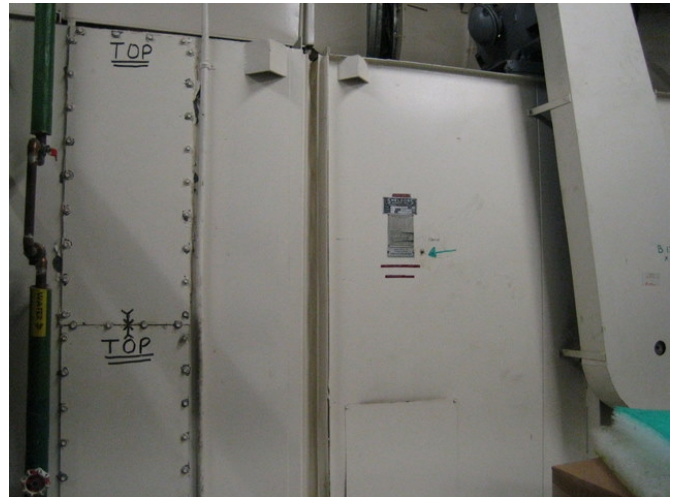
There are six (6) Sheldon Model U-O-35 air handling units serving the main part of the building and two (2) units (make and model not determined) serving the gymnasiums.

<u>Rating</u>	<u>Installed</u>	<u>Design Life</u>	<u>Updated</u>
4 - Acceptable	1977	30	JAN-07

<u>Type</u>	<u>Year</u>	<u>Cost</u>	<u>Priority</u>
Lifecycle Replacement	2010	\$120,000	Low

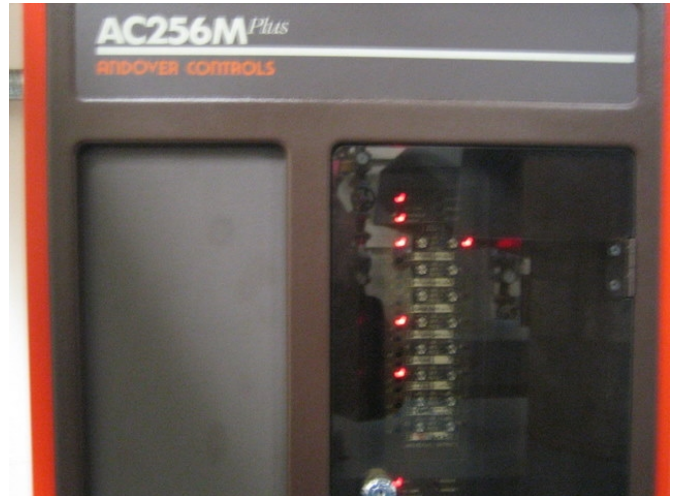
The building is equipped with an Andover building management system (BMS). Temperatures and offsets are controlled off site.

<u>Rating</u>	<u>Installed</u>	<u>Design Life</u>	<u>Updated</u>
4 - Acceptable	1995	25	JAN-07

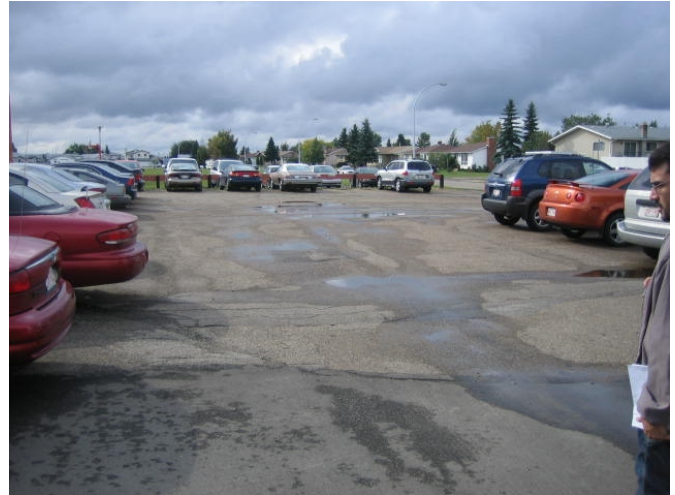
There is a flexible pavement parking lot for staff at the southwest side of the facility. Parking for 22 vehicles.

<u>Rating</u>	<u>Installed</u>	<u>Design Life</u>	<u>Updated</u>
4 - Acceptable	1990	10	JAN-07

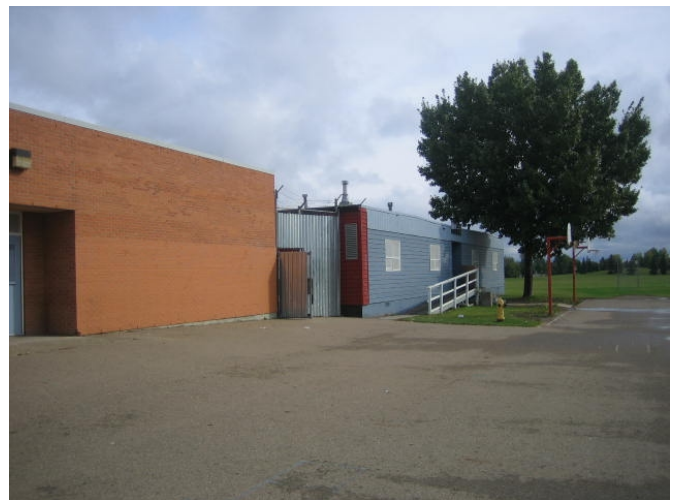
Asphalt pedestrian pavement is used in various locations around the facility, specifically the south side.

<u>Rating</u>	<u>Installed</u>	<u>Design Life</u>	<u>Updated</u>
4 - Acceptable	1990	10	JAN-07

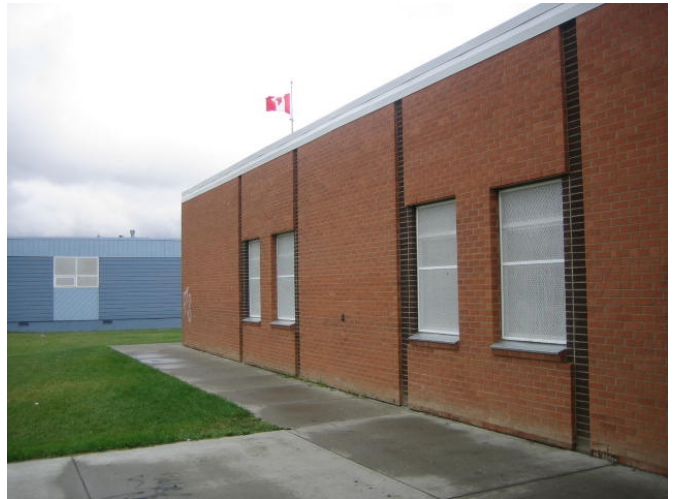
Concrete pavement for pedestrians surrounds the perimeter of the facility and specifically can be found on the north and west sides.

<u>Rating</u>	<u>Installed</u>	<u>Design Life</u>	<u>Updated</u>
5 - Good	2000	15	JAN-07

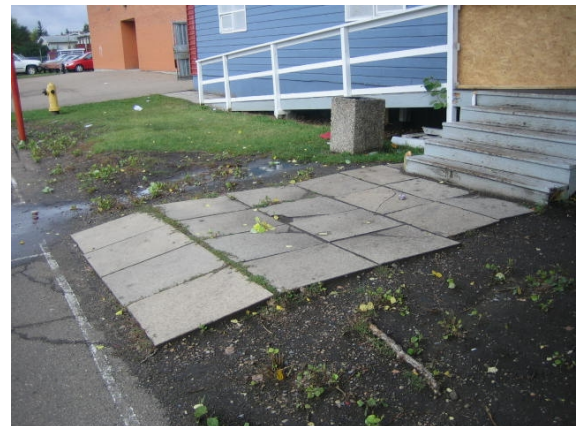
Exterior ramp to clustered portables is concrete pavers.

Potential tripping hazard.

<u>Type</u>	<u>Year</u>	<u>Cost</u>	<u>Priority</u>
Repair	2007	\$1,500	Low

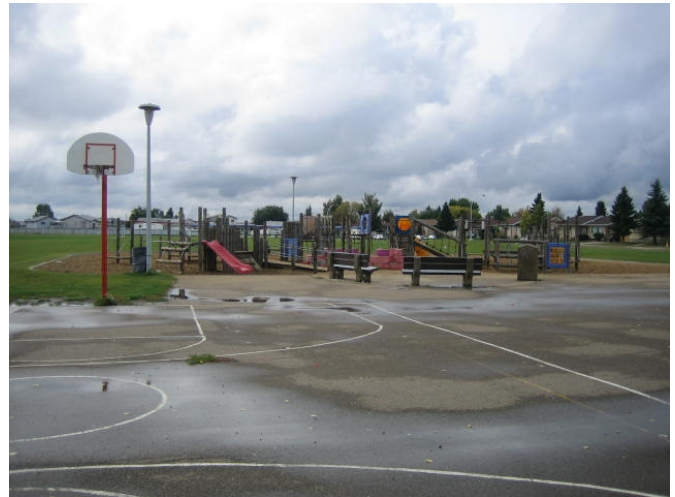
Athletic and recreational surfaces range from grass covered playing fields, asphalt paved basketball courts, shale-surfaced baseball diamonds with backstop, and surfaced playground area.

<u>Rating</u>	<u>Installed</u>	<u>Design Life</u>	<u>Updated</u>
5 - Good	1990	25	JAN-07
