RECAPP Facility Evaluation Report

Florence MacDougall Community School

B3539A

Evaluation Details	
Evaluation Company:	PGA Architects Ltd.
Evaluation Date:	November 30 2006
Evaluator Name:	Peter Komuniecki B. Mngt

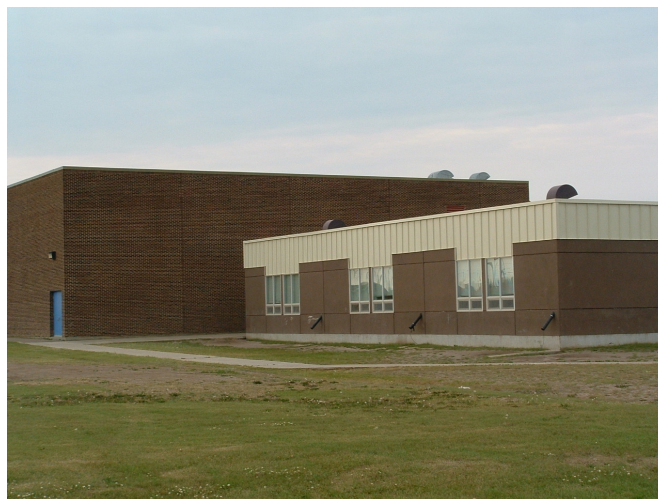
(1992) South-West side of the building - 2 portables with 4 classrooms, gross area 400 sq. m. fully integrated with the main building with stucco finish and metal pitch roof.

<u>Rating</u>	<u>Installed</u>	<u>Design Life</u>	<u>Updated</u>
5 - Good	1992	25	MAR-07
