RECAPP Facility Evaluation Report

Westwind School Division #74

Stirling School

Evaluation Details

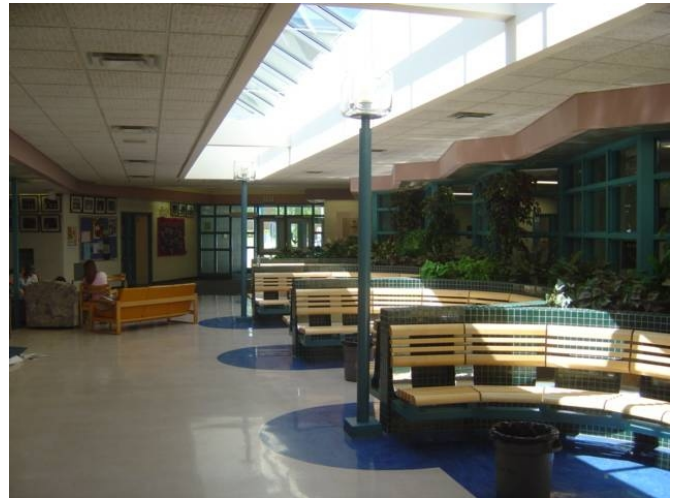
Fixed seating at the gathering area in front of the library and the administration section of the school. Seats are solid pine bench type with metal supports.

<u>Rating</u>	<u>Installed</u>	<u>Design Life</u>	<u>Updated</u>
4 - Acceptable	1992	35	MAR-12

Fixed seating in front of the 1993 gathering area.

Event: Replace wood seating (44 seats)
