RECAPP Facility Evaluation Report

Calgary School District #19

Cecil Swanson Elementary School

B2570A

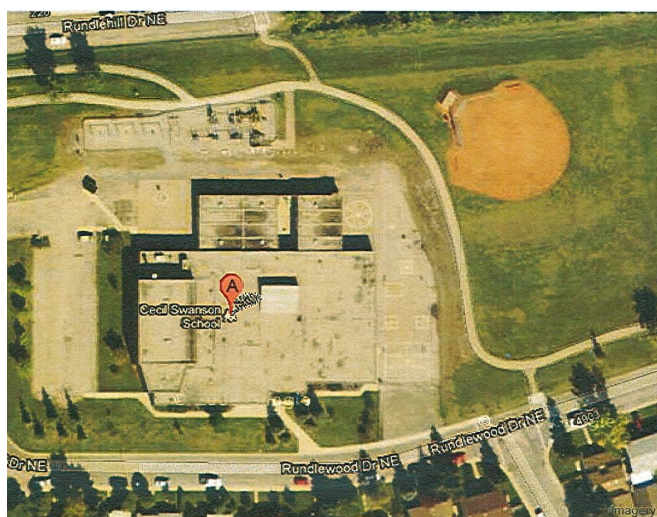
Google site view

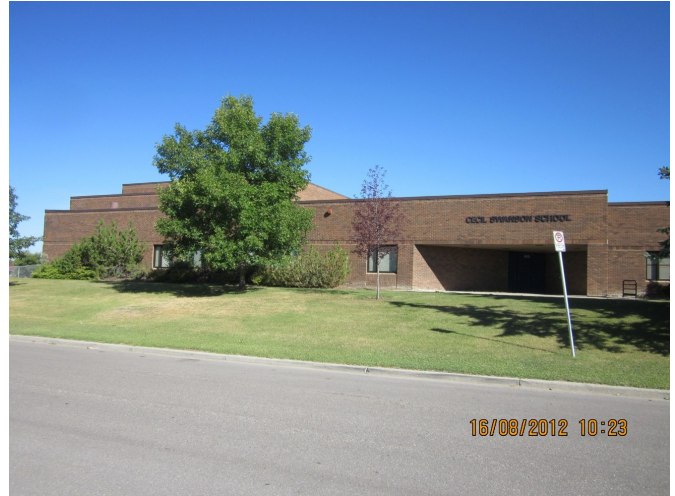
View of west front of school

Cecil Swanson school is located at 4820 Rundlewood Drive N.E. The school is a 1980 Single storey, slab on grade, 3653 m2. Brick veneer clad concrete masonry building with open web steel joists supporting wood deck. 6 relocatable classrooms with open air garden courtyard between the relocatable classrooms. Individual portable information is provided on separate data files (reference numbers T4699, T4700, T4701, T4702, T4703 and T4704)
